Columbia Crew Survival Investigation Report

NASA/SP-2008-565

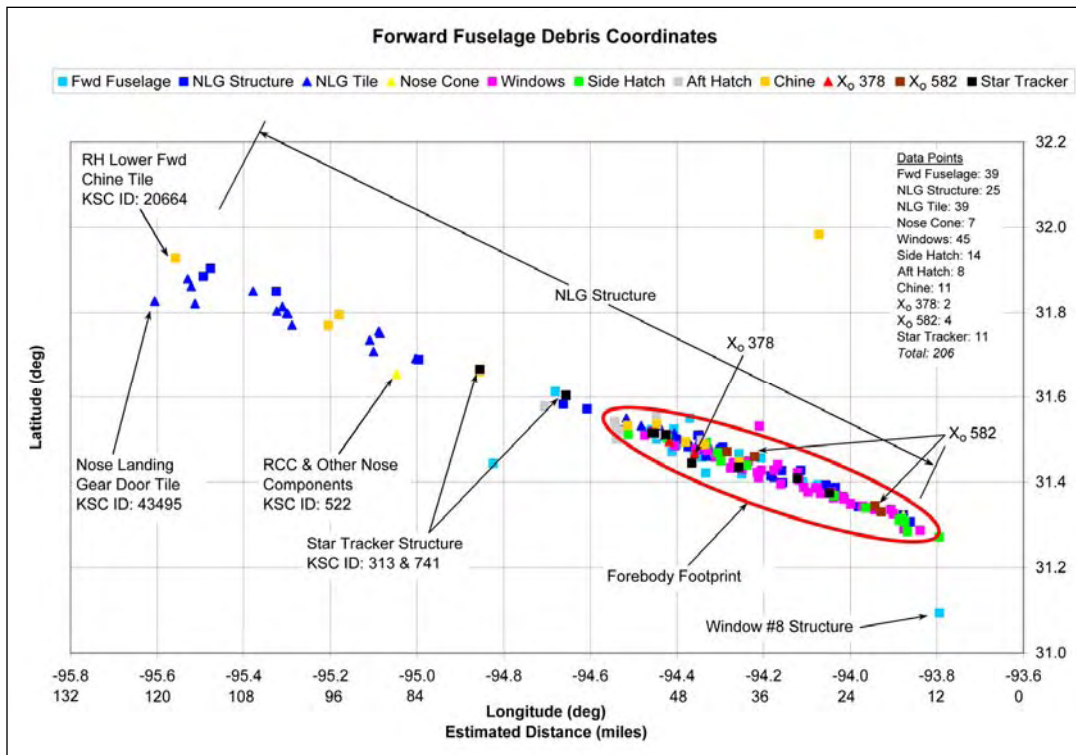
More impacts likely occurred as the forebody continued to rotate. From the CE to the CMCE, it is likely that the CM swung back and forth inside the FF, with both the CM and the FF experiencing impacts at multiple locations. The FF structures would have received damage, possibly creating paths for thermal inflow, as the forebody rotated. Impacts from the relative motion between the CM and the FF would damage the forward bulkheads (X_o 378 and X_{cm} 200), the fuselage frames, and the thinner areas of CM aluminum skin, star tracker well area, etc., depending on the attitude and the rotational movement. Recovered crew equipment debris also came from the forward lockers on the portside, not far from the star tracker wells, lending credence to this. Frame and bulkhead damage would destabilize the FF structures, perhaps popping open numerous items, including the star tracker panels, the TPS around the forward windows, the forward RCS module, the nose gear doors, and the side hatch outer layer. Review of forebody items found in the debris field prior to the main debris field support this conclusion, as portions of the nose gear, star tracker, and multiple tiles and portions of TPS made up this early released debris (figure 2.4-34).

Figure 2.4-34. Forward fuselage debris field showing tile, nose landing gear door structure, and star tracker door structure west of the main forebody debris field.

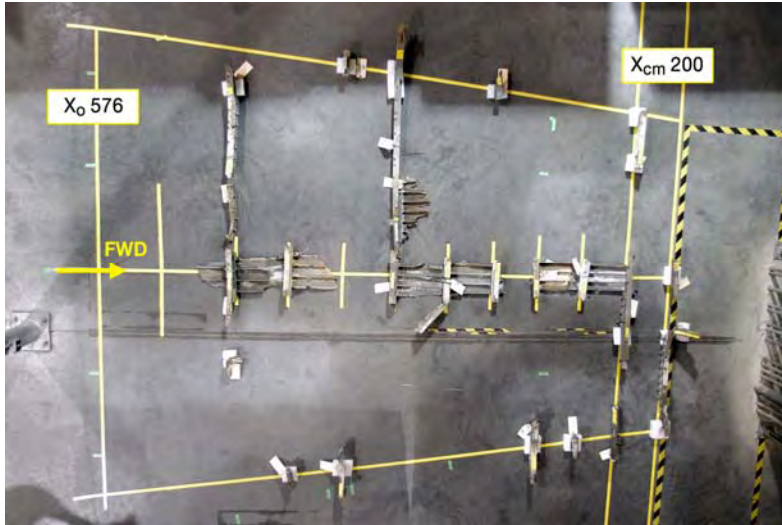
Very little CM skin structure survived. It is very thin, and probably melted quickly after breakup when exposed to entry heating. Only a relatively thicker region of skin strip (0.131-in. thick) along the bottom at the centerline was recovered in multiple pieces (figure 2.4-37).

Figure 2.4-37. Recovered crew module pressure vessel base skin.

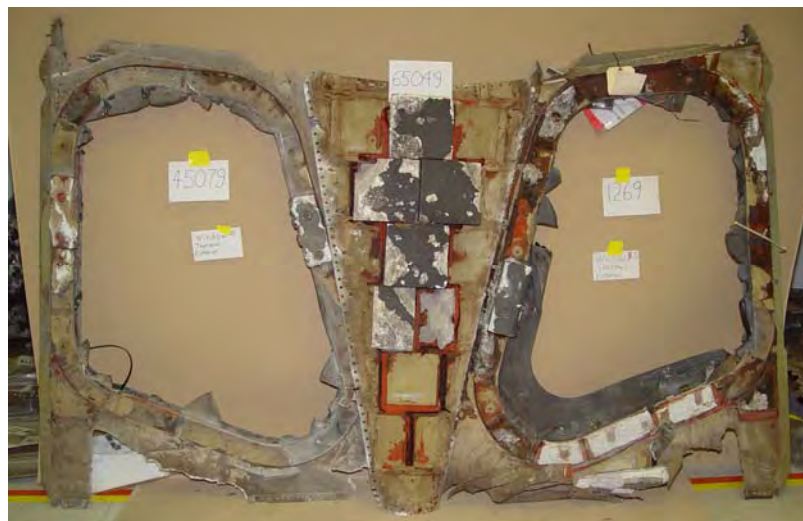
The “arrowhead” skin/TPS panel between Windows 3 and 4 (debris item no. 65049) (figures 2.4-38 and 2.4-39) on the front of the forebody was recovered near the middle of the forebody debris field. It appears to have been torn on the portside and pulled through on the starboard side by mechanical loading, probably initiated by a relative movement between the port Windows 1 through 3 and the starboard Windows 4 through 6.

Figure 2.4-38. Forward fuselage arrowhead panel and the forward two windows, facing in.

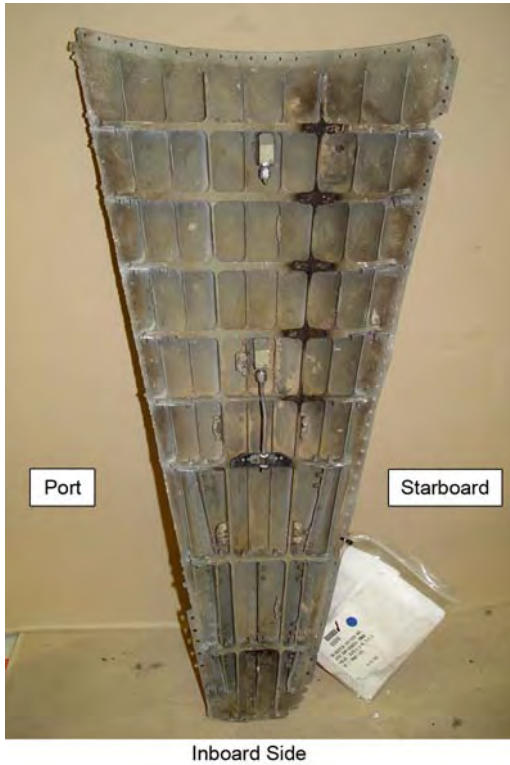
Figure 2.4-39. Low-heat damage on the forward fuselage arrowhead panel, facing out, Columbia Reconstruction Database debris item no. 65049.

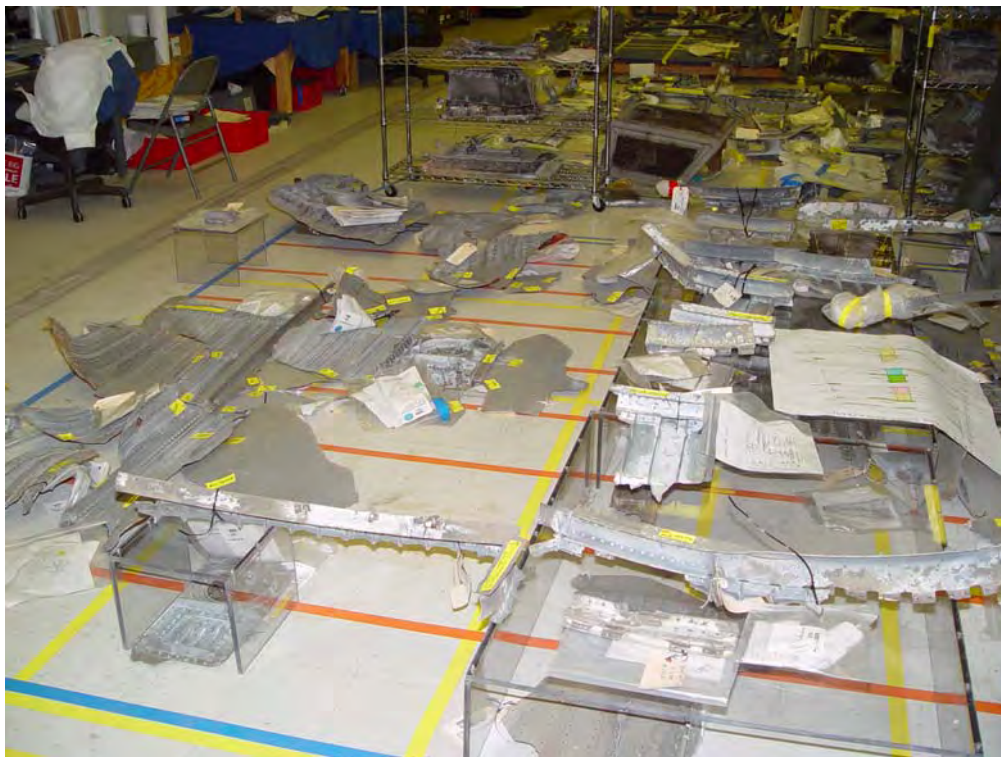
Figures 2.4-40 and 2.4-41 are of the FF skin debris items that lie below the CM. Many panels have little molten metal deposition on the inside surfaces. Broken edges show little thermal damage, and some still have intact primer. This indicates that the plenum behind these areas was not exposed to long durations of thermal flow. Some skin pieces even had stringers that were removed mechanically. Most of the recovered skin debris appears to have mechanically fractured edges. Many forward RCS structural items were recovered; it appears that the forward RCS was pulled away mechanically and broke up into pieces with low thermal effects. The conclusion was that it is likely that the FF skin panel peeled away and broke up quickly.

Figure 2.4-40. Lower forward fuselage skin and frame debris.

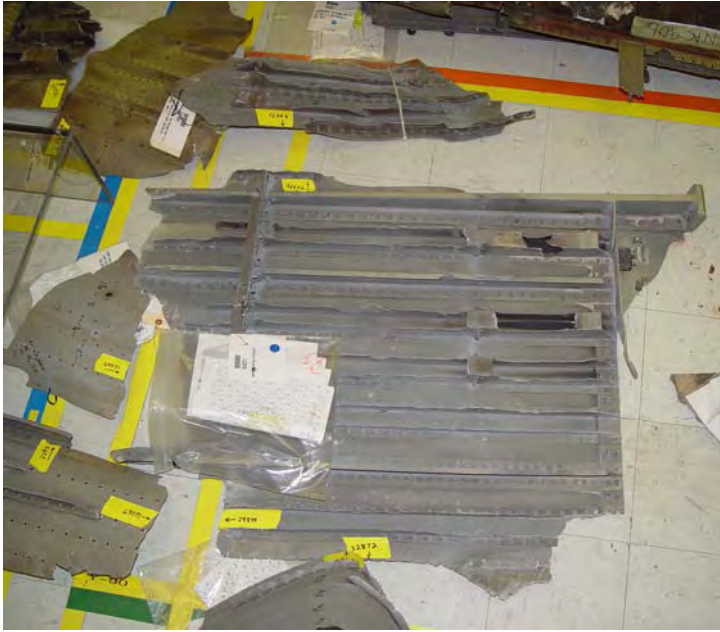
Figure 2.4-41. Lower forward fuselage skin panel near external tank attachment.

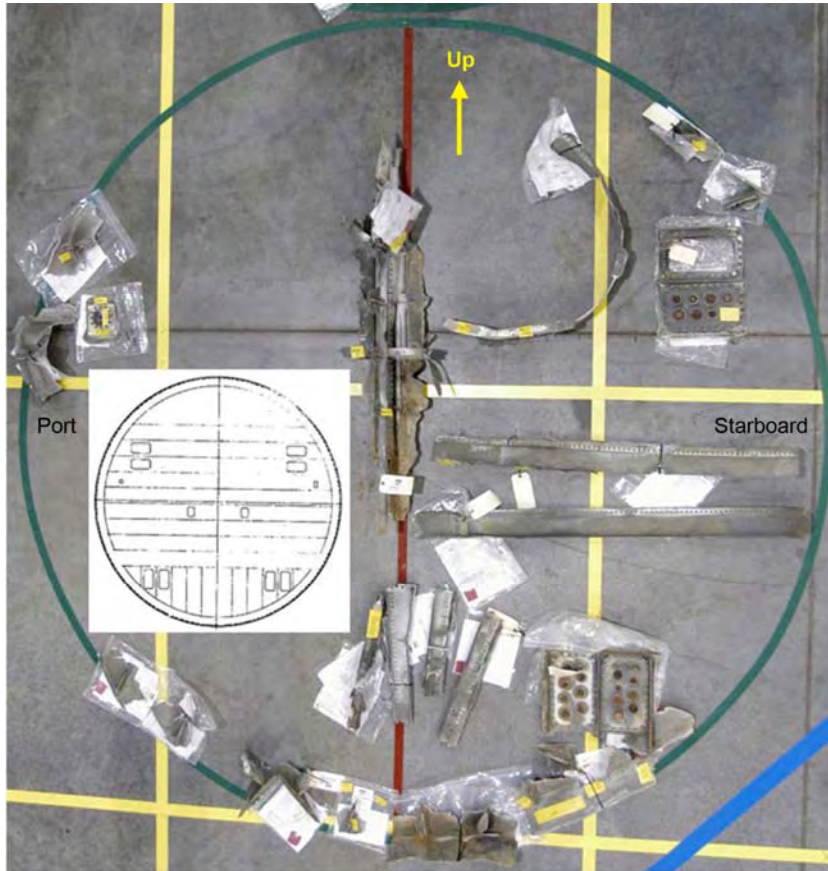
Figure 2.4-42 shows recovered CM forward bulkhead (X_{cm} 200) debris on a grid that is the size of the original bulkhead. As described in the debris field cluster analysis, the CM forward bulkhead debris was recovered west of the aft bulkhead debris, and the middeck starboard debris was recovered west of the port debris. This suggests that the CM middeck starboard/forward was shed first and that the starboard and forward CM areas were exposed to higher heating first and/or faced the velocity vector at the time of the CM major breakup. The main CM breakup involved the departure of the middeck area, including the middeck floor and everything that was attached to that floor. Anything not firmly attached to the flight deck floor also came out with the middeck. Most equipment that was above and below the middeck floor was supported by the middeck floor; avionics bays are also supported by the side skins and bulkheads.

Figure 2.4-42. View looking forward of the recovered crew module X_{cm} 200 bulkhead debris.

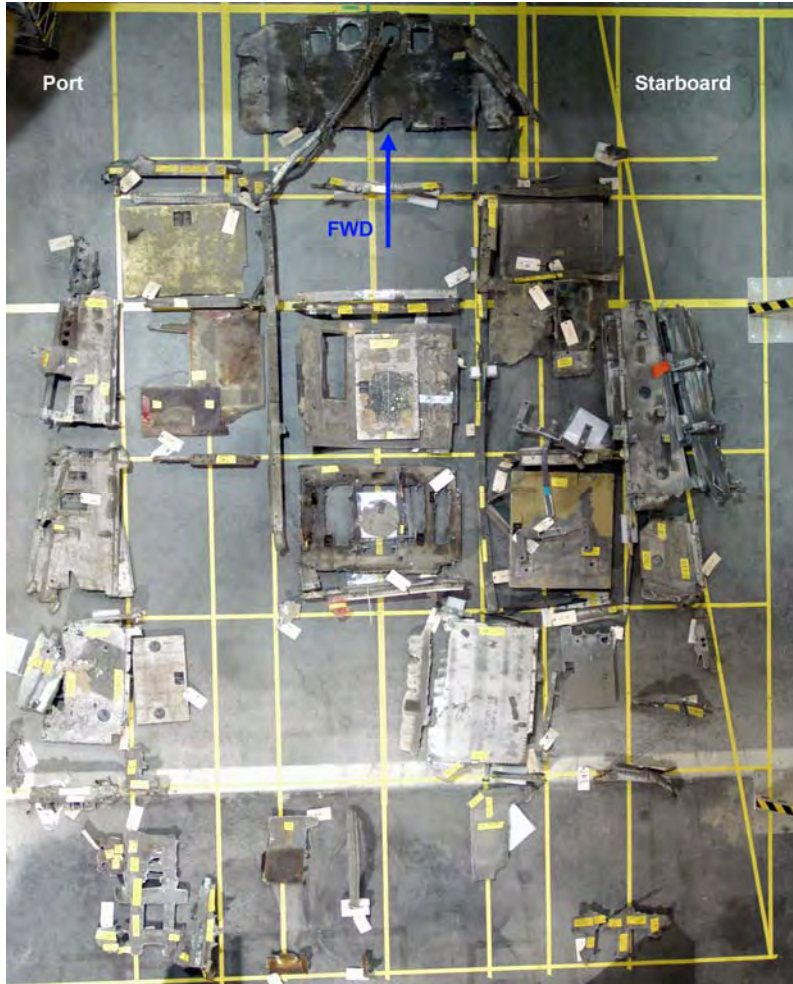
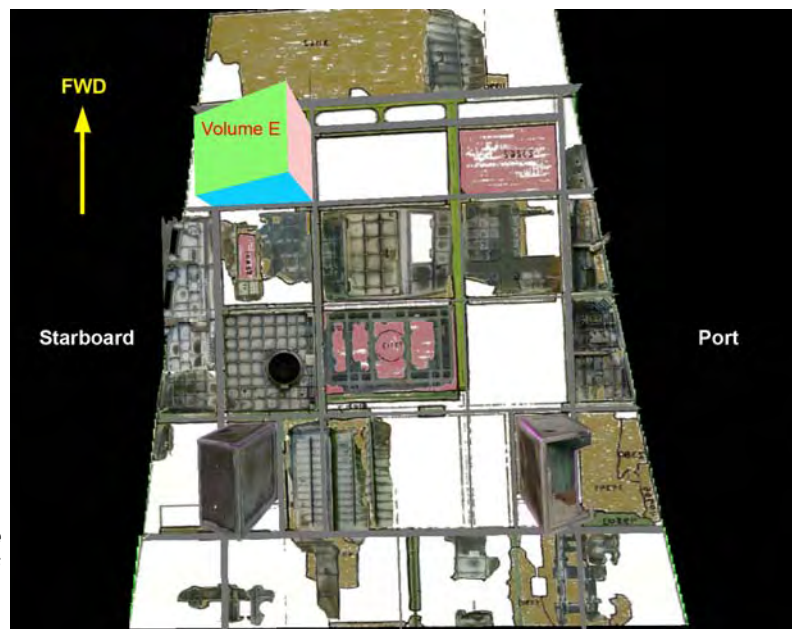
Structurally, the flight deck section is connected to the middeck section and the lower equipment bay is mainly connected by the CM side skin, avionics bay partitions, and the aft and forward bulkheads. The side skin and the forward bulkhead could be easily damaged by aerodynamic heating after the CM lost the protection from the FF shell. Therefore, as soon as the middeck side skin and forward bulkhead were compromised structurally, the lower half of the CM could have swung away from the flight deck portion by the effects of aerodynamic drag. It is likely that the whole middeck floor assembly came out together with the lower equipment bay. The hinge line appears to be at or near where the middeck floor attaches to the aft bulkhead. This motion would expand the middeck compartment (similar to opening a clam shell) and release all items attached to the middeck floor as well as other items stowed beneath that floor. Because the middeck floor disintegrated into many smaller parts without being significantly heated, it appears that the middeck floor failed as a result of structural loading. This may help to explain why more than 65% of the middeck floor was recovered without significant thermal erosion (figures 2.4-43 and 2.4-44).

Figure 2.4-43. Top view of the crew module middeck floor debris.

Figure 2.4-44. Bottom view of the recovered middeck floor items from virtual reconstruction.

The middeck floor and the lower equipment bay quickly disintegrated, with middeck floor panels, crew escape pole, MAR, and other crew equipment items (window shade bag, middeck lockers, sub-floor components, MADS/OEX recorder, etc.) departing quickly from the CM.

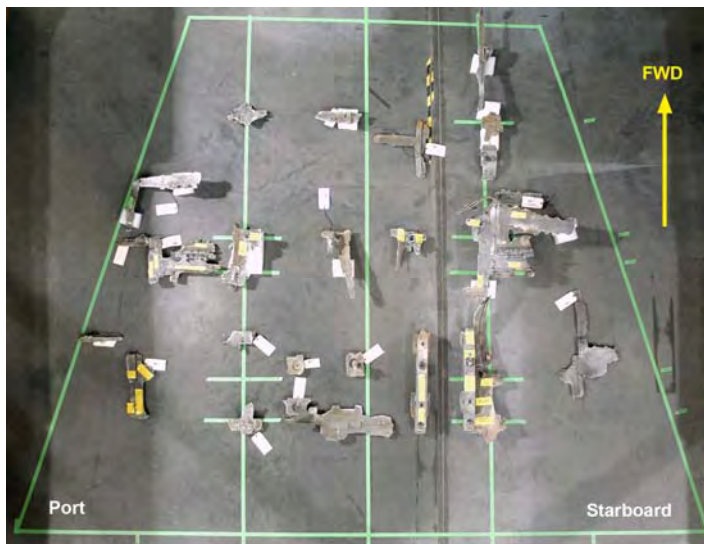
Figure 2.4-45. Top view of the crew module flight deck debris.

From the thermally eroded state of the flight deck debris, it appears that the flight deck stayed nearly intact for a period of time following the departure of the middeck area. This explains why so little of the flight deck floor was recovered (figure 2.4-45). Based on debris field evidence, the internal airlock, which was supported by the MAP (which is part of the X_o 576 bulkhead), likely stayed together with the bulkhead and the flight deck.

Significant mechanical damage was noted on the starboard aft panels of the flight deck. These panels were recovered in much smaller segments than other flight deck panels. This suggests that the starboard side of the flight deck near the aft bulkhead (near the starboard x-link) experienced a more dynamic

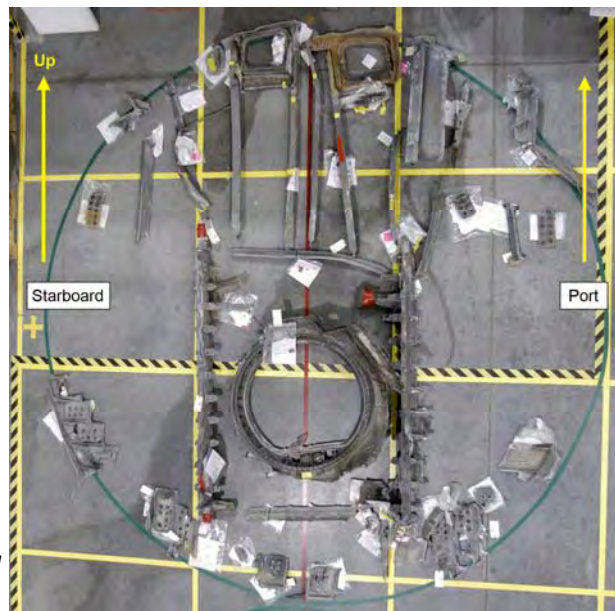
In general, heavy portions of the X_o 576 bulkhead (including the MAP) survived the entry heating (figure 2.4-46). This is possibly due to the high heat absorption property of the aluminum bulkhead.

Some “T”-section stiffeners survived with little heat damage, possibly because of the early departure of these elements before the high thermal event that consumed the bulkhead.

Figure 2.4-46. View looking aft of the recovered X_o 576 bulkhead debris.

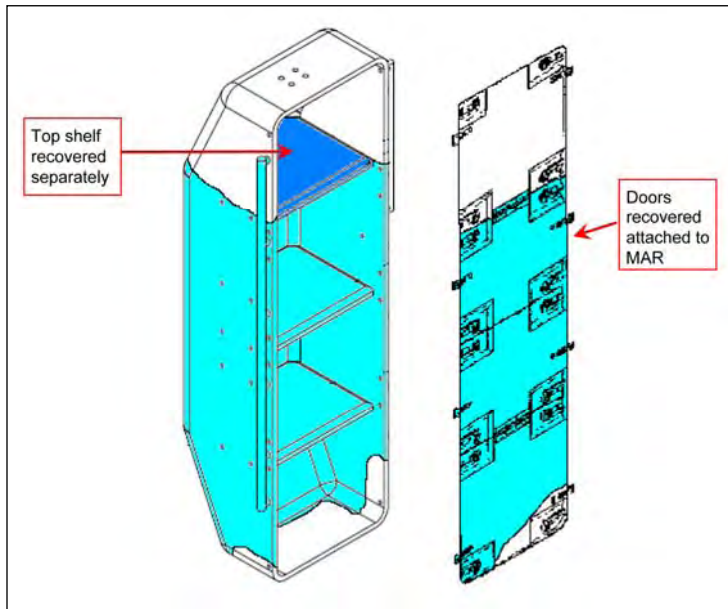
Approximately 75% of the MAR structure was recovered, mostly intact. The blue areas in figure 2.4-48 represent the MAR structure that was recovered. The portions that were not recovered included the upper one-fourth of the MAR structure (including the upper attachment bracket), the top half of the upper door, a portion of the bottom half of the lower door, and the bottom surface of the MAR structure (including floor attachment brackets).

Figure 2.4-48. Recovered middeck accommodations rack structure (shown in blue).

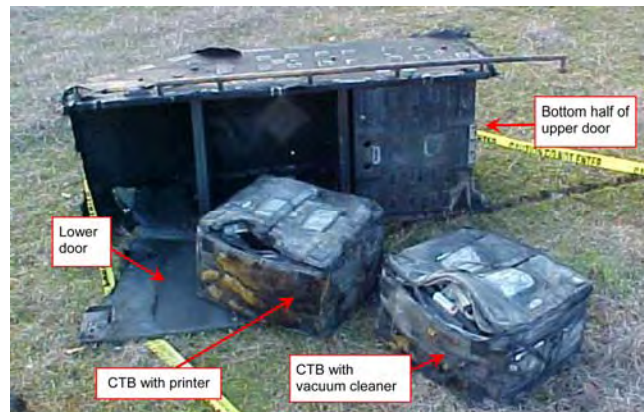
The MAR was recovered with the middle and bottom shelves still attached. The top shelf was recovered separately. The lower door and the bottom half of the upper door were recovered with the MAR structure, as were the contents of the compartment between the middle and bottom shelves (CTBs with the printer and the vacuum cleaner (figure 2.4-49)). The contents of the compartment between the middle and top shelves and the contents of the compartment below the bottom shelf were recovered separately from the MAR structure and were highly fragmented.

Figure 2.4-49. Main middeck accommodations rack structure, as found.

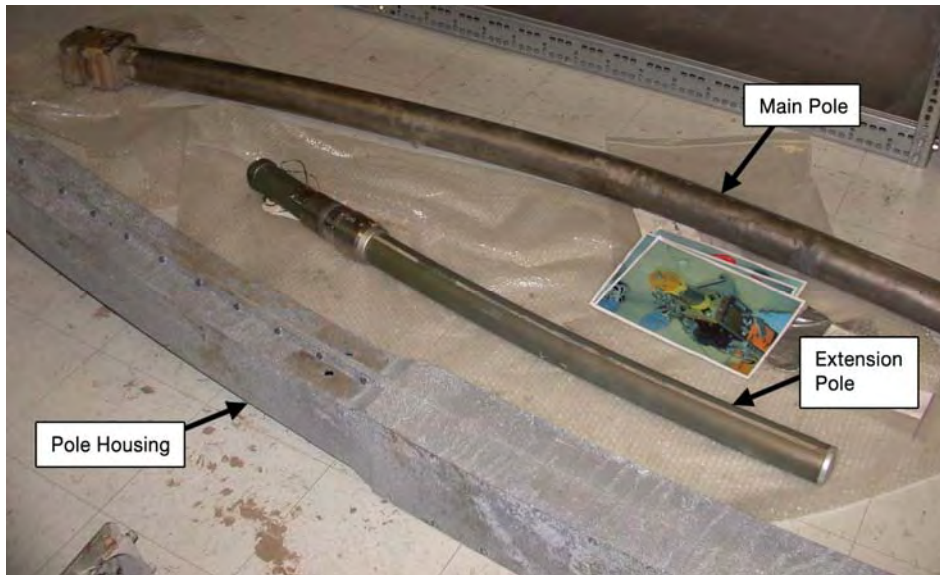
The debris indicates that the pole was installed in the launch/landing position. There is no evidence to suggest that the pole had been deployed (or that the side hatch had been jettisoned³). The pole housing, the main pole, and the extension pole (figure 2.4-52) were recovered separately. The starboard end of the housing, including the middeck ceiling mounting bracket, shows evidence of thermal damage. The main pole and extension pole (figure 2.4-53) were recovered in relatively good condition, showing little mechanical or thermal damage. The main pole deployment spring was recovered separately from the housing, with the starboard end cap of the pole housing attached to the spring. Additionally, the portion of the CM port wall to which the pole attaches was recovered and analyzed. Several lanyards were recovered separately, but the lanyard magazine was not recovered.

Figure 2.4-52. Pole housing, main and extension poles.

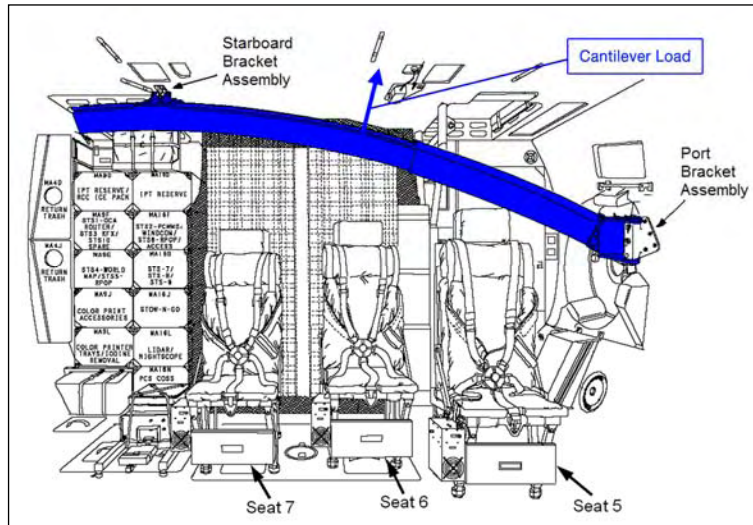
Deformation of the upper portion of the knuckle that attaches to the CM indicates that it experienced an upward cantilever load (figure 2.4-54). This could be caused by the starboard end of the pole moving upward. This suggests that the flight deck separated from the middeck roughly at the flight deck floor/middeck ceiling level.

Figure 2.4-54. Crew escape pole in launch/landing position, middeck, looking aft, with direction of cantilever load noted from debris.

The relative lack of significant witness marks on the pole housing indicates that it experienced very few impacts. These conclusions support the earlier conclusions that the middeck breakup was rapid and expansive, with very little interaction between major structures.

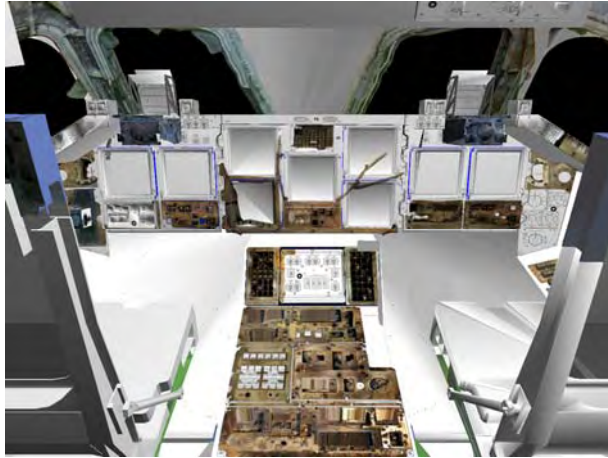
Figure 2.4-56. Virtual reconstruction of the recovered Columbia flight deck panels.

This virtual reconstruction was studied to investigate whether there were clear indications of a thermal or structural breach. However, adjacent panels were seen to have received significantly different amounts of thermal damage. This indicated that some panels broke off earlier than other panels, or were temporarily shielded from the thermal flow during the breakup. The damage varied greatly from one panel to the next, indicating a chaotic breakup sequence. No clear evidence of the initial breach location could be determined.

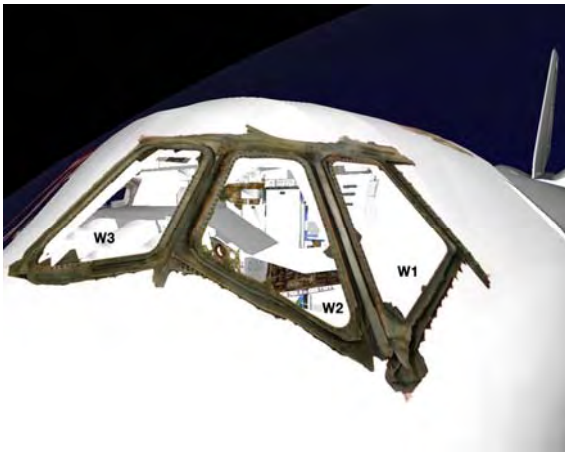
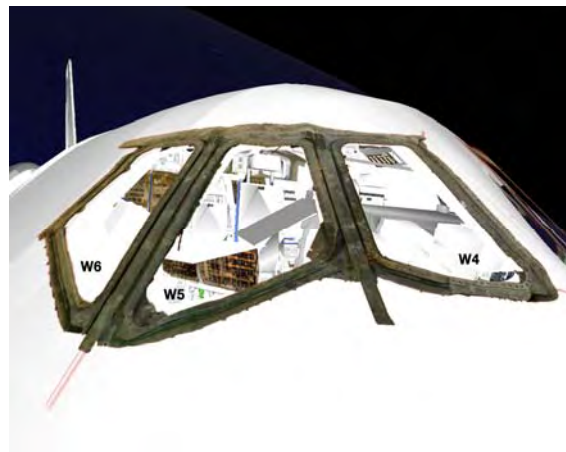
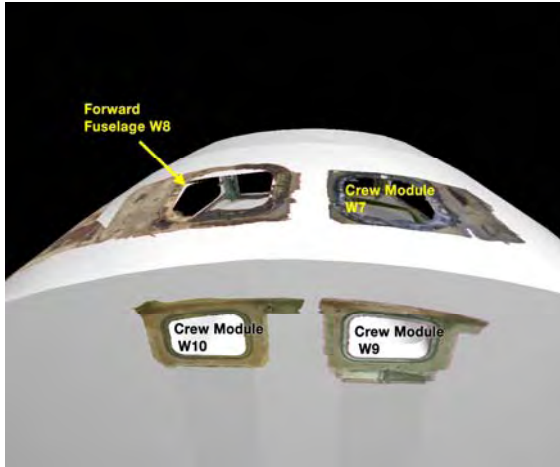
Figure 2.4-57. Port view looking aft, recovered Columbia crew module Windows 1, 2, and 3.

Figure 2.4-58. Starboard view looking aft, recovered Columbia crew module Windows 4, 5, and 6.

Figure 2.4-59. View looking forward, recovered Columbia crew module Windows 7, 9, and 10 and forward fuselage Window 8.

Debris evidence suggests that most of the CM skin structures surrounding the CM flight deck windows had been melted away during the event. One exception is the upper edge of CM aft Windows 9 and 10, which shows mechanical fracture edges.

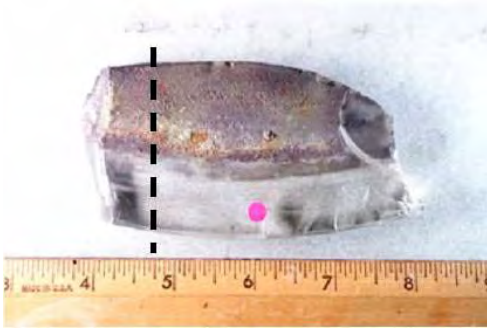
Figure 2.4-60. Window fragment removed from the thermal pane frame from Window 8. The black dashed line denotes the sectioning plane. The red dot was used to indicate the outward face of the pane.

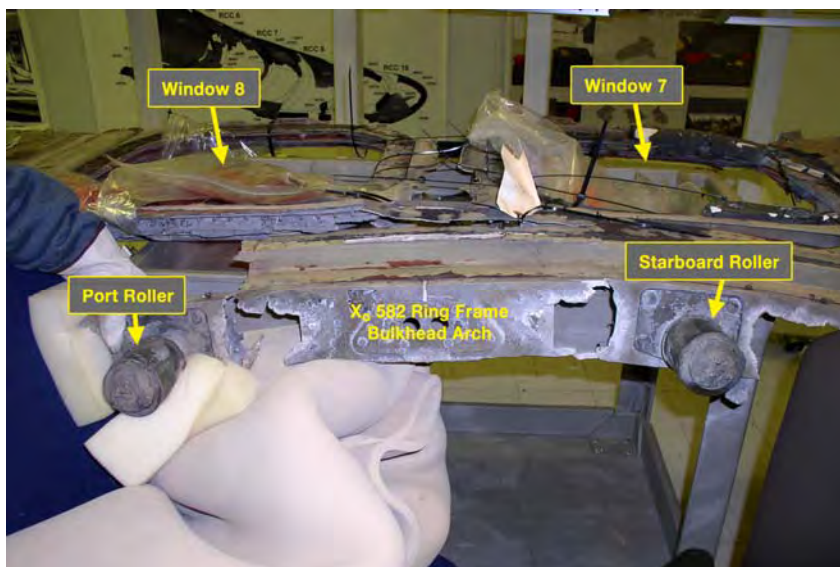
Figure 2.4-63. Columbia debris for same location. Note eroded rollers and eroded region of the X, 582 ring frame bulkhead arch between the rollers.

The recovered rollers for the location closest to the overhead windows both showed significant signs of erosion. While these rollers were not the only components made of titanium, they were the only ones recovered that possessed the proper material, proximity, and thermal indications and were, therefore, concluded as the source location. Given these findings, the rollers were the most probable source of titanium causing the deposition on the windows.

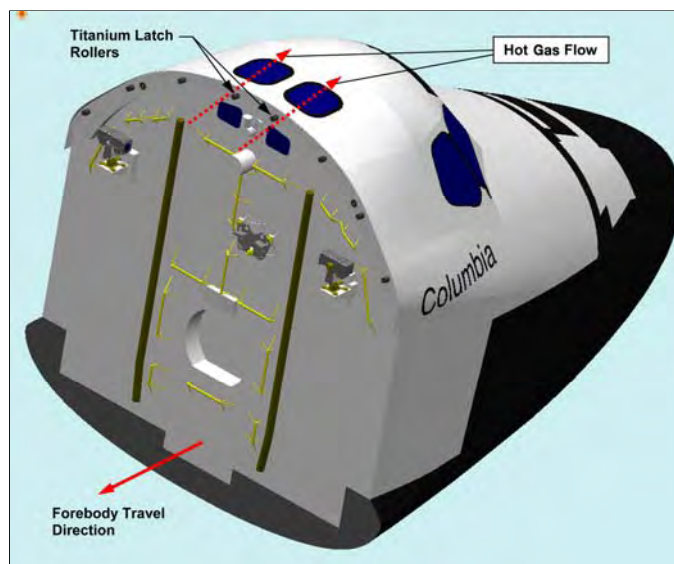
Since the rollers are located on the X₀ 582 ring frame bulkhead arch aft and below these two windows, and protected by the PLBDs, the PLBDs must have been compromised or fully departed while the bulkhead arch was still attached to the CM. Additionally, the forebody must have been traveling aft-end forward for some period of time to have the directional thermal flow that caused the titanium to “vaporize” flow over the glass external surface of the Windows 7 and 8 redundant panes, it can be concluded that the thermal panes were intact at the time of this event. This is consistent with other findings showing that the FF remained with the CM until breakup of both elements.

Figure 2.4-64. Titanium deposit on windows indicates forebody traveled backwards.

Finding. Windows 7 and 8 experienced a titanium deposition event that occurred prior to window breakup.

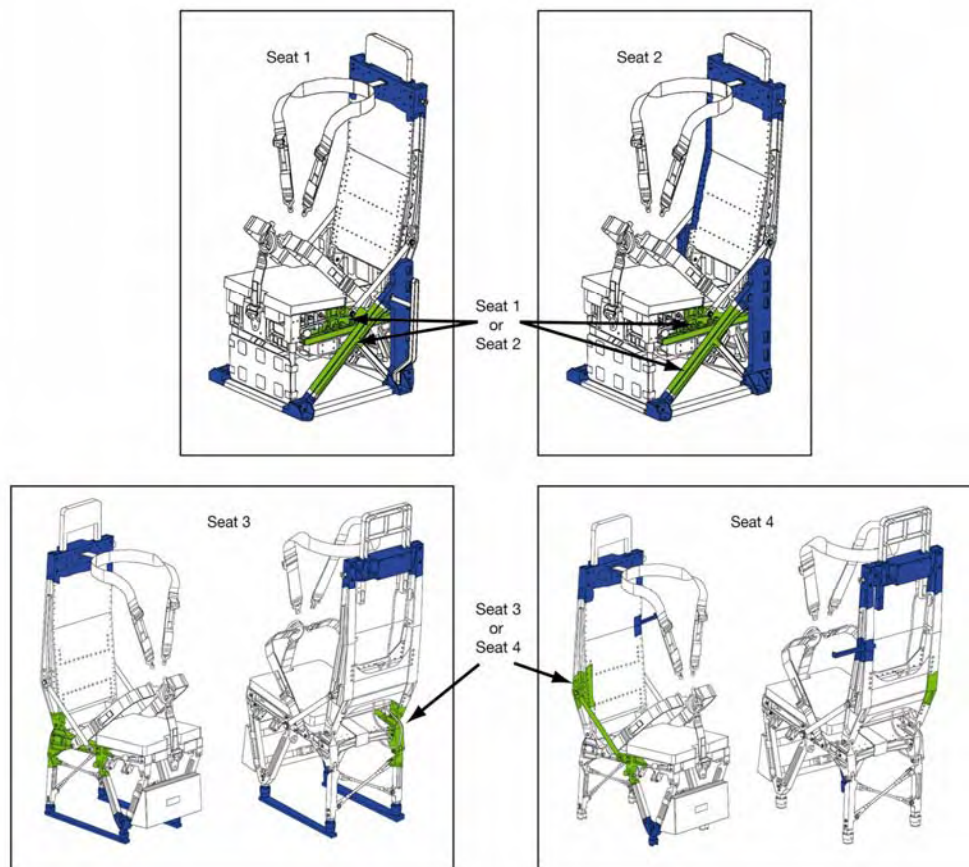
Figure 3.1-6. Identified debris from the flight deck seats. [Adapted from the Space Shuttle Systems Handbook]

Figures 3.1-6 and 3.1-7 show seat structure pieces that were identified to each seat location. The blue items in these figures represent items that were positively identified to a seat location. The green items are those items that could be from one of two seats. Figure 3.1-8 shows the major seat structure debris pieces that could not be identified to a specific seat location (the colors in this figure distinguish the different pieces and are otherwise inconsequential). Although represented in figure 3.1-8 on just two seats, the seatback and seat restraint items could be from any of the seven seats. However, the seat pan items could only be from the Mission Specialist seats.

Blue items are positively identified to a specific seat;
green items could be from either one of the two indicated seats.

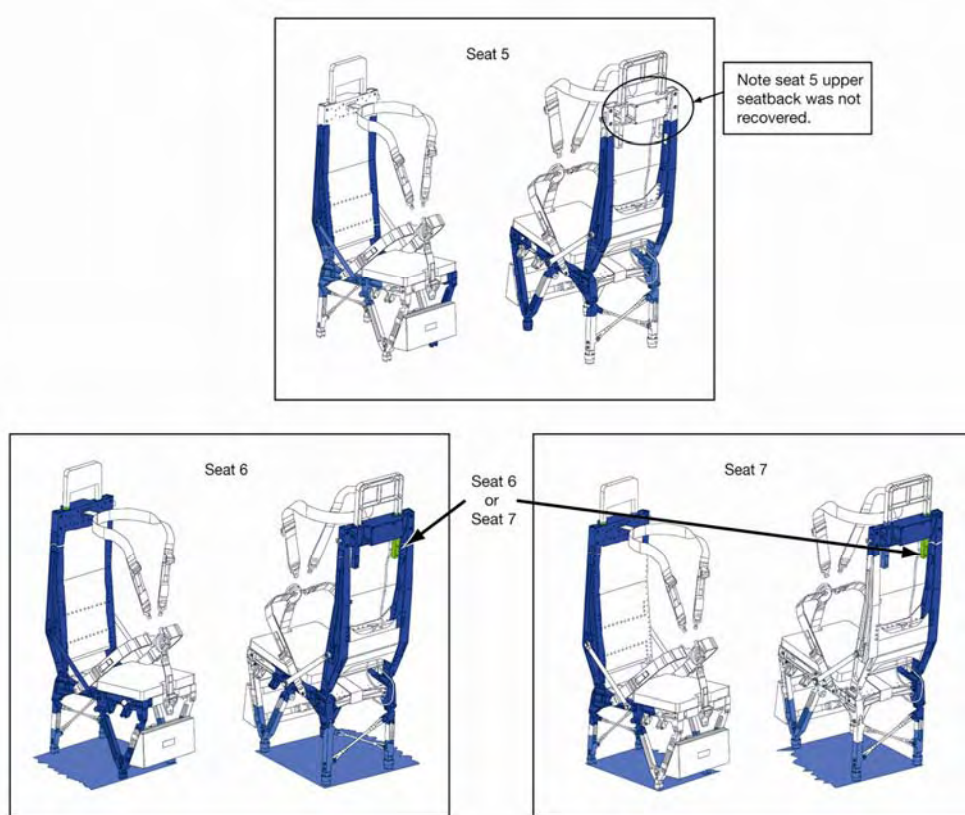
Figure 3.1-7. Identified debris from the middeck seats. [Adapted from the Space Shuttle Systems Handbook]

Blue items are positively identified to a specific seat;
green items could be from either one of the two indicated seats.

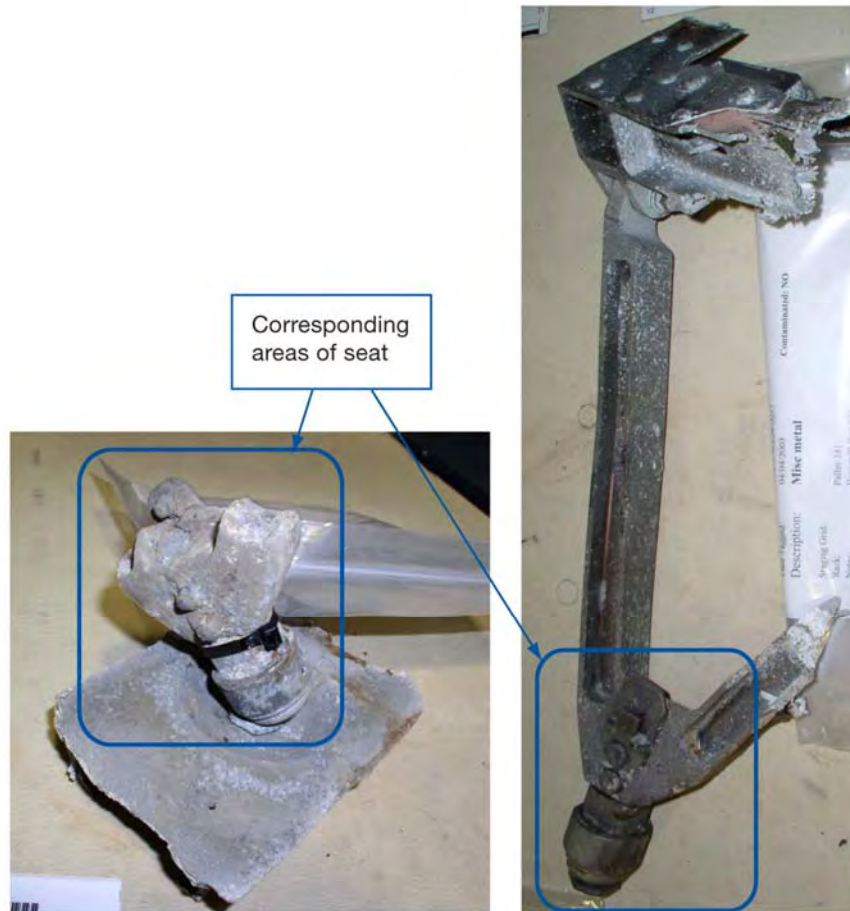
The magnitude and distribution of heating of flight deck seat components indicates a prolonged attachment to other crew module (CM) structure during exposure to heating. This indicates that the flight deck seat components were released from the CM later in the breakup sequence than the middeck seat components. Ground plots of debris recovery locations also support this conclusion (figure 3.1-9). Figure 3.1-10 compares a portion of the seat leg from a flight deck Mission Specialist seat component with a similar component from a middeck seat.

Figure 3.1-10. Comparison of seat debris from a flight deck Mission Specialist seat (left) and a middeck Mission Specialist seat (right).

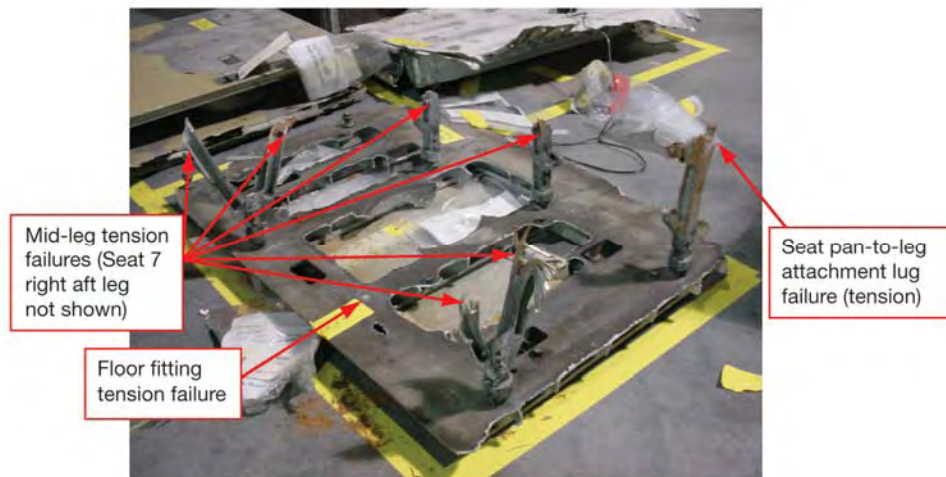
Figure 3.1-14. Recovered lithium hydroxide door with seats 6 and 7 legs attached.

Seats 6 and 7 leg failures occurred with the legs in tension. The lowest strength margin (and, therefore, the expected failure point) at room temperature is at the leg attachment lug at the top of the leg. Analysis indicates that the leg attachment lug should fail at around 12,000 lbs. at room temperature, but only the left aft leg of seat 6 failed at the attachment lug (figure 3.1-14). Another expected leg failure point is the seat attachment floor fitting. At room temperature, the floor fitting should fail at around 21,400 lbs., but only the right forward leg from seat 6 failed at the floor fitting.

Five of the eight seat legs failed at mid-leg locations. The room temperature failure load for mid-leg fractures of the forward leg is 45,000 lbs. and the aft leg failure load is 24,000 lbs.

The seat 7 right forward leg floor fitting is present, but the corresponding seat 7 leg was not recovered; therefore, the failure location was not the floor fitting. Because this leg is very close to the edge of the LiOH door, it is possible that the failure occurred because the locking collar⁷ was thermally damaged as the LiOH door/seat 6/seat 7 complex experienced entry heating.

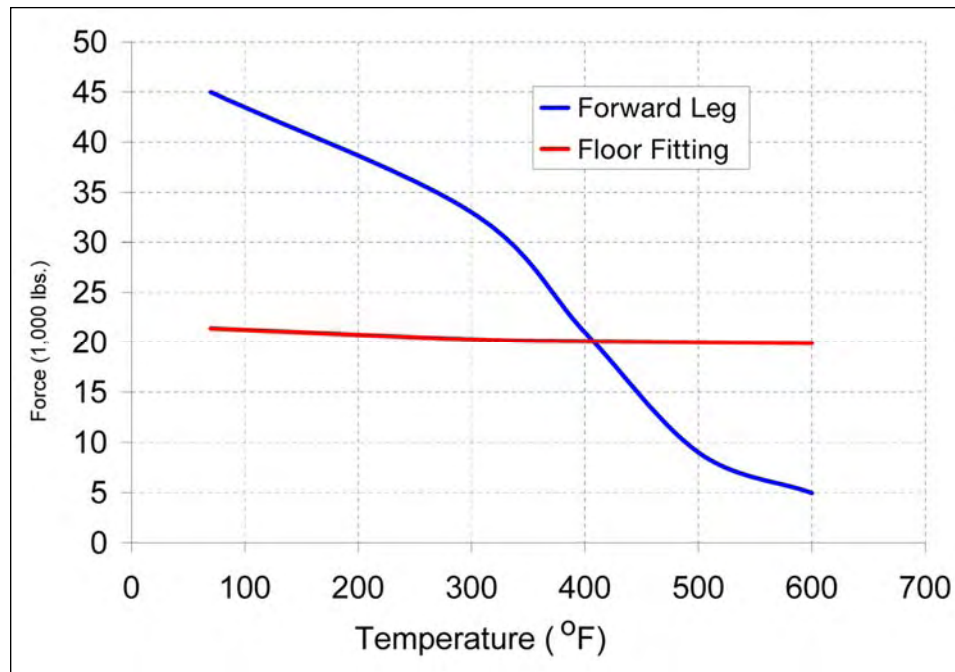
A force of 21,400 lbs. is required to fracture the floor fitting at room temperature. This force decreases to 20,300 lbs. (~95% of room temperature strength) at 300°F (149°C), 20,100 lbs. (~94%) at 400°F (204°C), and 19,900 lbs. (~93%) at 600°F (316°C). These values are plotted in figure 3.1-15.

Figure 3.1-15. Failure force of seat forward leg and floor fitting vs. temperature.

This plot reveals that heating greater than 400°F (204°C) is needed to weaken the materials such that the leg failure would occur at the mid-leg location. Otherwise, the forward legs should have failed at the floor fitting, which did not occur.

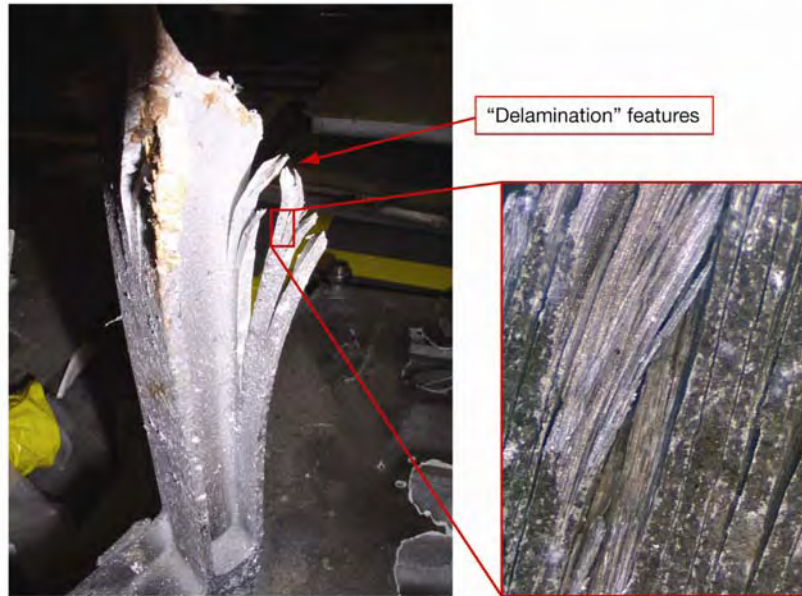
Inspection of the seat structure fracture surfaces revealed a “delamination” fracture pattern that is consistent throughout the seat debris items. The most drastic of the fractures makes it appear almost as if the 7075 aluminum material is constructed of a laminate material (figure 3.1-16). This phenomenon is termed a “broom-straw” fracture.

Figure 3.1-16. Example of a “broom-straw” fracture on a Columbia seat leg.

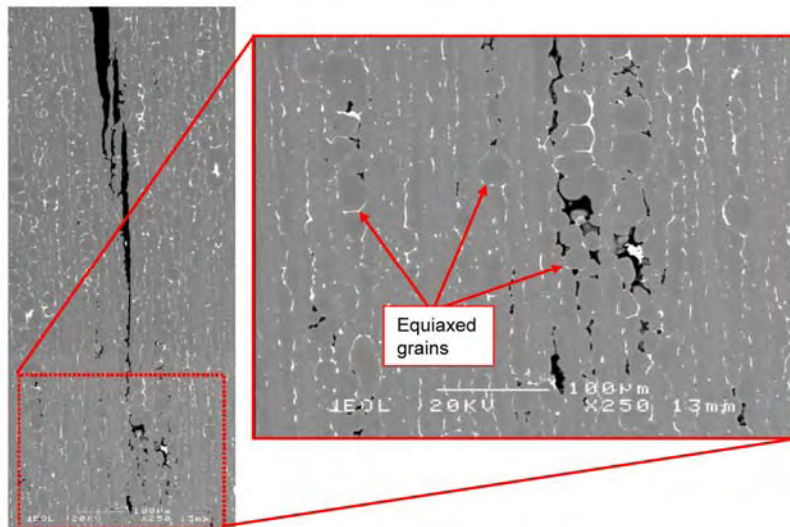
Scanning electron microscope analysis of the seat broom-straw fracture surface cross sections revealed fully intergranular fractures and equiaxed grain⁸ microstructure. This finding is consistent with exposure to elevated temperatures and high strain rates. Equiaxed grains were discovered both along and away from the crack surfaces (figure 3.1-17).

Figure 3.1-17. Scanning electron microscope image of broom-straw fracture surface cross sections.

Metallurgical evaluation was completed in proximity to, and away from, the crack surfaces using energy dispersive X-ray spectroscopy. This revealed heavy grain boundary precipitation that is consistent with the aluminum alloy experiencing temperatures greater than 900°F (482°C).

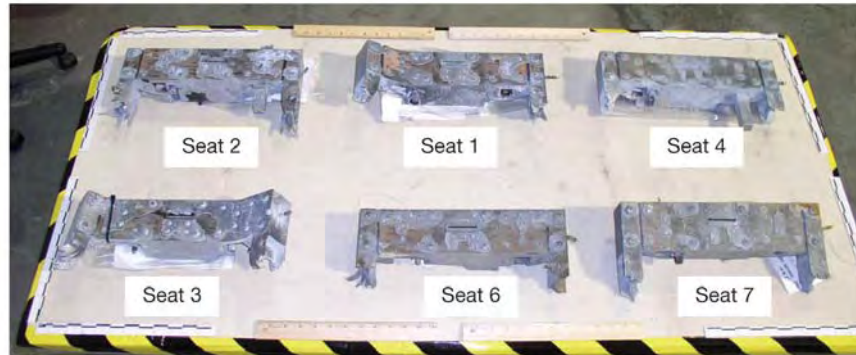
As with the general seat failures that were described previously, all of the fractures at the upper seatback location occurred at the minimum thermal cross section, away from heat sinks on either side. Fracture surfaces did not exhibit melting or materials deposition, indicating that the upper seatback fractures occurred near the end of the period of heating and material deposition. Figure 3.1-19 shows all six recovered upper seatback items. Table 3.1-1 summarizes the upper seatback findings.

Figure 3.1-19. Upper seatbacks (front view).

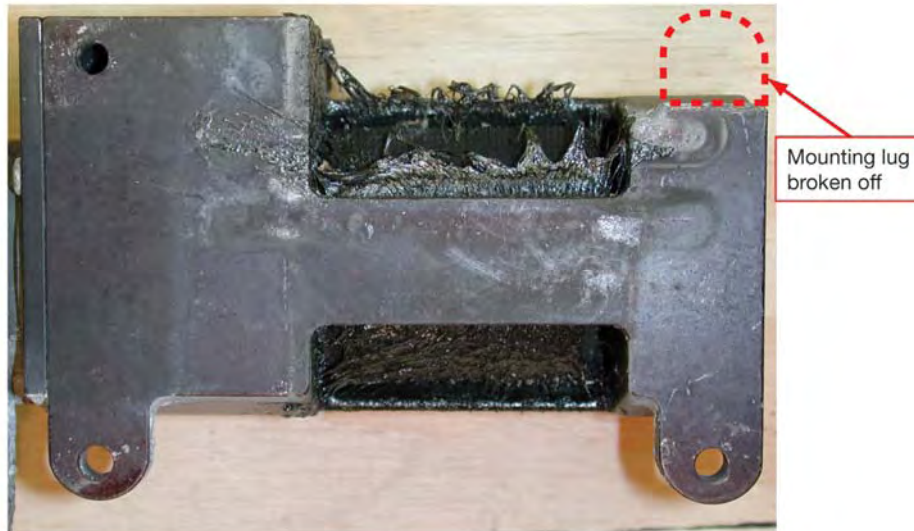
Only seat 3 showed deformation of the inertial reel housing mounting hardware. All four mounting bolts were bent slightly. One inertial reel housing mounting lug was broken with melted metal deposits on both fracture surfaces; i.e., the fracture surface of the lug and the fracture surface of the inertial reel housing (figure 3.1-21). The inertial reel mounting hardware for the other five recovered upper seatbacks exhibited no deformations.

Figure 3.1-21. Seat 3 inertial reel, looking aft.

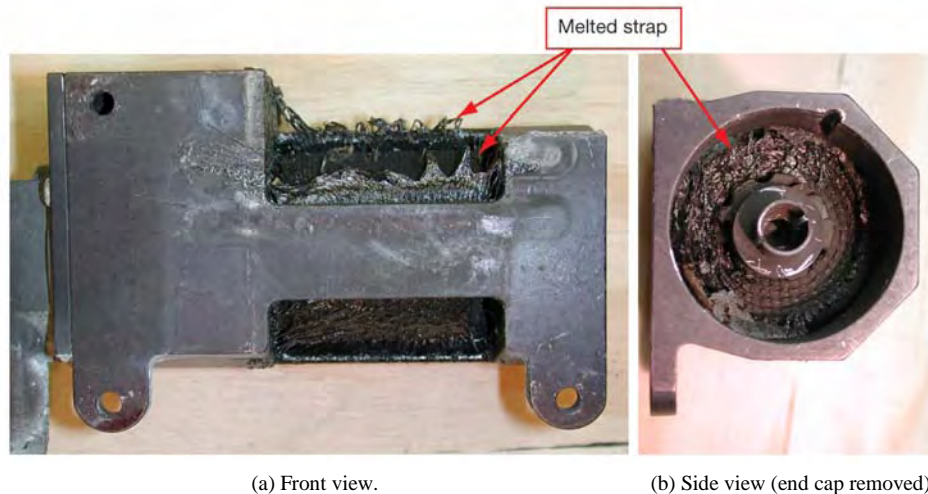
In all cases, the inertial reel straps were melted only in areas that were immediately adjacent to the strap pass-through openings and along the lateral edges of the strap (figure 3.1-23). The strap material in other areas was not melted and appears normal.

Figure 3.1-23. *Inertial reel melted strap material.*

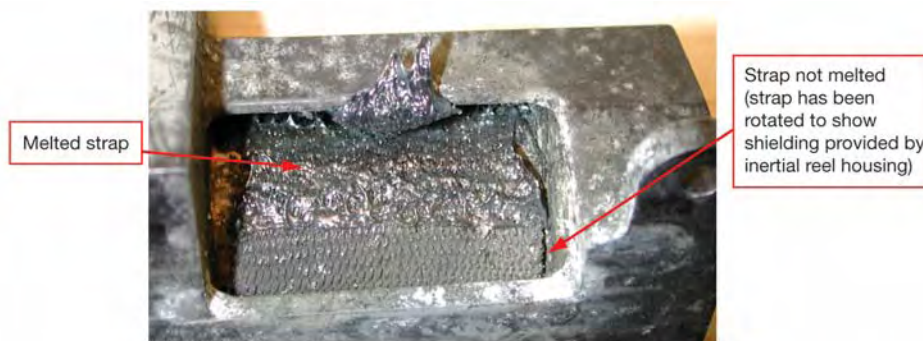
Five of the six recovered strap ends terminated along a straight line. The exception was the strap for seat 2, which terminated in a jagged line. Away from, but in close proximity to, the melted areas, the residual strap material remains flexible. This is consistent with melting that occurred after the strap recoiled into the housing (the straight lines correspond to where the straps were exposed at the pass-through slot). If the whole strap was exposed to significant heating/melting, a definite thermal gradient (varying degrees of melting) and some melting and “pulling” at the broken end of the strap would be seen. However, none of the straps exhibited a thermal gradient along the strap or melting and pulling at the broken end. The demarcation between melted and non-melted areas is very distinct (figure 3.1-24), indicating that the straps were protected inside the inertial reel housings during the period of high heating.

Figure 3.1-24. *Close-up of strap melt pattern.*

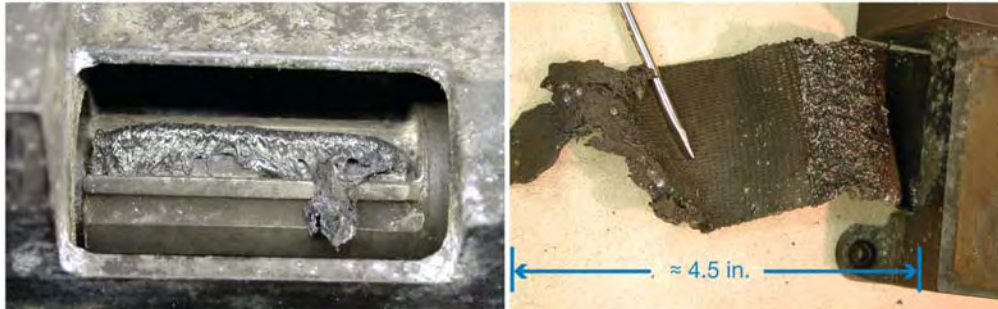
Seat 1 experienced strap failure at the end of the strap next to the inertial reel, and seat 2 experienced strap failure near the end of the strap next to the inertial reel. The seat 1 strap failure (figure 3.1-26) occurred in a straight line along the strap attach point shear plane (the expected failure point if the strap is fully extended).

The seat 2 strap failed at an approximate 45-degree angle, over a 1- to 2-in. length, approximately 4.5 in. from the inertial reel (figure 3.1-26). The way in which the seat 2 belt failed is unique among the

Figure 3.1-26. Seat strap failures: seat 1 (left) and seat 2 (right).

Finding. The seat 2 inertial reel strap exhibits “strap dumping” failure features. The strap failed progressively, possibly due to damage to the lateral edge of the strap from contact with the sharp edge of the strap pass-through slot.

Recommendation L2-5. Incorporate features into the pass-through slots on the seats such that the slot will not damage the strap.

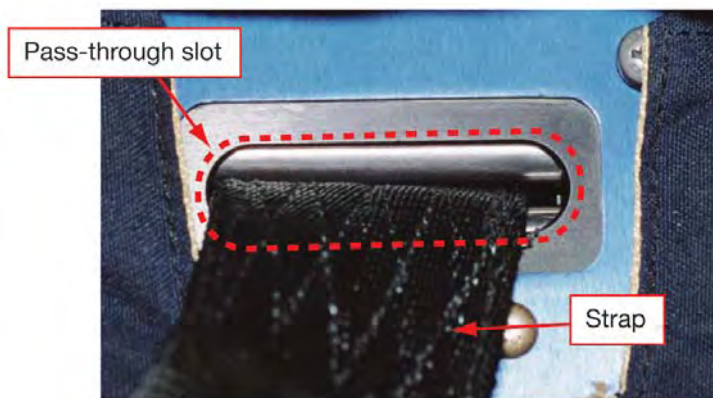
six recovered inertial reel straps. This failure is similar to a failure mode known as strap “dumping.”¹² It is theorized that loading of the inertial reel strap laterally against the pass-through slot (figure 3.1-27) resulted in damage to the strap and, eventually, strap failure.

Figure 3.1-27. Seat strap pass-through slot (intact seat shown). [Picture from a shuttle training mockup in the JSC Space Vehicle Mockup Facility]
