Columbia Crew Survival Investigation Report

NASA/SP-2008-565

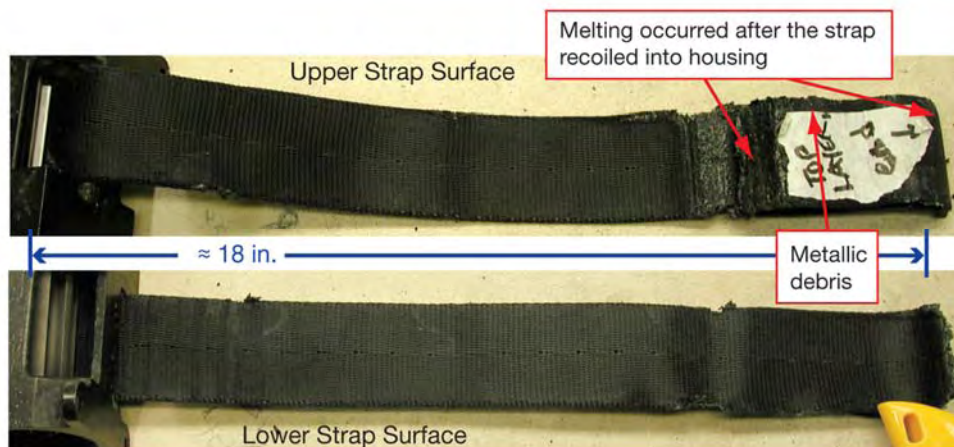
Figure 3.1-29. Seat 4 inertial reel strap.

The seat 4 inertial reel strap (figure 3.1-29) failed at approximately 80% of the extended length, which is in proximity to the attachment at the shoulder harness y-split (~18 in. away from the inertial reel). One very small ball of melted metallic material (< 1/16 in.) was located approximately 14 in. from the inertial reel attachment on the lateral edge of the upper strap surface (the debris came off during inspection.). No witness marks were observed along the entire strap length.

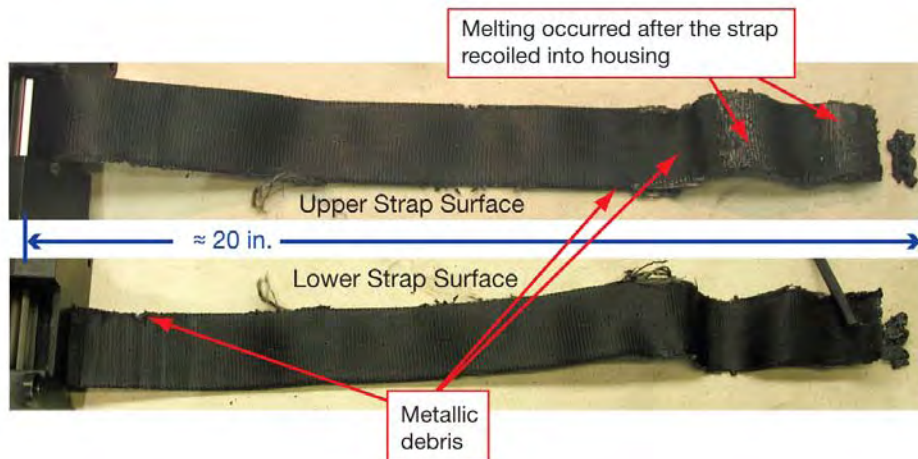
Figure 3.1-30. Seat 6 inertial reel strap.

The seat 6 inertial reel strap (figure 3.1-30) failed at approximately 90% of the extended length (~20 in. away from the inertial reel). Strap failure occurred in close proximity to the shoulder harness y-split attachment (the expected failure point if the strap was not fully extended). No witness marks were observed along the entire strap length. Three pieces of metallic debris were deposited on the strap surfaces: a small ball of melted material (< 1/32-in. dia.) deposited on the upper surface, approximately 16 in. from the reel

attachment (debris came off during inspection); a small fragment of melted material (< 1/32-in. dia.) deposited on the lateral strap edge located approximately 13 in. from the reel attachment; and a small fragment of melted material (< 1/32 in. dia.), which was deposited on the lateral strap edge located approximately 1.75 in. from the reel attachment. The strap was melted completely through one layer near the strap pass-through opening.

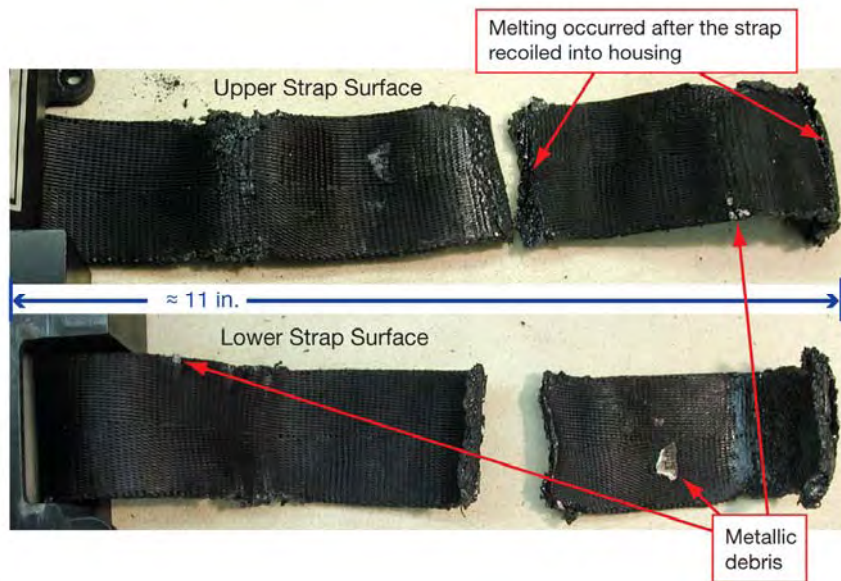
Figure 3.1-31. Seat 7 inertial reel strap.

The seat 7 inertial reel strap (figure 3.1-31) failed at approximately 50% of its length (~11 in. away from the inertial reel). No witness marks were observed along the entire strap length. Three areas of metallic debris deposits were noted on the strap: one approximately 1/10-in.-diameter, roughly spherical piece of metal debris stuck to the edge (the right side of seat) of the lower surface of the strap, approximately 1.5 in. from the inertial reel; one 0.5-by-0.3-in. roughly triangular (~0.05-in.-thick) piece of metal debris stuck to the lower surface of the strap, approximately 8 in. from the inertial reel; and several small, roughly spherical metal debris items stuck to the upper side of the strap fragment, along the edge, approximately 2 in. from the end. Localized melting caused the strap to separate into two pieces after the strap had recoiled into the housing.

The inertial reel straps are certified to sustain at least 5,000 lbs. of load (at least 2,500 lbs. of load when the strap is fully extended). Vendor testing indicates that the straps fail at approximately 5,200 lbs. (or at ~3,500 lbs. if the strap is fully extended). These values are for straps tested statically at room temperature; the loads required to fail the straps at elevated temperatures are unknown. Additionally, the material properties (combustion vs. chemical degradation vs. melting) in a high-temperature/low-O₂/low-pressure environment are not known, neither are the strap properties in highly dynamic loading situations (high loads over very short time periods). Therefore, the inertial reel straps alone could not provide sufficient evidence for determining the loads at which the straps failed.

Finding. All inertial reel straps are tested with static loads at room temperature. Load testing has not been conducted to determine the loads required to fail the straps at elevated temperatures or under dynamic loads. Testing has not been conducted to determine the material properties (combustion vs. chemical degradation vs. melting) in a high-temperature/low-O₂/low-pressure environment.

Recommendation L2-6. Perform dynamic testing of straps and testing of straps at elevated temperatures to determine load-carrying capabilities under these conditions. Perform testing of strap materials in high-temperature/low-oxygen/low-pressure environments to determine materials properties under these conditions.

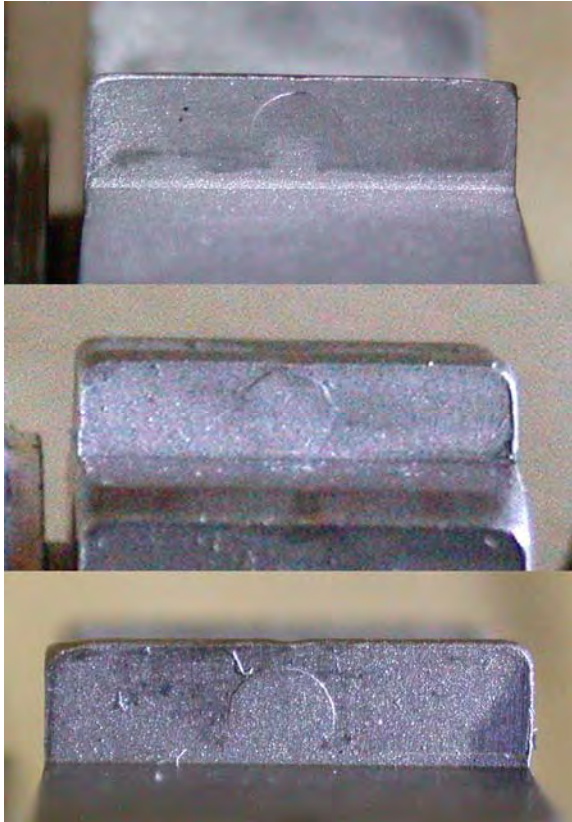
It was initially thought that the witness marks were an indication of inertial reel strap loading during the accident. However, extensive investigation of inertial reels from training seats and other flown shuttle seats as well as a new inertial reel revealed identical circular witness marks (figure 3.1-34).

Figure 3.1-34. Circular witness marks on inertial reels from a training seat (top), a flight (non-Columbia) seat (middle), and a new (unused) flight-qualified inertial reel (bottom).

All inertial reels/straps of this type are proof-tested by the manufacturer with a 3,350-lb. static load prior to delivery to the customer. Because these inertial reels (and the *Columbia* inertial reels) were proof-tested, the investigation concluded that the witness marks on all of the inertial reels are a result of proof-testing. The absence of a second witness mark on the inertial reel led to the conclusion that the inertial reel straps failed at forces below the equivalent of a 3,350-lb. static load. However, it is probable that the straps failed under dynamic loading. As discussed above, the straps' load-carrying capabilities under dynamic loading are unknown.

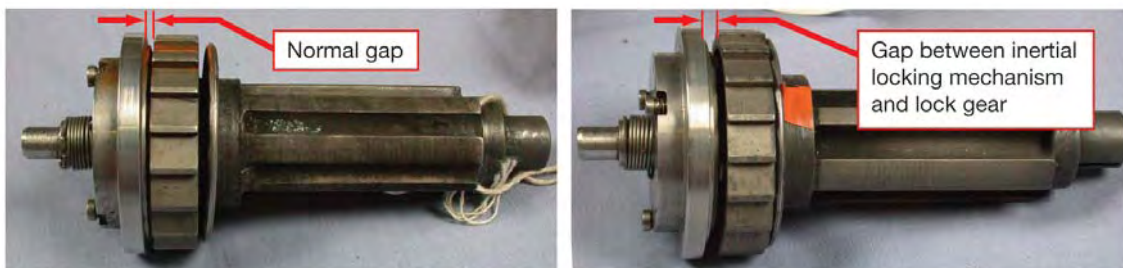
A relatively large gap was discovered between the inertial locking mechanism and the lock gear on the seat 4 inertial reel (figure 3.1-35).

Figure 3.1-35. Separation gap on the seat 4 inertial reel.

Upon further inspection, it was noted that the locking mechanism had permanently “jumped” out of the normal track position, creating a gap between the inertial mechanism and the locking gear. Because this configuration would not function nominally, it is concluded that this “jump” occurred during the accident.

The observed gap between the inertial reel locking mechanism and the locking gear on seat 4 is consistent with information in the manufacturer’s experience base and occurs in crash events resulting in accelerations above 100 G at the strap input. However, the inertial reel locking mechanism can also be moved away from the locking gear by an impact along the axis of the inertial reel spool. Therefore, the observed failure (and resulting gap) could have been caused by impacts during the breakup dynamics, ground impact, or actual loads on the inertial reel strap. Because the cause of failure cannot be determined positively, no conclusions are possible regarding seat 4 inertial reel strap loads/accelerations.

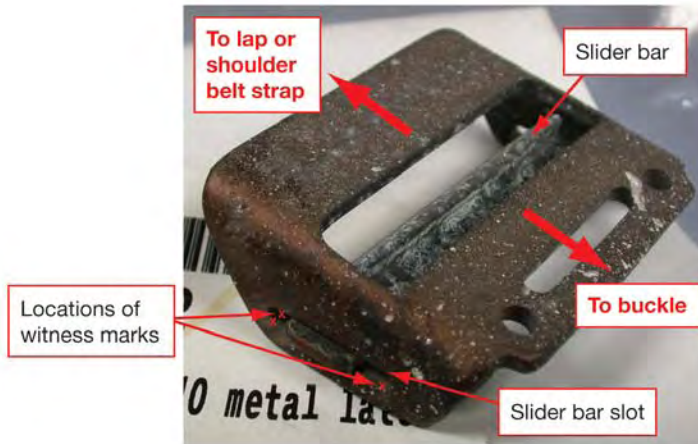
The belt adjusters exhibited evidence of exposure to material deposition and heating. Molten metal debris impacts were observed in varying degrees (with no apparent directionality). Miniscule amounts of residual melted nylon belt material were observed on the adjusters.

Three of the four adjusters exhibited witness marks within the slider bar slot surface (figure 3.1-37). Tension on the belt will cause the slider bar to contact the slider bar slot as the bar rotates and slides within the slot. The witness marks in the adjusters are a result of significant loading on an intact restraint belt.

Figure 3.1-37. Recovered belt adjuster rear view.

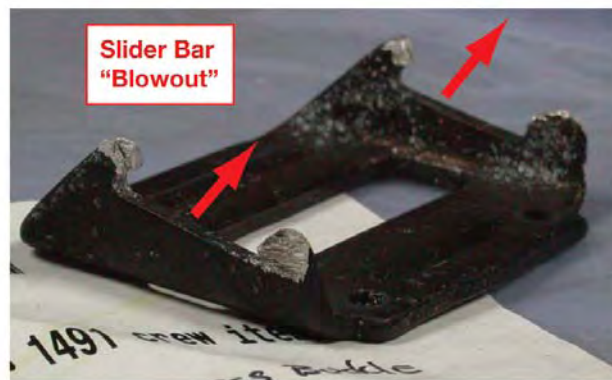
The fourth adjuster was missing the slider bar, and experienced fractures on both the left and the right slider bar slots. These fractures were apparently caused by the slider bar “blowing out” away from the body surface (figure 3.1-38).

Figure 3.1-38. Fractured belt adjuster.

The fracture surfaces exhibited delamination fractures (the “broom-straw” fractures described in section 3.1.3), indicating material property degradation due to elevated temperature exposure combined with high strain rate loading. The heating occurred quickly and allowed material degradation of the metallic belt adjuster to occur without compromising the material properties of the nylon restraint belt to the point that the belt could not transmit forces to the adjuster.

The slider bar “blowout” on one of the four strap adjusters was the result of significant loading on an intact restraint belt. It cannot be determined positively when this strap adjuster failure occurred.

The witness marks and the slider bar “blowout” fracture are indicative of significant loading events causing force translation through the intact belt restraint system, resulting in the impact of the slider bar against the corresponding slot surface within the belt adjuster housing.

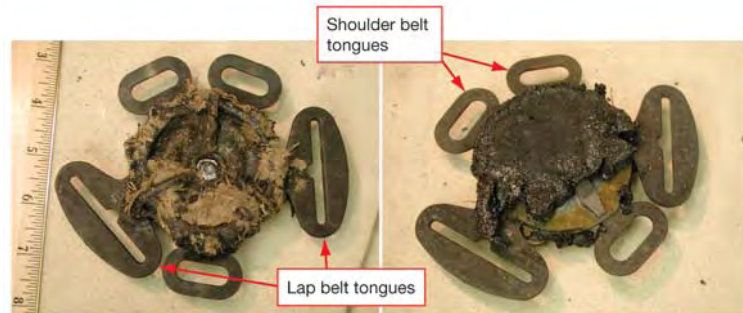
One of the seven 5-point seatbelt buckles on board *Columbia* was recovered (figure 3.1-40). Positive identification to a seat position was not possible. Although the buckle experienced significant entry heating, resulting in substantial melting of the outer plastic housing, the structure remained intact with all five belt tongues still in place.

Figure 3.1-40. *Recovered five-point seatbelt buckle (front and back).*

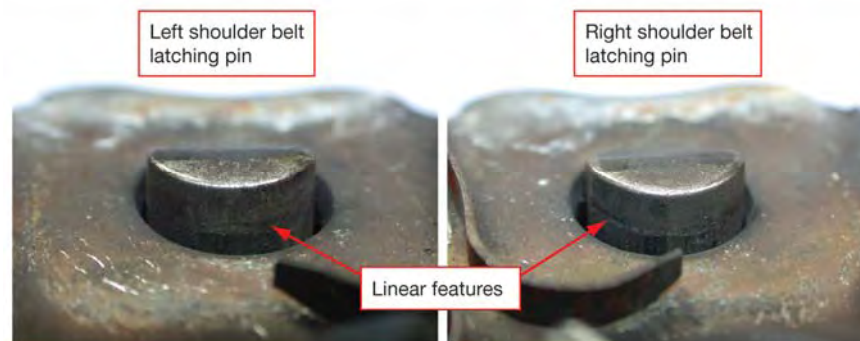
The buckle assembly was disassembled for analysis. The two shoulder belt tongues and the two lap belt tongues were bent outward slightly (i.e., away from the crew member). Both of the shoulder belt tongue latching pins had very shallow linear features corresponding to the mating surfaces of the belt tongue (figure 3.1-41). These features may be witness marks as a result of dynamic loading events that were experienced in flight by the restraint system or of forces imparted to the five-point attach buckle during disassembly by the CAIB investigation team. A definitive conclusion cannot be made based on these witness marks alone. The other latching pins did not exhibit any noticeable marks or deformations.

Figure 3.1-41. *Indentations on latching pins, looking from center of buckle towards outer edge.*

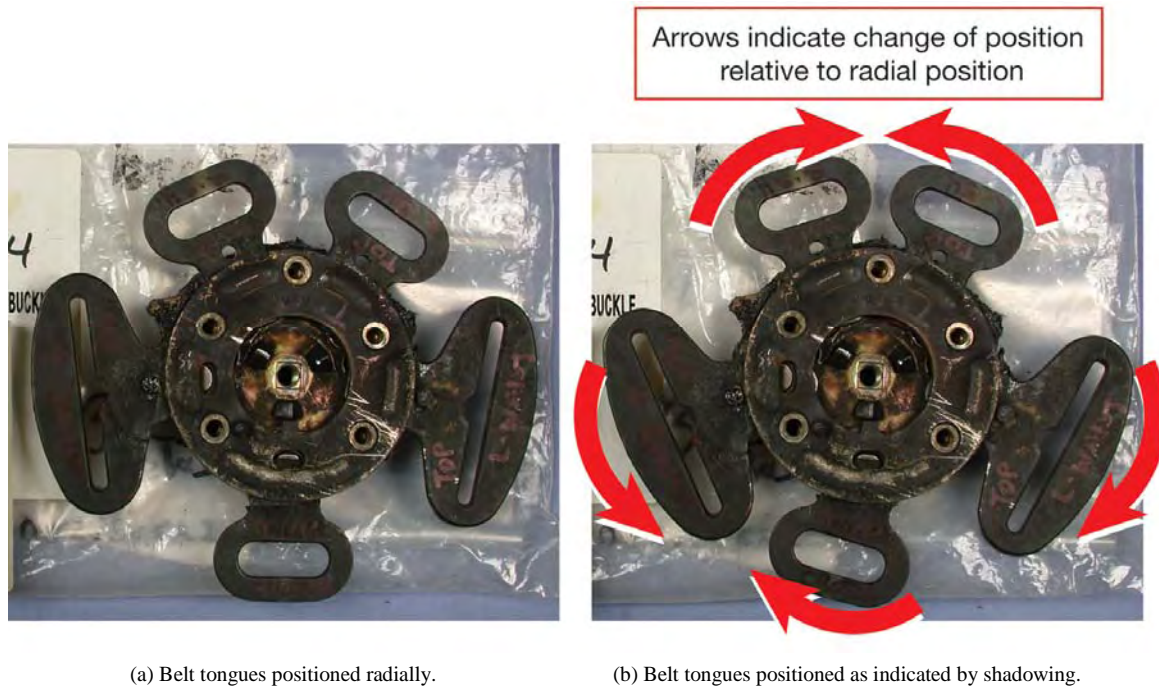
Figure 3.1-42. Belt tongue positions.

Shadowing¹⁴ on the belt tongues indicates that the belt tongues were in the position shown in figure 3.1-42(b). These positions, when compared to the positions of the tongues being straight out from center of buckle (radially, figure 3.1-42(a)), are: the shoulder belt tongues are moved toward the centerline (medially), the crotch belt tongue is moved toward the right side of the seat, and the lap belt tongues are moved down. It cannot be determined positively when the deposition (and shadowing) occurred, so no conclusions can be made relative to timing.

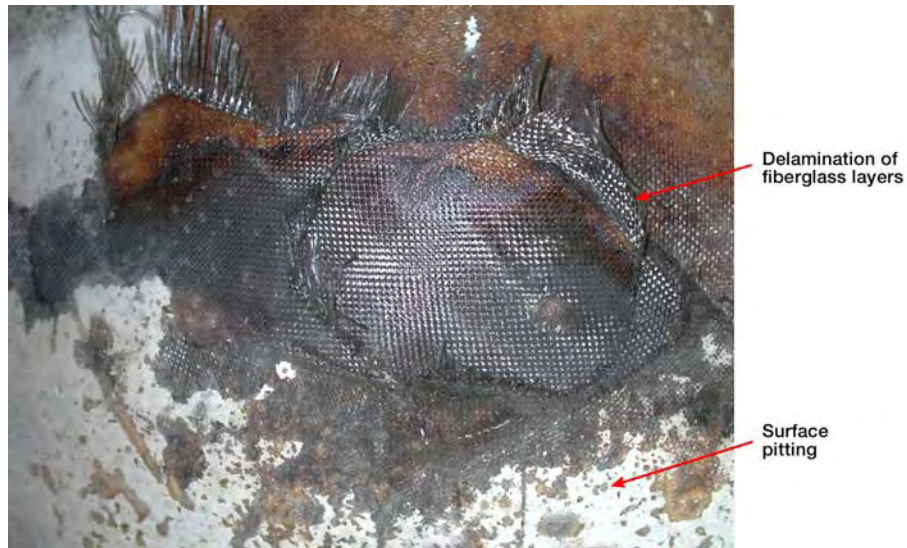
Thermal effects were apparent throughout all helmet surfaces. Significant variations in thermal conditions were noted from helmet to helmet (both interior and exterior helmet surfaces). The reflective tape was missing from all of the helmets, and fiberglass delaminations of various sizes and depths were observed. Some white paint remained, except in the areas removed via fiberglass delamination. Residual paint on the exterior helmet surfaces shows signs of damage (pitting) that are consistent with impacts with many small debris items. Figure 3.2-22 shows examples of delaminations and pitting damage.

Figure 3.2-22. Delamination and pitting damage.

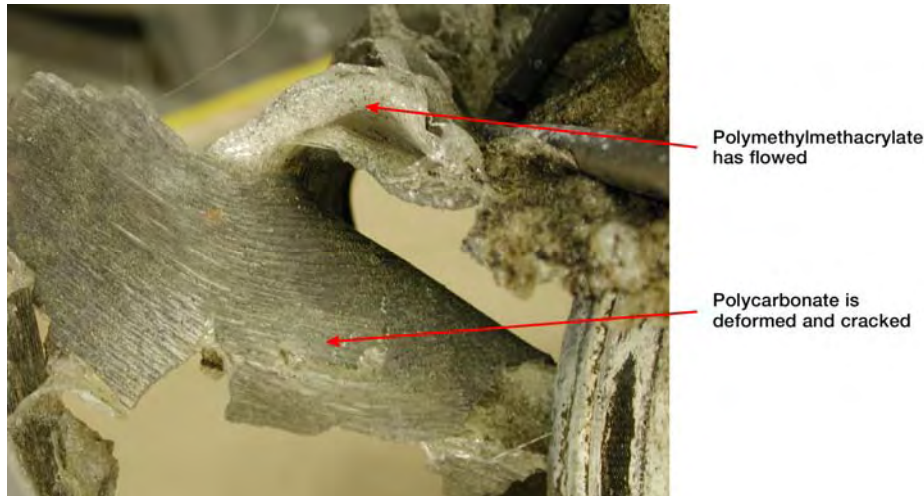
On all three helmets that have remaining pressure visor material, the polymethylmethacrylate flowed and pyrolyzed and the polycarbonate flowed in some places but did not pyrolyze (figure 3.2-23). Therefore, helmet visor materials experienced at least 300°F (149°C), which is the glass transition temperature of polycarbonate, to over 572°F (300°C), the pyrolysis temperature of polymethylmethacrylate, but certainly less than 752°F (400°C), which is the pyrolysis temperature of polycarbonate. Although there were small localized areas of fiberglass pyrolysis, in no case was there global pyrolysis of the helmet fiberglass material, indicating that the helmets did not experience temperatures globally above 735°F (391°C).

Figure 3.2-23. *Helmet pressure visor thermal effects.*

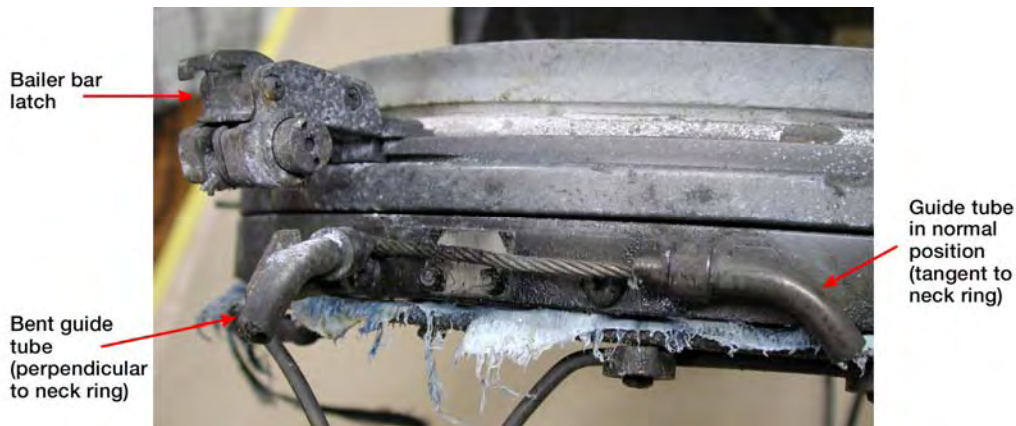
The hold-down cables on each neck ring were severed at the attach points to the cable guide tubes due to mechanical overload (figure 3.2-24). Most cable guide tubes experienced significant plastic deformation. The guide tubes display evidence of external contaminants (i.e., melted metal and suit material) and thermal effects on top of the fractures and localized deformation. This indicates that mechanical loading preceded exposure to the thermal environment. Rotation of the helmet relative to the normal forward position was observed on all neck rings varying from 90 to 180 degrees. Major cable guide tube deformation and helmet rotation indicates that a significant loading event occurred where helmets were removed via a mechanical (nonthermal) mechanism.

Figure 3.2-24. Hold-down cable guide tube.

The bailer bar latch mechanisms on five of the seven helmets remained attached to the helmets in good condition (figure 3.2-24). This would not be expected if the crew members had lowered and locked their visors. Mechanical separation of the bailer bar would be accompanied by fracture of the latch assembly if the visor was down and the bailer bar was locked. The other two helmets experienced latch mechanism separation due to failure of the fasteners that attach the latch mechanism to the helmet before subsequent deposition of melted suit materials. This suggests that latch separation was followed by suit melting. Neither of the two helmets shows evidence of the indentation or deformation that would be associated with forces expected if the bailer bar ripped the latch from the neck ring. Combined with the absence of melted visor material on the visor seal, this confirmed the conclusion that none of the crew members lowered and locked visors.

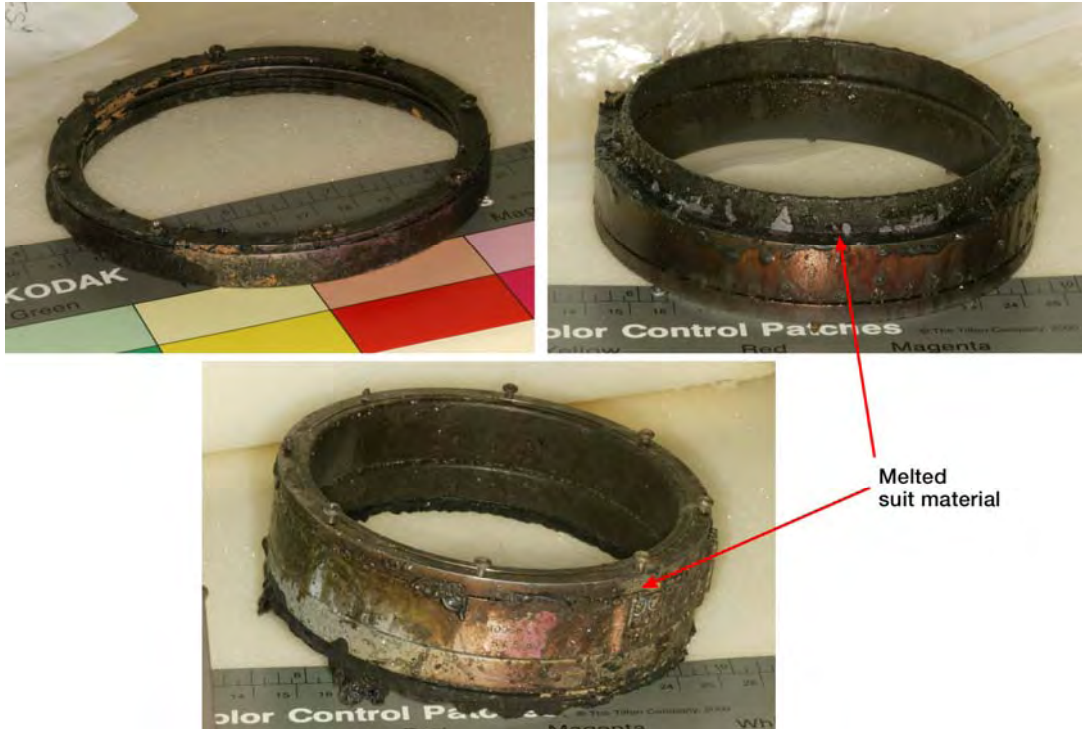
Melted aluminum deposits and/or tiny craters were observed on most of the glove and suit rings. Melted suit material (figure 3.2-26) was discovered on all recovered disconnect rings. Close inspection of the suit bladder clamp interface on the suit-side disconnect rings revealed mainly nylon and Teflon materials. In all cases, minimal amounts of Nomex remained clamped to the interface. Overall, the amount of residual melted suit material seems to correlate with the general magnitude of heating; that is, higher-magnitude heating resulted in the pyrolysis of residual suit material. As with the helmets, deposition of melted suit material on the glove disconnect areas occurred after mechanical separation. Small fragments of suit material were still clamped in the disconnect after mechanical separation. The failure modes at the disconnect ring (the ring-to-suit material interface) were similar to those observed in the suit-side helmet disconnect rings (see Section 3.2.5).

Figure 3.2-26. Recovered suit-side (upper left), glove-side (upper right), and mated (bottom) glove disconnects.

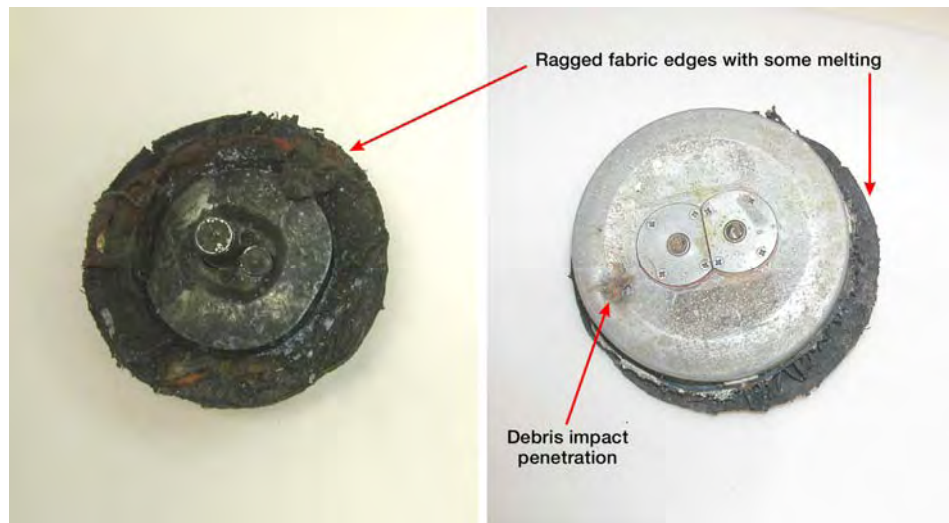
Four DSCs were recovered, all from flight deck crew members and all presenting similar appearances. One DSC (figure 3.2-28) was disassembled and inspected to determine the thermal environment exposure. The suit material edges were ragged with some localized melting around the edges, indicating that there was a mechanical disruption of the suit followed by thermal exposure to the suit fabric that was still attached to the DSC body. The DSC body back surface (i.e., the surface inside the suit) had many craters and one penetration (~0.5 in. × 0.25 in.). This indicates a rapid disruption of the suit, releasing the DSC while it was still in close proximity to the CM debris cloud. Some melting of the suit material to the DSC body caused the suit flange to adhere to the DSC body. All internal soft goods (O-rings, seals, diaphragms) were intact and showed no signs of mechanical or thermal damage. Both of the aneroids⁷ were still hermetically sealed with the sealing solder intact. The suit cover-layer Velcro was melted to the suit restraint-layer Velcro in some

areas. Although melting of the torn fabric edges and the Velcro® indicates thermal exposure, the complete lack of thermal damage to any of the internal soft goods suggests that the thermal exposure was limited in intensity and/or duration.

Figure 3.2-28. Recovered dual suit controller front (left) and back (right).

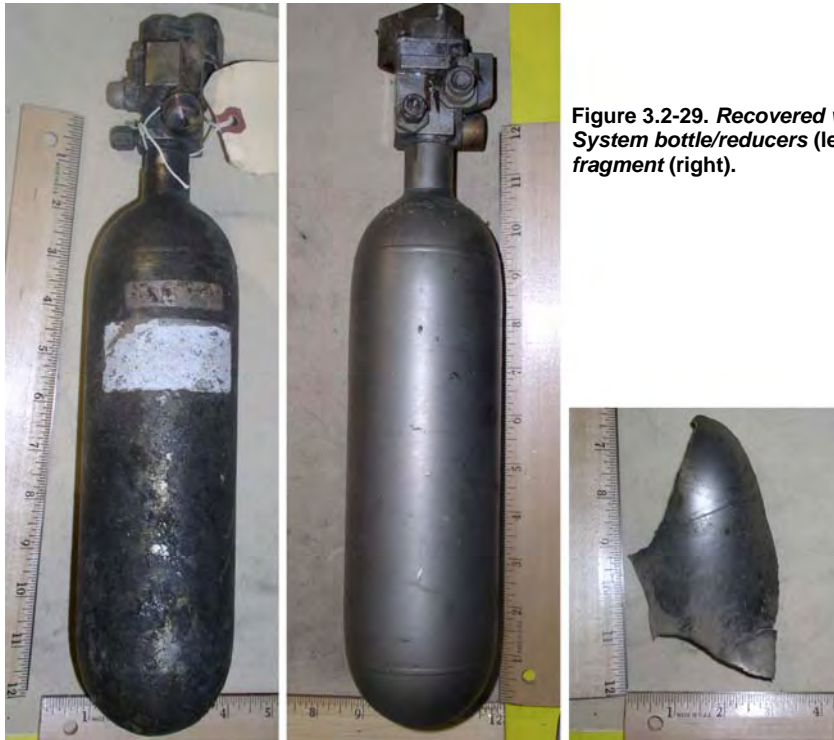
Ten whole EOS bottle/reducers were recovered (eight were ascribed to specific crew members), each with no O₂ remaining. All 10 of the recovered EOS bottle/reducers have similar appearances, with some variance in the amounts of material deposition. Additionally, three fragments of bottles were also recovered (figure 3.2-29).

Figure 3.2-29. Recovered whole Emergency Oxygen System bottle/reducers (left and center) and a bottle fragment (right).

No nylon material from the parachute harness adhered to the bottle/regulator assemblies. Minor evidence of elevated temperatures, directional burn marks, and discrete external impacts are visible. As with most of the *Columbia* hardware, corrosion that occurred while the debris was on the ground is also evident. X ray revealed that all of the EOSs were activated. However, the crew members were trained not to activate them unless their visors were down. Therefore, activation of the EOS (achieved by applying tension to the activation cables) probably occurred as the bottles separated from the harnesses rather than by crew action.

The EOS bottle fragments exhibited irregular edges along the fracture surfaces, some outward bent edges, evidence of heating on the inner surfaces, and some deposited/flowed black material along a fracture surface.

Heating on the inner surfaces indicates that the bottle failure occurred before the end of entry heating. Neither the cause of the bottle failures nor the status of the bottles at the time of failure (pressurized or unpressurized) could be determined.

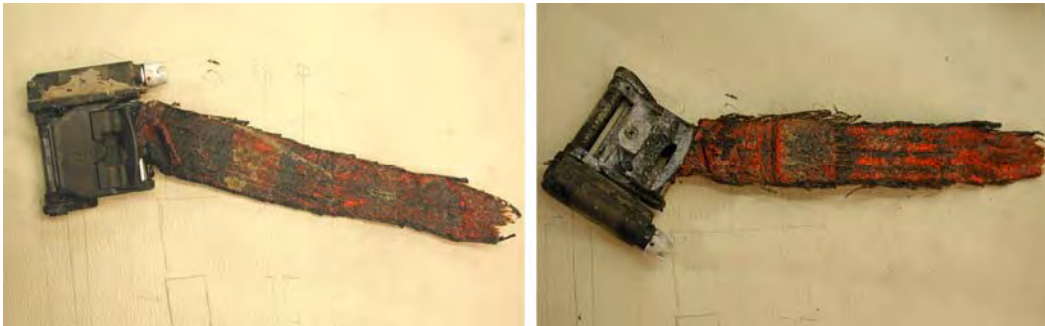
Six SEAWARS were recovered. None had automatically ignited, and all had both of the Frost fitting male and female halves still mated. All SEAWARS had similar appearances (figure 3.2-30), consisting of the SEAWARS assembly still attached to approximately 12 in. of nylon parachute harness strap. None had any parachute riser material attached.

Figure 3.2-30. Seawater Activated Release System with Frost fittings (male/female) still mated, with a segment of harness strap attached (two different SEAWARS are shown).

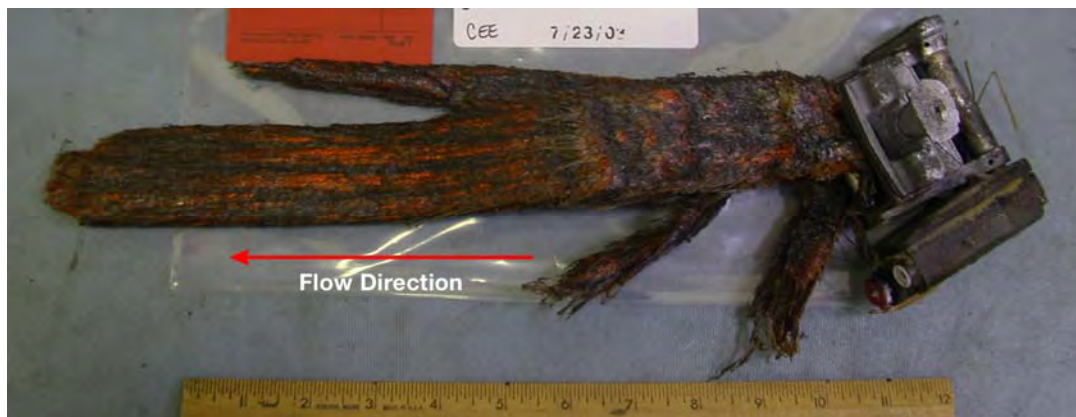
Each SEAWARS/strap item shows evidence of directional melting, burning, and mechanical loading. The surviving length of parachute harness strap is consistent with a harness strap failure at the waist. While the terminating ends show evidence of melting on the top layer of fabric, these ends appear to have failed primarily due to mechanical overload, not melting. Some surface melting occurred along the length of the straps, with distinct directionality away from the SEAWARS towards the broken end of the strap, corresponding to a head-to-foot direction when the harness is on a crew member. These directional heating/melting features are present on both sides of the straps, with little difference between the front and the back of the straps. Because both sides of the straps show signs of heating, the heating and melting must have occurred after the straps had separated from the crew member. Localized heating on the metallic SEAWARS Frost fitting buckle suggests intense, short-duration heat exposure. Each SEAWARS and strap was mechanically extracted from the harness webbing before experiencing this short-duration heating. Directionality suggests that each piece of riser trimmed with the SEAWARS into the airflow (figure 3.2-31).

Figure 3.2-31. Directional melting on Seawater Activated Release System/parachute harness strap.

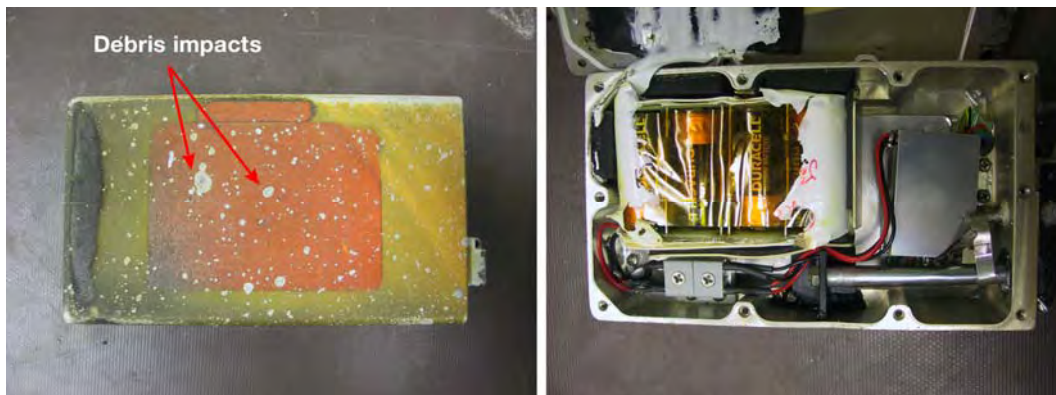
One TSUB-A SARSAT beacon is flown per crew member; it is located in the survival raft packed in the PPA. Six SARSAT beacons were recovered; none of them were activated during the accident. All six recovered SARSAT beacons show similar thermal and mechanical damage (figure 3.2-32).

Figure 3.2-32. External (left) and internal (right) views of a recovered search and rescue satellite-aided tracking beacon.

No material from the raft or the PPA was adhered to the outer aluminum casing. Various amounts of paint remained, displaying evidence of impacts with small, hot metal pellets. Corrosion was also present. All external plastic was melted. Internal inspection of the beacons revealed minor solder re-flow, with most of the components mechanically and electrically intact. Two SARSAT beacons were tested and, when externally powered, functioned properly. For each of the six SARSAT beacons, the processing module was extracted and interfaced with ground support equipment to read the beacon's unique identifier, thereby allowing all six beacons to be ascribed to individual crew members. Each SARSAT beacon was mechanically extracted from the PPA as temperatures were rising; then for a short duration and nearly simultaneously, it experienced high heating and a hot metal pellet-like shower. This indicates a rapid disruption of the parachute packs and release of the SARSAT beacons while they were still in close proximity to the CM debris cloud.

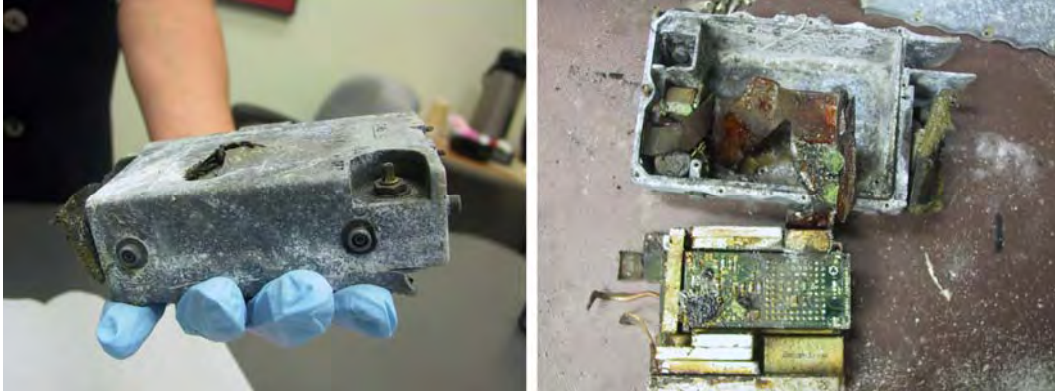
Four A/N PRC-112 radios were recovered, all of which looked similar (figure 3.2-33). No Nomex material from either the suit pocket or the survival gear pouch was adhered to the outer aluminum casing. Various amounts of paint showed evidence of impact with small, hot metallic pellets. Corrosion was also present. All external plastic was melted or missing. Internal inspection of the radios revealed evidence of moderate heating, with the center-most components experiencing only minor solder re-flow. For each of the four radios that were recovered, the control module was extracted and interfaced with ground support equipment to read the unique identifier of the radio. Thus, all four radios were ascribed to a specific crew member. Overall appearance suggests that each A/N PRC-112 radio experienced similar thermal and mechanical environments. Each radio was mechanically extracted from the ACES pocket and the survival gear pouch as temperatures were rising and, for a short duration and nearly simultaneously, each of the radios experienced high heating and a hot metal pellet-like shower. This indicates a rapid disruption of the suit survival gear pockets, releasing the radios while they were still in close proximity to the CM debris cloud.

Figure 3.2-33. External (left) and internal (right) views of a recovered Army/Navy personal radio communications-112 radio.

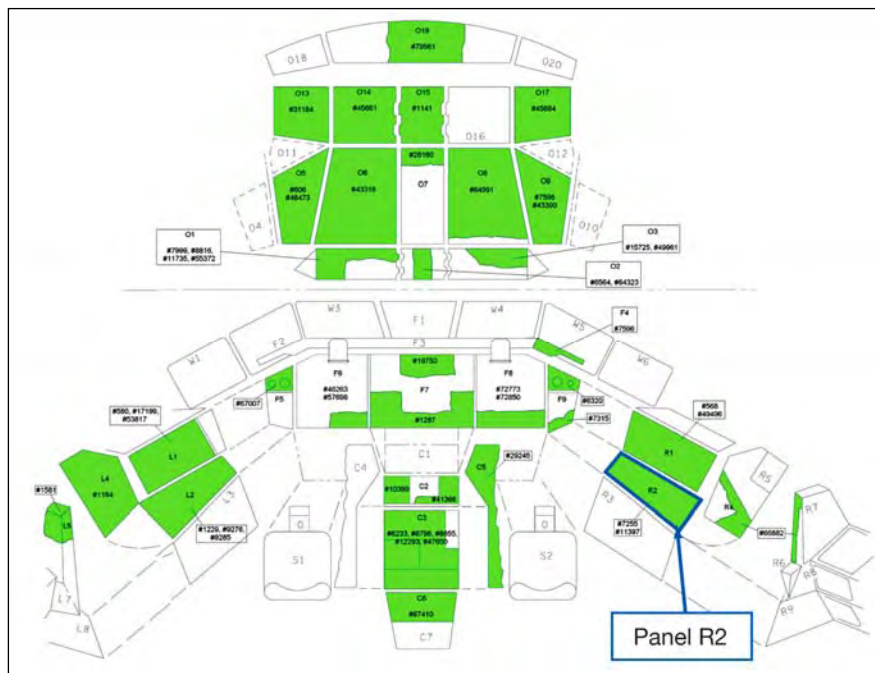
Following the 1986 loss of *Challenger*, a review of the recovered equipment showed that the crew took a few actions after the breakup and prior to losing consciousness.⁴ During the *Columbia* CM reconstruction, the switch panels were examined to determine whether any switches were out of the expected positions. Of the recovered flight deck panels (highlighted green in figure 3.3-2), an estimated 10% to 15% of the switches were found out of position with respect to the expected positions for the entry timeframe.

Figure 3.3-2. Columbia recovered flight deck forward panels (highlighted in green).

No further analysis was performed at that time as it was not possible to know whether the switch positions were due to crew action, the mishap, or handling during debris recovery. However, the R2 panel, to the immediate right of the PLT on the flight deck (figure 3.3-2), warranted further investigation. This panel contains the primary controls for the auxiliary power units (APUs). The APUs drive the hydraulic pumps that provide hydraulic pressure to the flight control surface actuators. During entry, these surfaces become increasingly important to vehicle control, and loss of hydraulic pressure can have catastrophic results. Reconstructed general purpose computer (RGPC)-2 data revealed that the hydraulic systems failed prior to GMT 14:00:03 while the crew was conscious and capable of taking action.

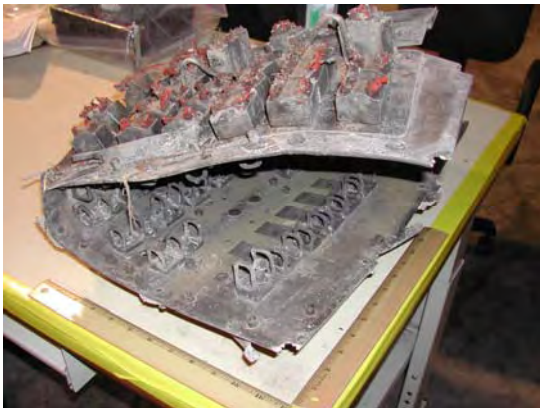
When recovered, the R2 panel was folded back in on itself (figure 3.3-3), protecting the innermost switches from manipulation during recovery operations. The switch positions were considered to be unaltered by external factors, making the switches valuable in determining crew actions.

Figure 3.3-3. Recovered R2 panel from Columbia.

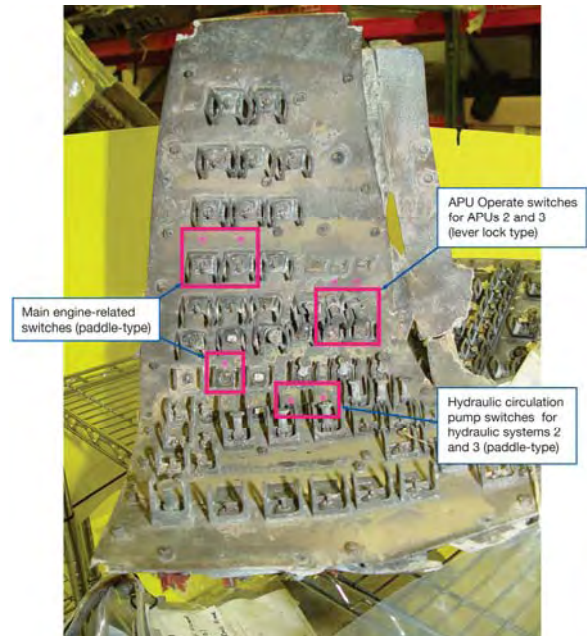
The panel was pried open during the investigation and switch positions were reviewed. In figure 3.3-4, all out-of-position switches are outlined with a pink box and noted with a pink dot.

Figure 3.3-4. Recovered R2 panel from Columbia (after it was unfolded). Pink dots are above the out-of-configuration switches.

The APU 2 and APU 3 Operate switches (“lever lock” switches that require two independent actions to change the switch position) were found in the “injector cool” position as opposed to the nominal “start/run” position. These switches are used when starting and stopping the APU. The “injector cool” position is used to cool down the APU after a shutdown prior to restarting it.

entry.⁵ The two paddle-type switches in the lower center of the panel are the circulation pump switches for hydraulic systems 2 and 3. These were found in the “on” position as opposed to the normal “off” position. The circulation pump is used for thermal conditioning of the hydraulic fluid while the orbiter is on orbit. The pump also is used to keep the hydraulic reservoir pressurized. This pump is not powerful enough to deploy the landing gear, but it can provide some hydraulic pressure if activated. The pump is neither used nominally on entry nor is it used in off-nominal procedures.

In response to a hydraulic system failure, the procedures require shutting down the APUs by placing the APU Operate switches in the “off” position, then moving the APU Operate switches into the “injector cool” position to cool down the APUs before attempting a restart of the APUs. RGPC-2 data indicate that the APU Operate and hydraulic circulation pump switches were in their nominal, expected positions.⁶ Therefore, these switches changed position after GMT 14:00:05, 13 seconds prior to the Catastrophic Event (CE).

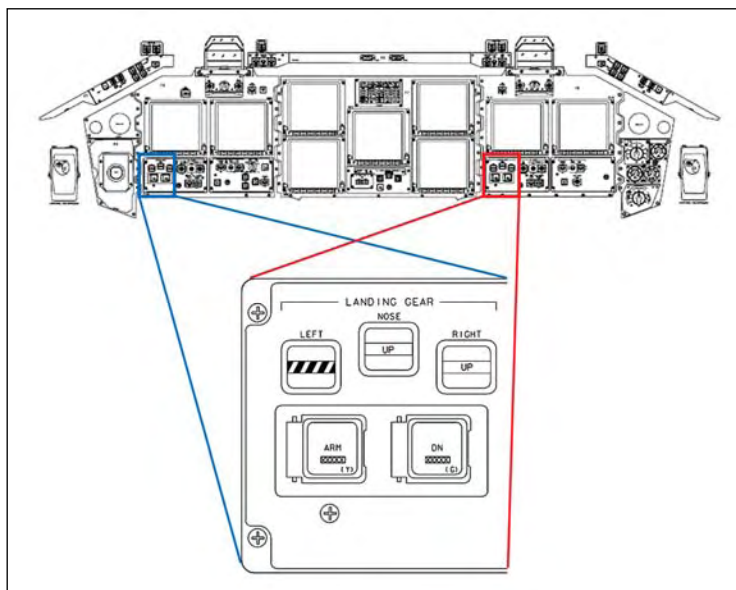
At GMT 13:59:06, 10 seconds after the fourth of four tire pressure fault messages, telemetry indicated that the “LEFT MAIN GEAR DOWN” lock sensor transferred to “ON.” Other sensors indicated that the landing gear door was still closed and the landing gear was locked in the “up” (stowed) position. These mixed signals caused the left landing gear position indicator to display a “barber pole” (figure 3.4-6), which indicates an indeterminate landing gear position. Post-accident analysis of the data and recovered debris indicates that the left landing gear was locked in the “up” position and the landing gear door was closed. The signal indicating that the gear was down was a false signal that was likely triggered by damage to the sensor system (sensor, wiring harness, etc.). Based on training experience, the crew was probably attempting to diagnose the situation given that it involved the same landing gear as the tire pressure messages and indicated a potential landing gear deployment problem.

Figure 3.4-6. Landing gear indicator panel, identical on both sides of the flight deck forward display panels. Left indicator showing “barber pole” (indeterminate position). [Adapted from the Space Shuttle Systems Handbook]

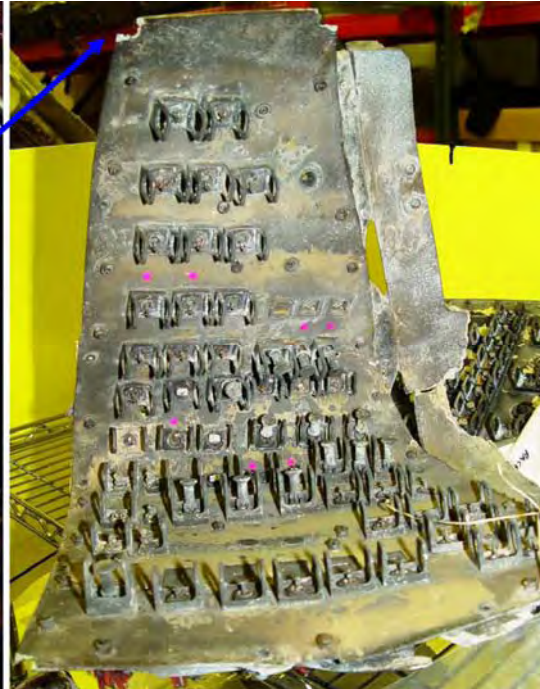
Recovered debris revealed that the APU Operate switches on flight deck panel R2 were in positions that were consistent with an attempted restart of two of the three APUs¹¹ (figures 3.4-10 and 3.4-11). The hydraulic circulation pump paddle switches for the two hydraulic systems corresponding to the two APUs were also turned on. While turning on the hydraulic circulation pump is not in any crew emergency checklist, the pump can provide some hydraulic pressure, and this action shows good systems knowledge by the crew members as they responded to the limited information presented to them and worked to restore orbiter control. The APU Operate switches are “lever-lock” switches that require three actions to change the position. They must be (1) pulled outwards to disengage the switch lever from the lock, (2) moved to the desired position, and (3) released (figure 3.4-12). The switches are spring-loaded to hold them in the detents. The RGPC data indicate that all of these switches were in the nominal configuration up to GMT 14:00:04.826. These findings strongly suggest that despite the very dynamic vehicle motion, the PLT was still capable of taking appropriate actions to attempt a recovery of the hydraulic pressure by performing an APU restart at some time after GMT 14:00:04.826. Based on the panel R2 switch throws and the lack of visors being lowered, it is probable that the crew never realized that the vehicle LOC situation was unrecoverable and had become a survival situation.

Figure 3.4-11. Recovered R2 panel from Columbia (after it was unfolded). Pink dots are above the out-of-configuration switches.

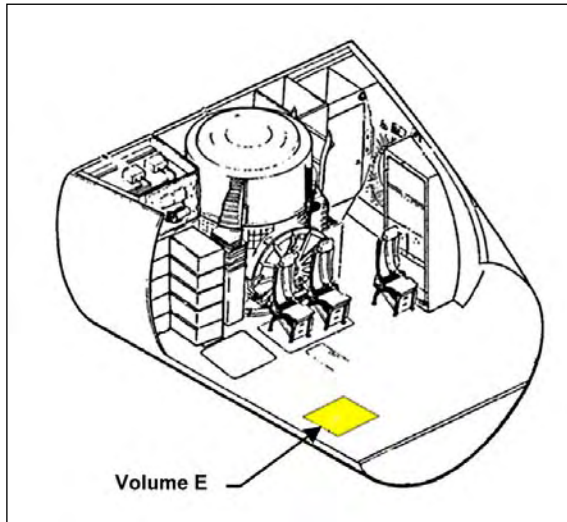
Analysis of several sources of information indicates that the forebody separated from the midbody at or shortly after GMT 14:00:18. It is unknown what accelerations occurred during separation of the orbiter forebody from the midbody; however, ballistic analysis estimates that the translational G that was experienced by the orbiter forebody at the CE decreased from approximately 3.5 G to 1 G. It is also likely that there were additional translational and rotational loads acting on the crew at this time. Analysis of structural debris supports that multiple small impacts occurred between the forward fuselage (FF) and the CM, including in the area of middeck Volume E (figures 3.4-13a and 3.3-13b).

Figure 3.4-13a. View of middeck floor and Volume E, looking aft.

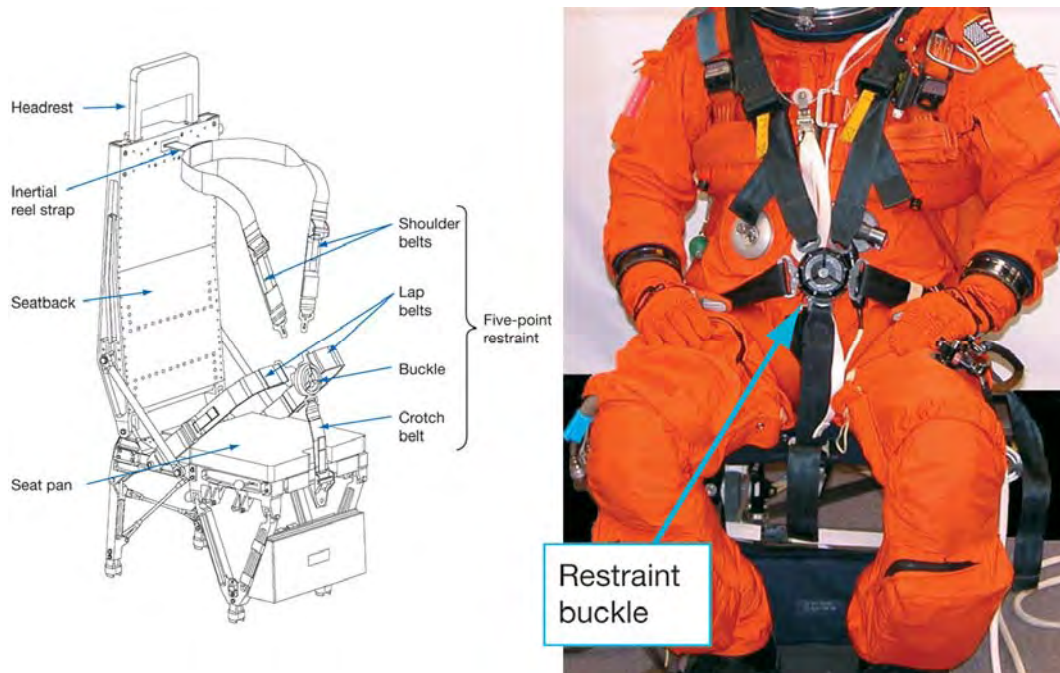
Figure 3.4-17. Detail of the five-point harness.

Engineering analysis of the STS-107 restraints indicates that most of the inertial reel straps were extended and did not lock or retract prior to failure of the straps. The inertial reels are normally unlocked to allow the crew to access displays and controls with a full range of motion. With the inertial reels unlocked, the crew members’ upper bodies were left unrestrained during the forebody dynamics. [REDACTED.]

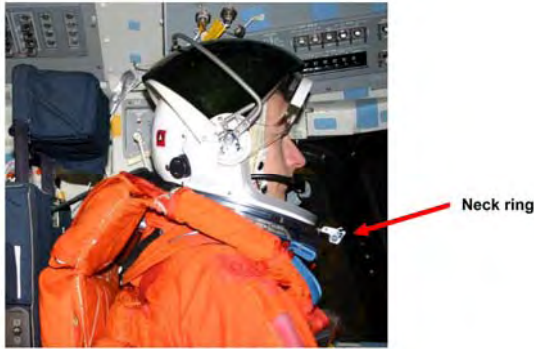
Figure 3.4-18. Demonstration of an integrated seat/suit/crew member in entry configuration.

Finding. Injuries were consistent with the crew’s upper bodies not being securely held to the seatbacks and with the evidence indicating that the inertial reel straps were extended at the time of failure.

Recommendation L2-4/L3-4. Future spacecraft suits and seat restraints should use state-of-the-art technology in an integrated solution to minimize crew injury and maximize crew survival in off-nominal acceleration environments.

Recommendation L2-8. The current shuttle inertial reels should be manually locked at the first sign of an off-nominal situation.

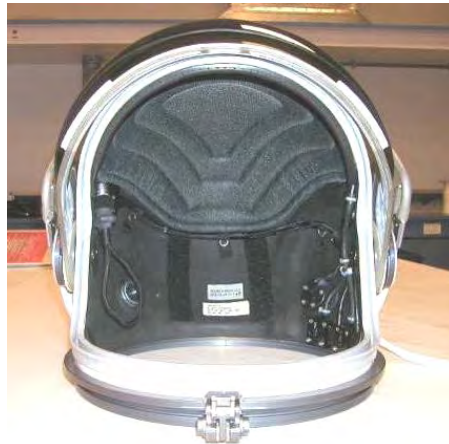
[REDACTED.] Figure 3.4-19 shows an interior view of an intact, pristine ACES helmet demonstrating exposed hardware. [REDACTED.]

Figure 3.4-19. Example of an intact, pristine advanced crew escape suit nonconformal helmet (not an STS-107 helmet).

Recommendation L2-7. Design suit helmets with head protection as a functional requirement, not just as a portion of the pressure garment. Suits should incorporate conformal helmets with head and neck restraint devices, similar to helmet/head restraint techniques used in professional automobile racing.

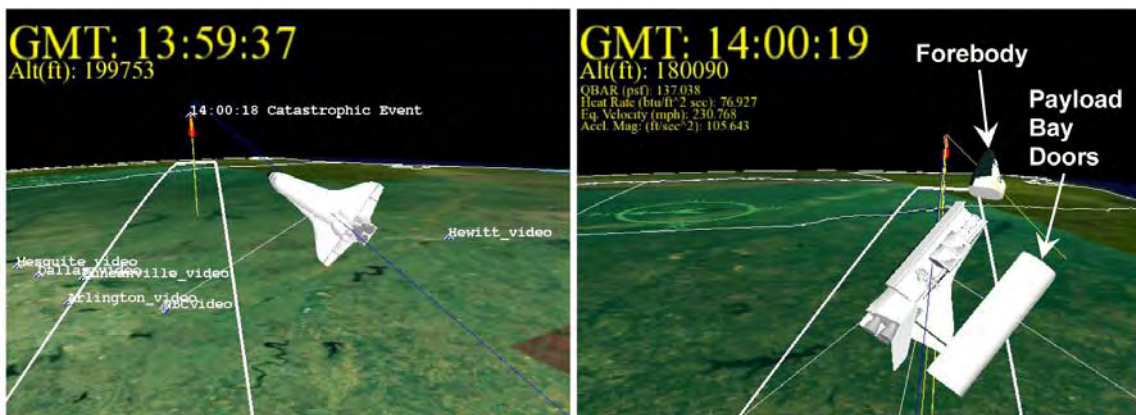
The simulation was used to visualize the predicted vehicle dynamics and breakup sequence. Telemetry data were used where available to represent the flight path and vehicle orientation. The reference trajectory was used to represent translation. The aerodynamic simulation of the vehicle attitude (see Section 2.1) was used between LOC and the Catastrophic Event (CE). The aerodynamic simulation of the forebody was used to represent the orientation after the CE. Figure 4-4 shows frames from the dynamic visual simulation. The image on the left represents the orbiter just before the LOC, and is viewed from a point above, behind (west), and to the left (north) of the flight path. The image on the right represents the orbiter just after the CE, and is viewed from above and behind (west) of the flight path. The three main items in this view are the payload bay doors, the forebody, and the main portion of the orbiter. The left wing has already departed from the orbiter and is not visible in this view.

Figure 4-4. Visual representation of the breakup sequence, looking east.
