Columbia Crew Survival Investigation Report

NASA/SP-2008-565

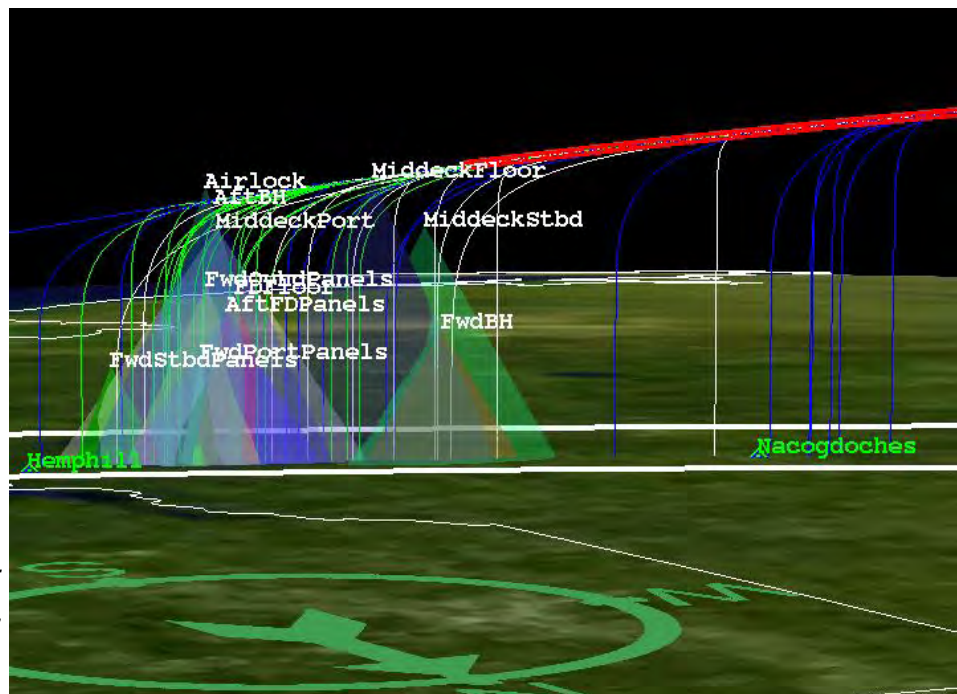
The simulation could be viewed from any vantage point, such as zooming in on the CM debris spread or any of the sites from which ground-based video was recorded. Figure 4-6 shows the trajectory and CM debris groupings as viewed from a point north of the trajectory, looking south-southwest. Debris item groupings are shown as triangles and are labeled (“Airlock”, Middeck floor”, etc.).

Figure 4-6. Crew module debris groups, looking south-southwest.¹²

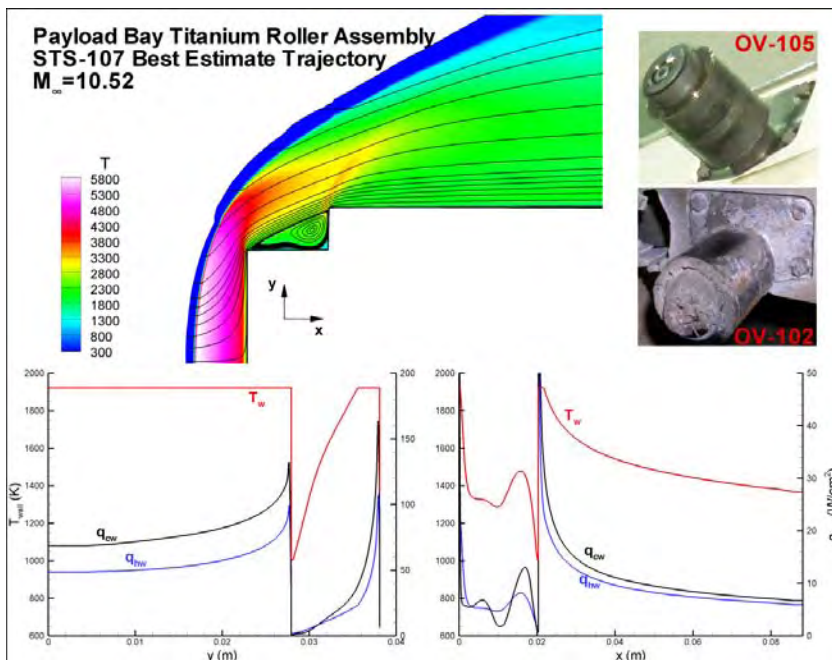
A computational fluid dynamics (CFD) thermal analysis of the payload bay door rollers was performed by the JSC Applied Aerosciences & CFD Branch. Various Mach numbers, from $M = 7.5$ to $M = 15$, were used to determine the flow field environment and temperature at the face of a roller for an orientation with the front of the roller facing directly into the direction of travel. Figure 4-10 shows the predicted heating rate and temperature distribution along the payload bay door roller at $M = 10.5$. The notations q_{cw} refers to "cold wall" and q_{hw} refers to "hot wall." In this figure, the CFD solution assumes a steady-state solution, meaning that given enough time, the flow will develop into the calculated results. This is a reasonable assumption for high-speed entry because the flow field will form very quickly. The wall temperature is calculated by assuming radiation equilibrium. This means that the amount of heat that is being absorbed by convective heating is the same amount of heat that is being expelled through re-radiation. Also seen in the upper right of figure 4-10 are two photographs of payload bay door rollers. The photograph for OV-105 shows an intact roller, and the photograph for OV-102 (*Columbia*) clearly shows the erosion of the exposed titanium surface on the front face of the roller.

Figure 4-10. Computational fluid dynamics analysis of heating at the tip of the payload bay door roller for orthogonal geometry into the direction of travel at $M = 10.5$.

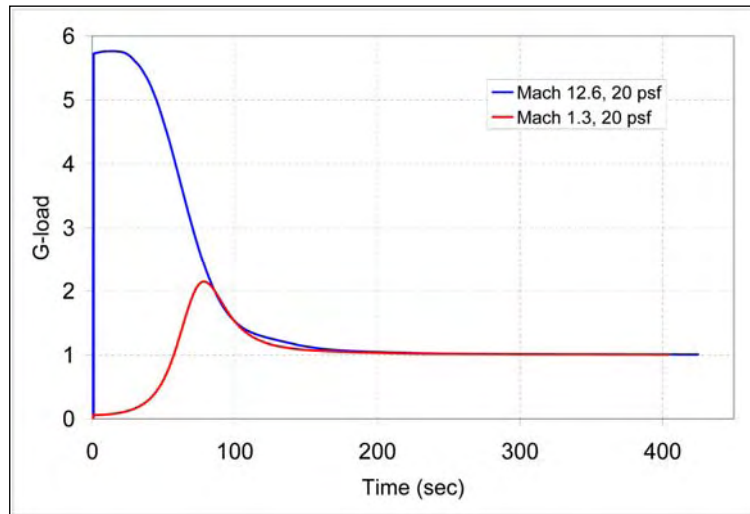
In a previous example, we examined the effect of initial velocity on two objects with the same BN. What would their G-loads look like? The G-loads for the Mach 12.6 and Mach 1.3 spheres are shown in the plot below. The red line is the Mach 1.3 object, and the blue line is the Mach 12.6 object.

The object with the higher release velocity had a larger G-load spike. The reason for this is found in the drag acceleration equation. It is a function of velocity squared. So, the higher-velocity object will experience a greater drag acceleration than the lower-velocity object.

But why did the G-load of the object at the lower initial velocity ramp up? That object's velocity actually increased after release, increasing the drag acceleration, which increased the G-load.
