Crash Following Encounter with Instrument Meteorological  
Conditions After Departure from Remote Landing Site  
Alaska Department of Public Safety  
Eurocopter AS350 B3, N911AA  
Talkeetna, Alaska  
March 30, 2013

NTSB/AAR-14/03  
PB2014-108877

# Aircraft Accident Report

Eurocopter AS350 B3, N911AA

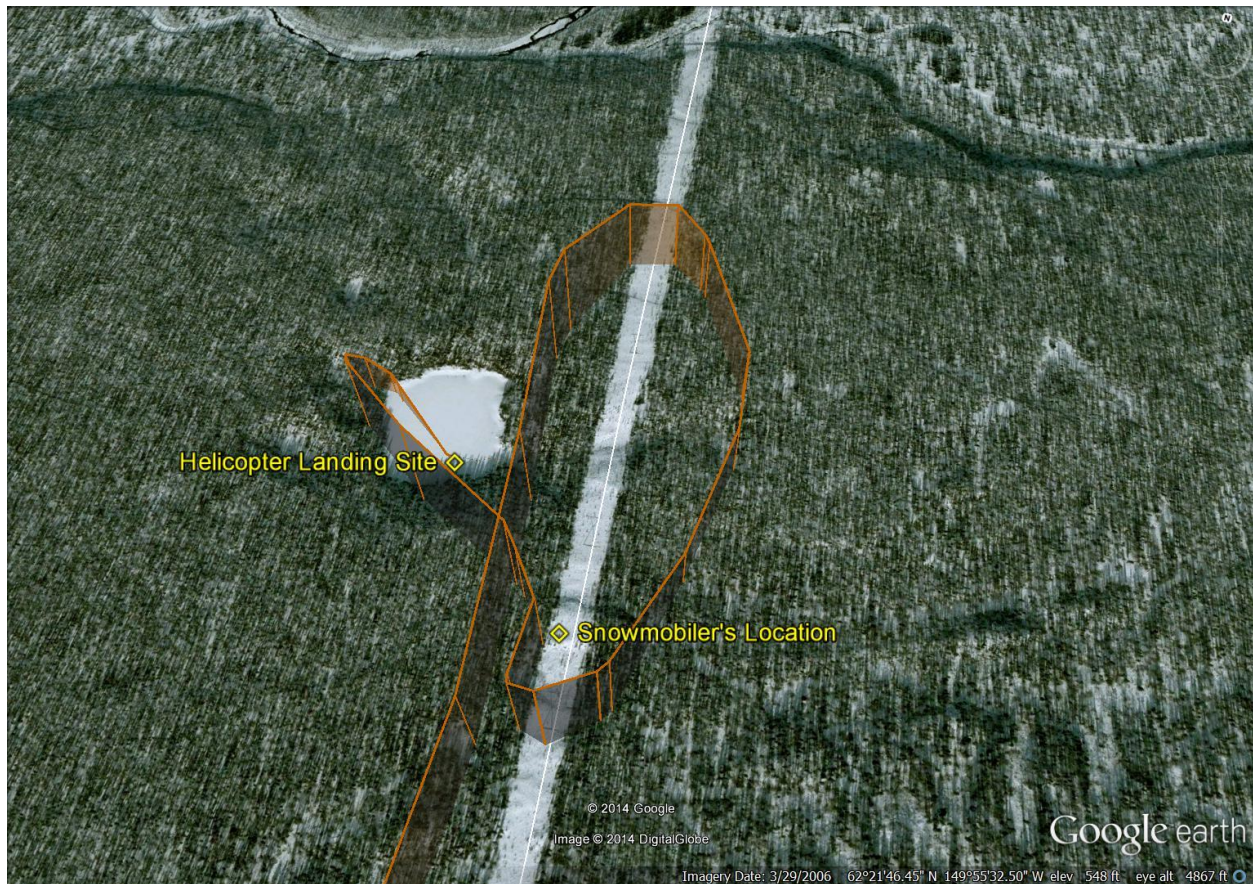
GPS data<sup>8</sup> showed that the helicopter departed Sunshine and proceeded north until it reached the Intertie. As shown in figure 1, the helicopter continued north along the Intertie for about 0.6 mi at an altitude of about 1,100 to 1,200 ft mean sea level (msl), made a right 360° turn over the Intertie, and landed immediately west of it on a frozen, snow-covered pond at 2156. The flight duration was about 11 min, and the landing site pond was about 16 mi north of Sunshine. The landing site elevation was about 460 ft above msl. Hand-written coordinates on the pilot's kneeboard that was recovered from the wreckage indicate that the snowmobiler's location was about 0.2 mi from the landing site.

**Figure 1.** End of GPS flight track from Sunshine to landing site with flight track shown in orange.

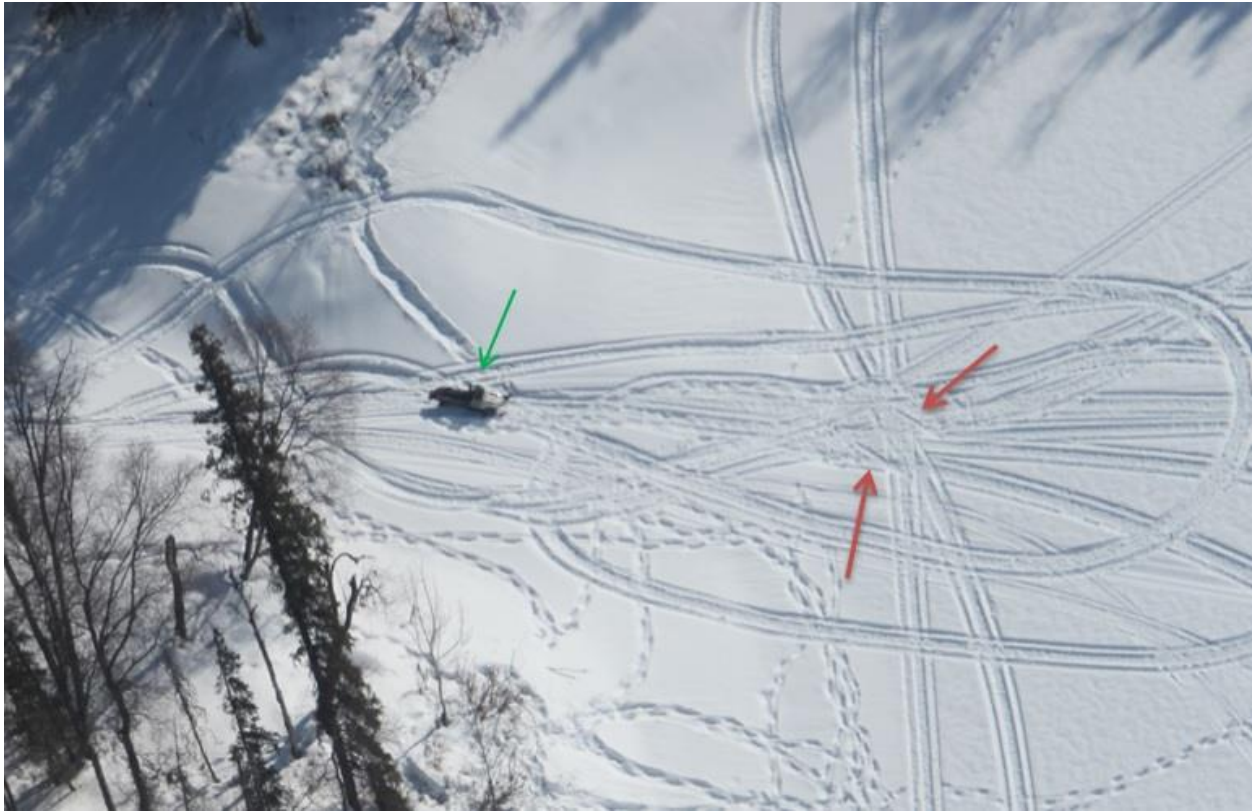
The pilot and trooper did not report to the dispatcher how they assisted the snowmobiler or transported him to the helicopter. However, the snowmobile was later found parked on the frozen pond (not under the Intertie) near two parallel linear marks in the snow with dimensions that corresponded to the helicopter's landing skids (see figure 2).

**Figure 2.** Aerial photograph of helicopter landing site. (Red arrows point to marks consistent with helicopter's landing skids. Green arrow points to the snowmobile.)

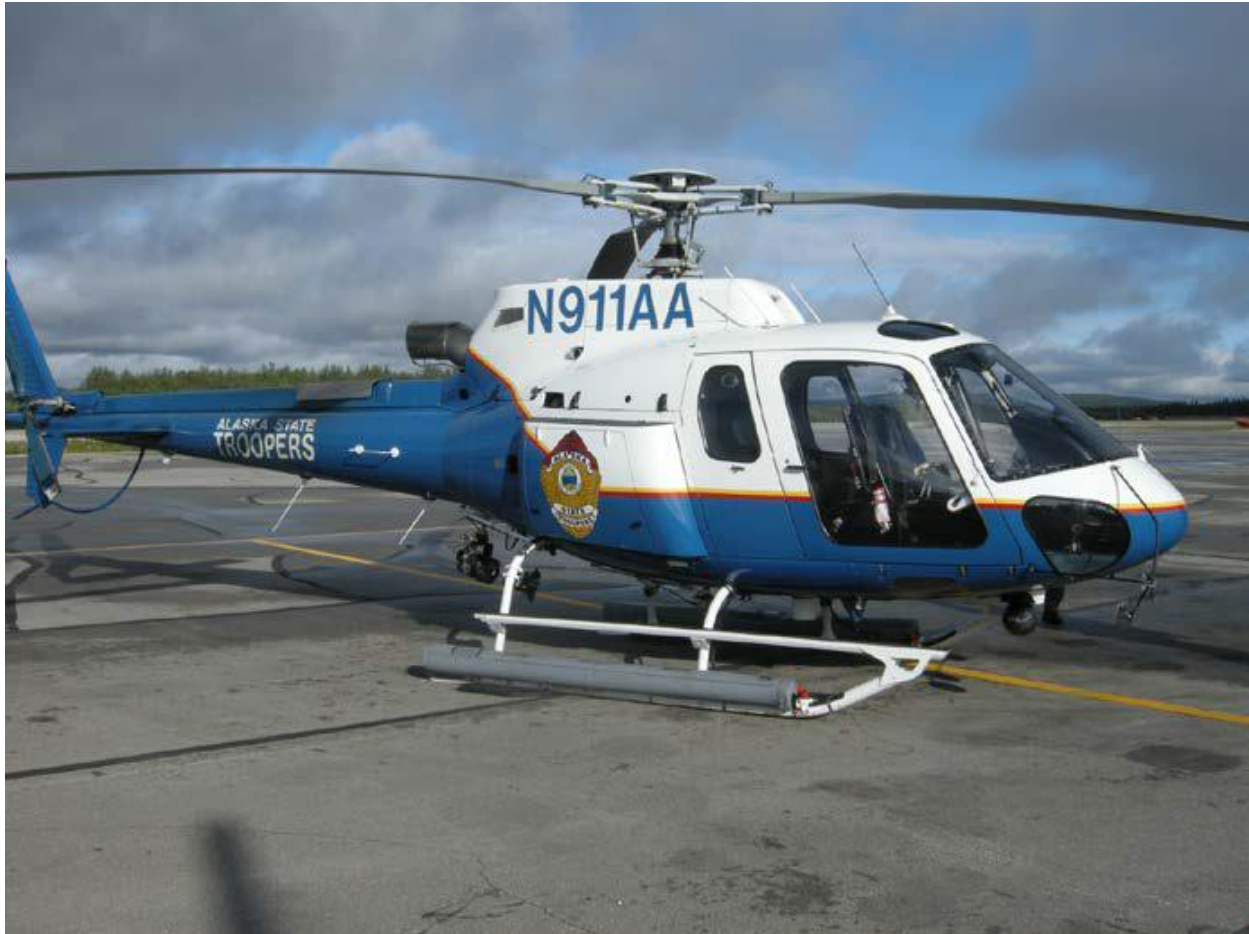
The accident helicopter, pictured in figure 5, was a Eurocopter AS350 B3 model powered by a single Turbomeca Arriel 2B turboshaft engine with a single three-bladed main rotor system using a conventional two-bladed tail rotor for antitorque and heading control. The helicopter had four large doors, two located on either side of the helicopter, for access to the cockpit and passenger seating area. For the SAR mission, the left seat controls had been removed, and the

**Figure 5.** Preaccident photograph of the helicopter.

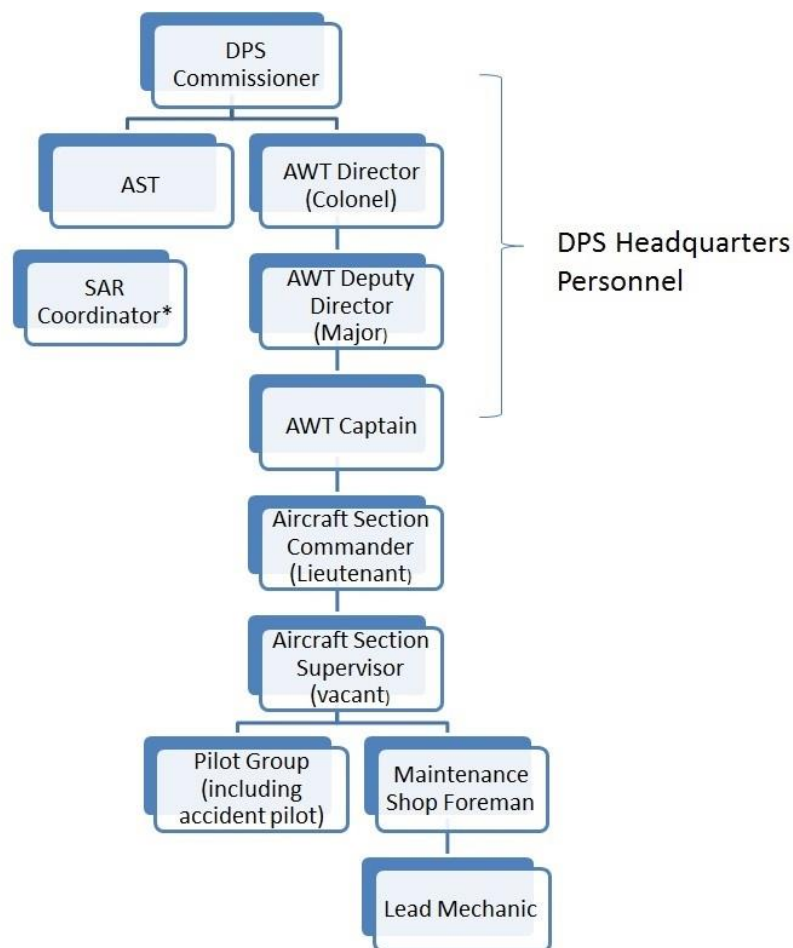
Figure 8 illustrates the chain of command structure that was in place at the time of the accident, based on interviews with DPS personnel.

**Figure 8.** Chain of command structure in place at the time of the accident. (\*Note: Although the SAR coordinator is part of the AST, the AST chain of command personnel are omitted because they are not discussed in this report.)
