**AIRCRAFT ACCIDENT REPORT**  
**PAN AMERICAN WORLD AIRWAYS INC.**  
**BOEING 747, N747PA**  
**FLIGHT 845**  
**SAN FRANCISCO, CALIFORNIA**  
**JULY 30, 1971**  
**ADOPTED: MAY 24, 1972**

**NATIONAL TRANSPORTATION SAFETY BOARD**  
**Washington, D. C. 20591**  
**REPORT NUMBER: NTSB-AAR-72-17**

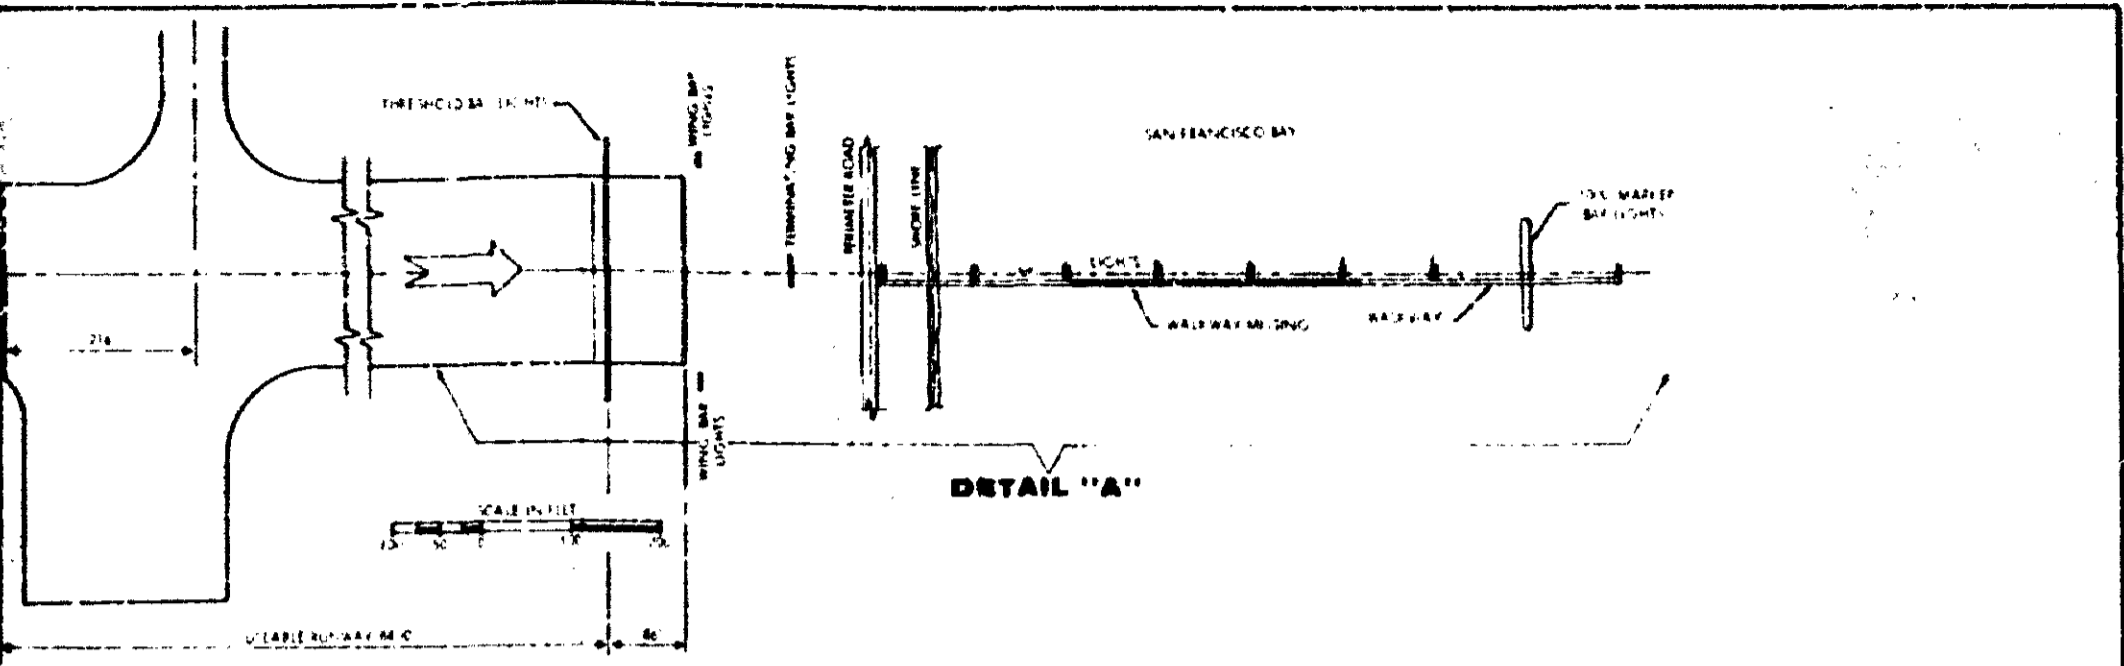
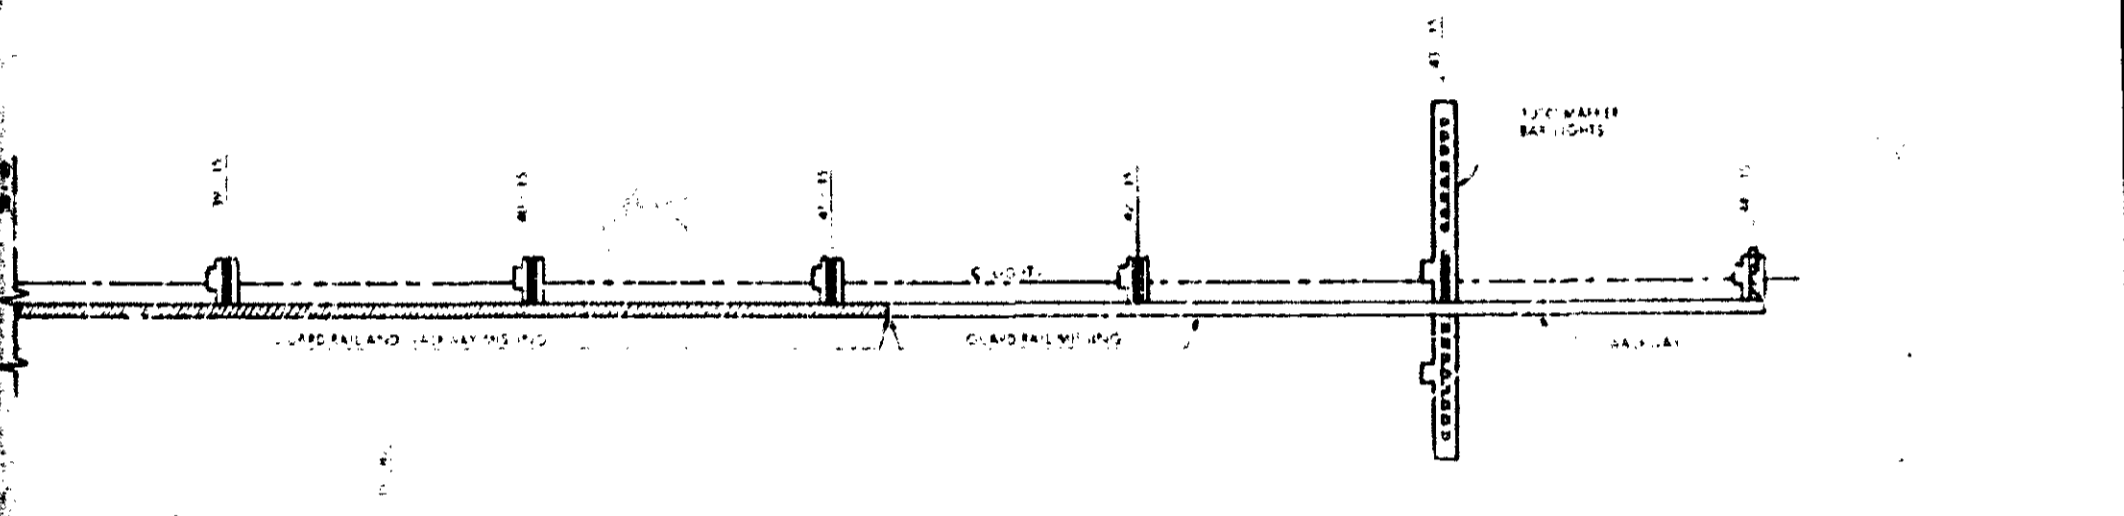
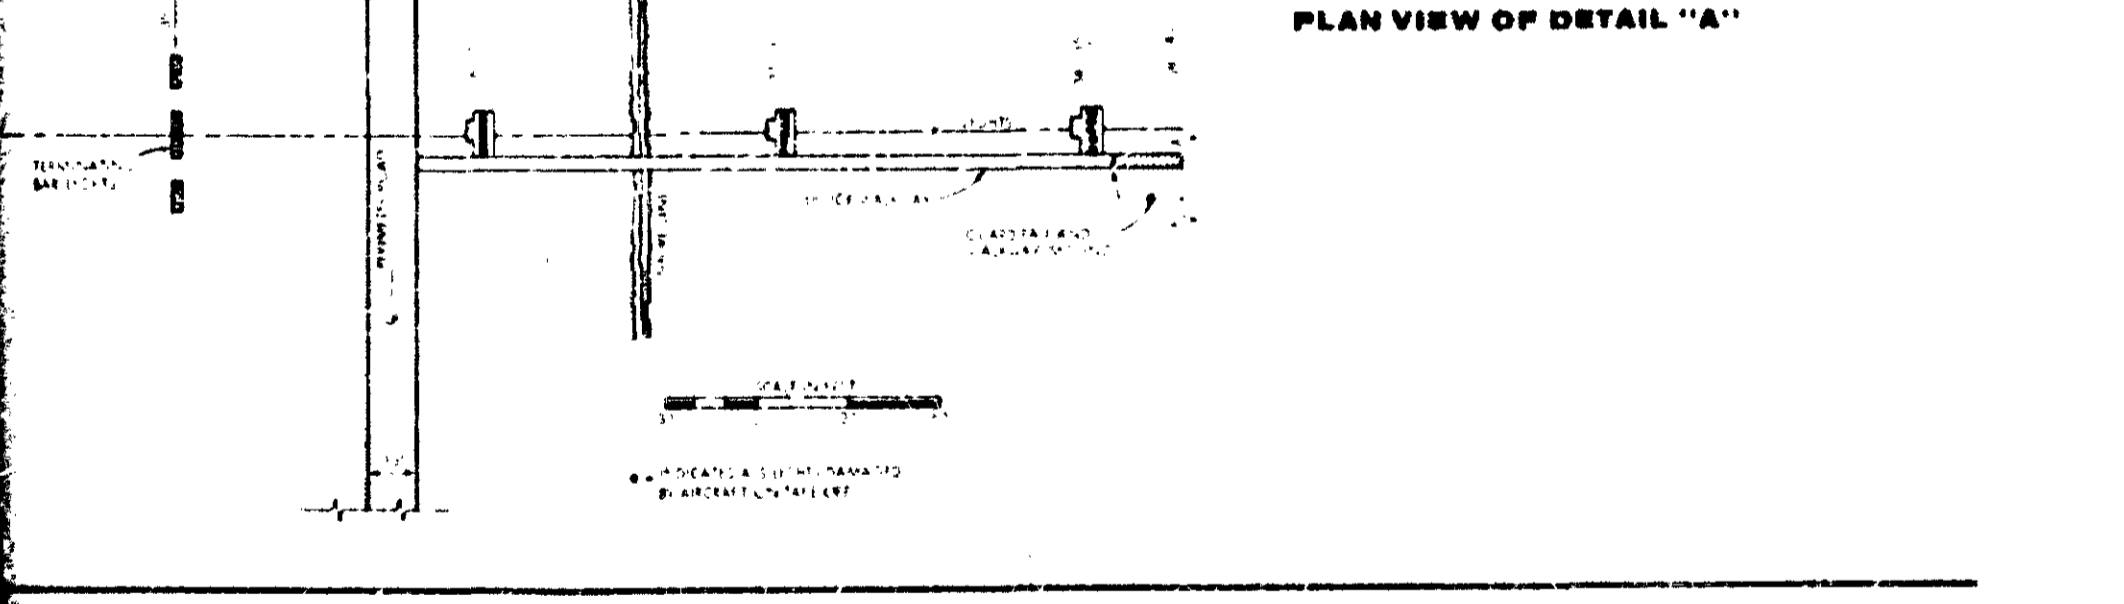
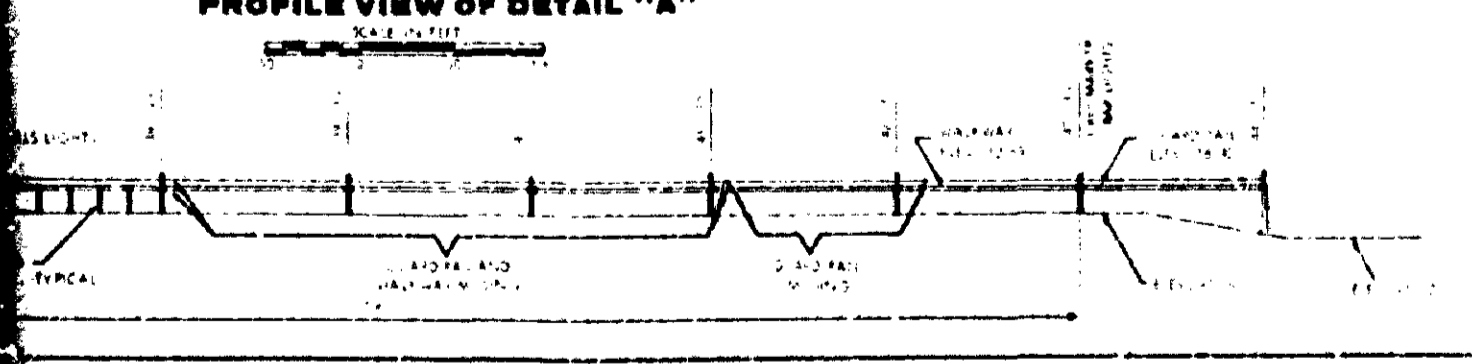
**Attachment 1**  
**NATIONAL TRANSPORTATION SAFETY BOARD**  
 Washington, D.C.  
 DAMAGE TO APPROACH LIGHTING SYSTEM RUNWAY 18L  
 PAN AMERICAN AIRWAYS, INC. BOEING 747-121, N-747PA  
 SAN FRANCISCO INTERNATIONAL AIRPORT  
 San Francisco, Calif.  
 July 30, 1971
