AIRCRAFT ACCIDENT REPORT

AIR CANADA FLIGHT 797
McDONNELL DOUGLAS DC-9-32, C-FTLU
GREATER CINCINNATI
INTERNATIONAL AIRPORT
COVINGTON, KENTUCKY
JUNE 2, 1983

NTSB/AAR-86/02
(SUPERSEDES - - NTSB/AAR-84/09)

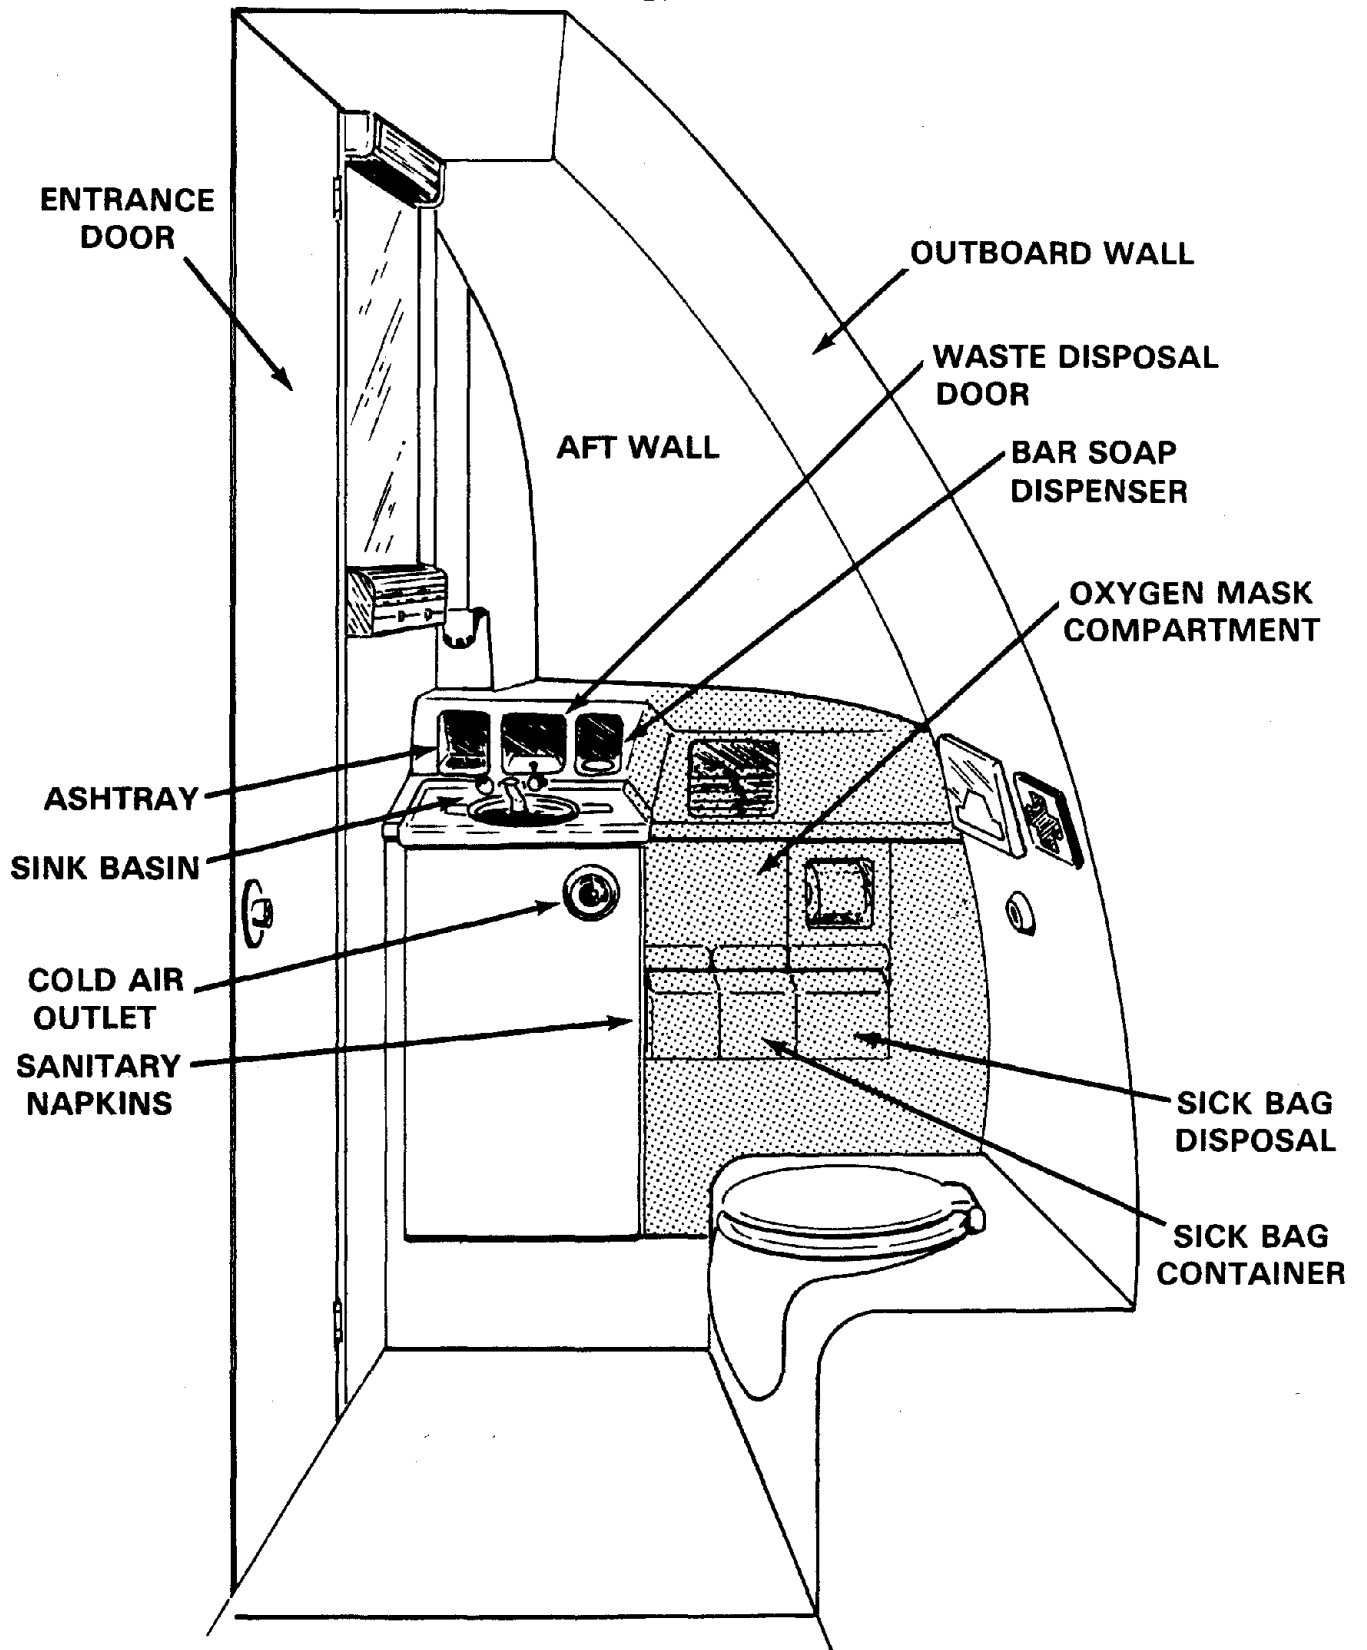
Figure 9.—Diagram of aft lavatory, viewed aft.

The aft lavatory was on the left side of the cabin, and began at FS 965 and extended aft to FS 1019, or just forward of the aft pressure bulkhead. The lavatory's outboard wall conformed essentially to the shape of the airplane's fuselage. There was a vanity section containing a stainless steel sink and amenities located along and extending forward from the aft wall. The commode containing a flushing motor was located along the lavatory's outboard wall. A trash chute and container were located below and behind the sink, and a fresh air supply outlet was positioned below the sink in the door of the vanity. Also, below the trash container, an aluminum shelf was installed. In addition, there was an oxygen outlet located in the oxygen mask compartment in the amenities section. (See figures 9 and 10.)

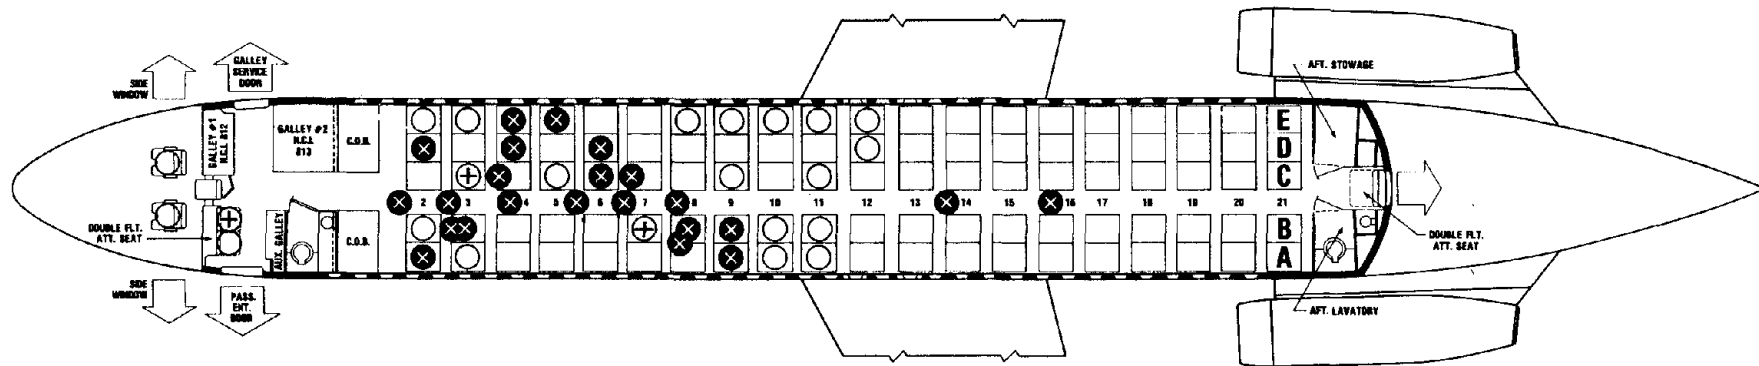
Figure 12.—Diagram of passenger seat locations.

Except for two fatalities found in the aisle at rows 14 and 16, the majority of the fatalities were found either in the aisle or seated in rows 2 through 9. (See figure 12.) The fatalities at rows 14 and 16 had been seated in seats 8-B and 9-B, respectively.

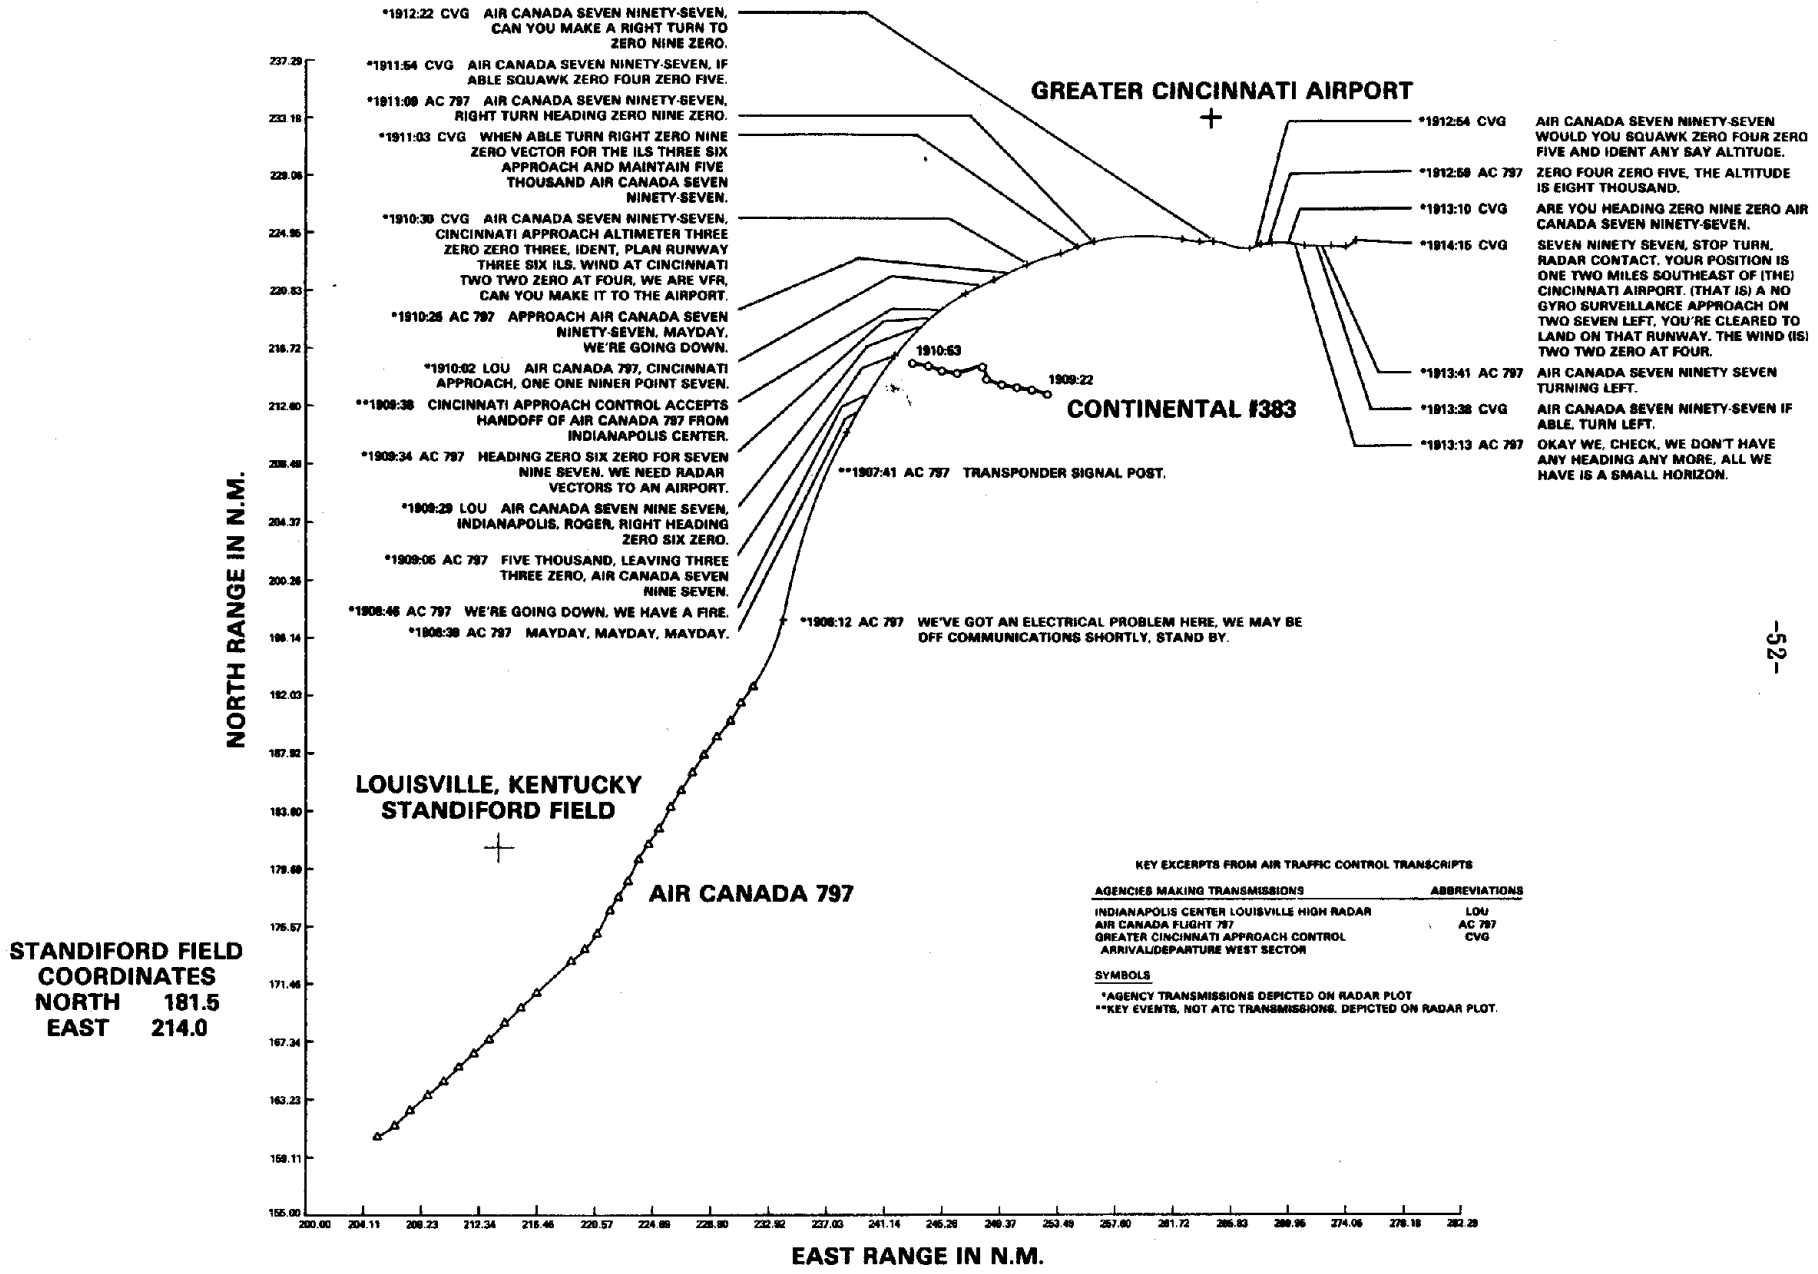
Figure 13.—Ground radar tracks for Flights 797 and 383.

18-36 of the Greater Cincinnati Airport were digitized and plotted with the ground tracks. Times of key transmissions and selected key events were included along Flight 797's radar ground track. The last radar fix retrieved from the DART's data occurred at 1914:15, and the last transponder information from Flight 797 was received at 1906:12. (See figure 13.)
