NATIONAL TRANSPORTATION SAFETY BOARD

AIRCRAFT ACCIDENT REPORT

**COLLISION OF
AERONAVES DE MEXICO, S.A.
McDONNELL DOUGLAS DC-9-32, XA-JED
AND PIPER PA-28-181, N4891F
CERRITOS, CALIFORNIA
AUGUST 31, 1986**

NTSB/AAR-87/07

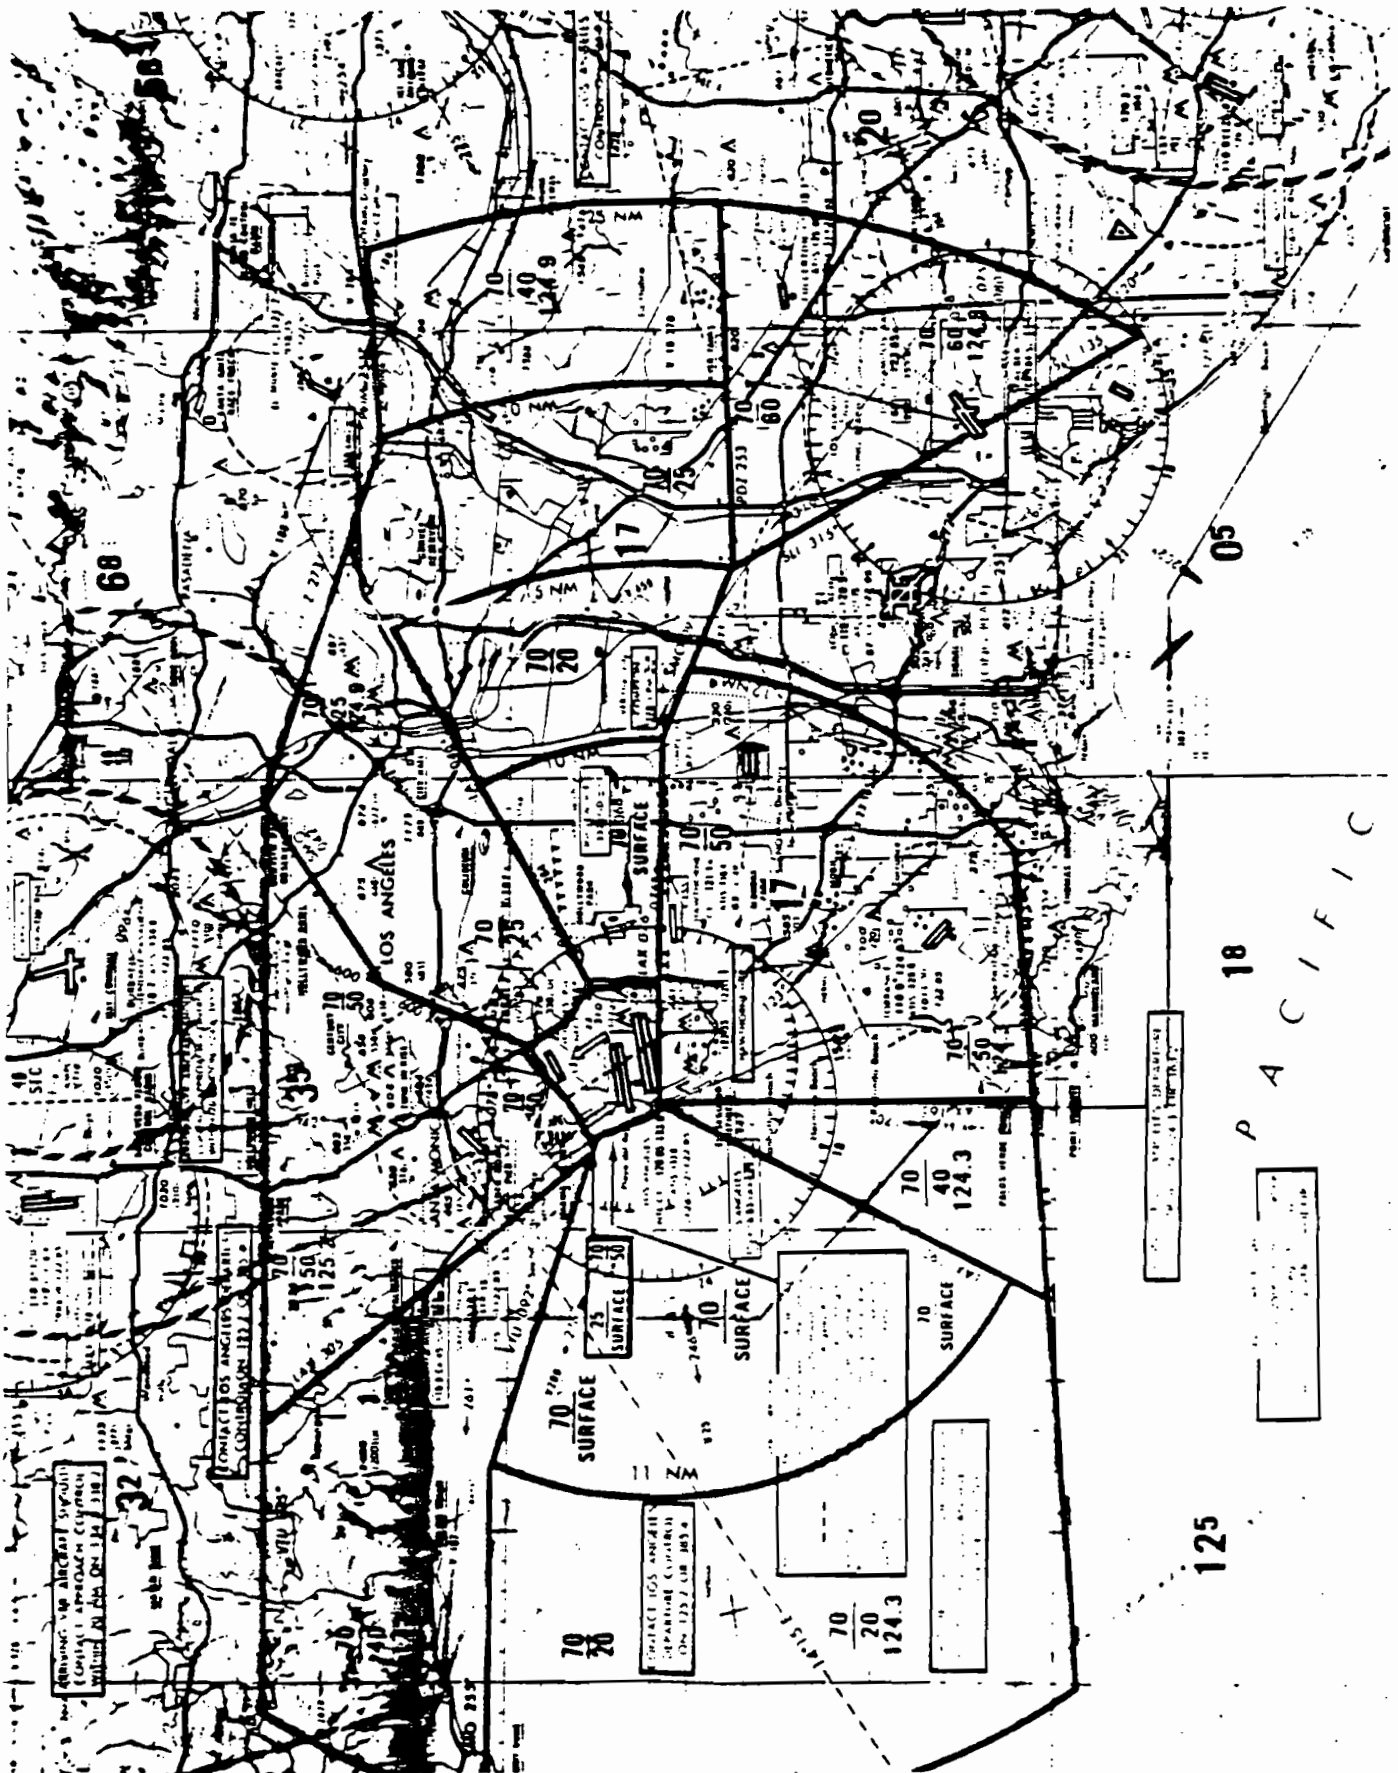
Figure-1.--Los Angeles Terminal Control Area (TCA).

L.A. International is located near the center of its TCA. Except for a triangular segment in the vicinity of Long Beach, California, the apex of which extends northward from its southern boundary, the TCA is essentially a parallelogram. Its western and eastern boundaries are about 20 nmi and 25 nmi, respectively, from the western edge of L.A. International. The TCA's northern and southern boundaries are essentially parallel to the extended centerlines of L.A. International's four runways and are each about 10 nmi from the center of the airport, respectively. (See figure 1.)

Vertically, the TCA resembles an "upside down" wedding cake, beginning at the surface at L.A. International and rising to a ceiling of 7,000 feet. Proceeding westward from the airport and aligned with the extended centerlines of the airport's runways, the floor of the TCA remains at the surface. Between 11 nmi and 20 nmi west of the airport, the floor rises to 2,000 feet. A similar gradient exists along the eastward extensions of the four runway centerlines. To the north and south of the airport and the extended centerlines of the four runways, the floor of the TCA rises sharply. (See figure 1.)

The TCA charts show that Torrance Municipal Airport is under the southern edge of the TCA and that the floor of the TCA above the airport is 5,000 feet. The Piper pilot bought a Los Angeles Sectional Chart and a Los Angeles VFR Terminal Area Chart on the morning of the accident. The Terminal Area Chart, folded to display the combined map and TCA diagram, was found in the Piper's cockpit wreckage; course lines had not been drawn on either side of the chart.

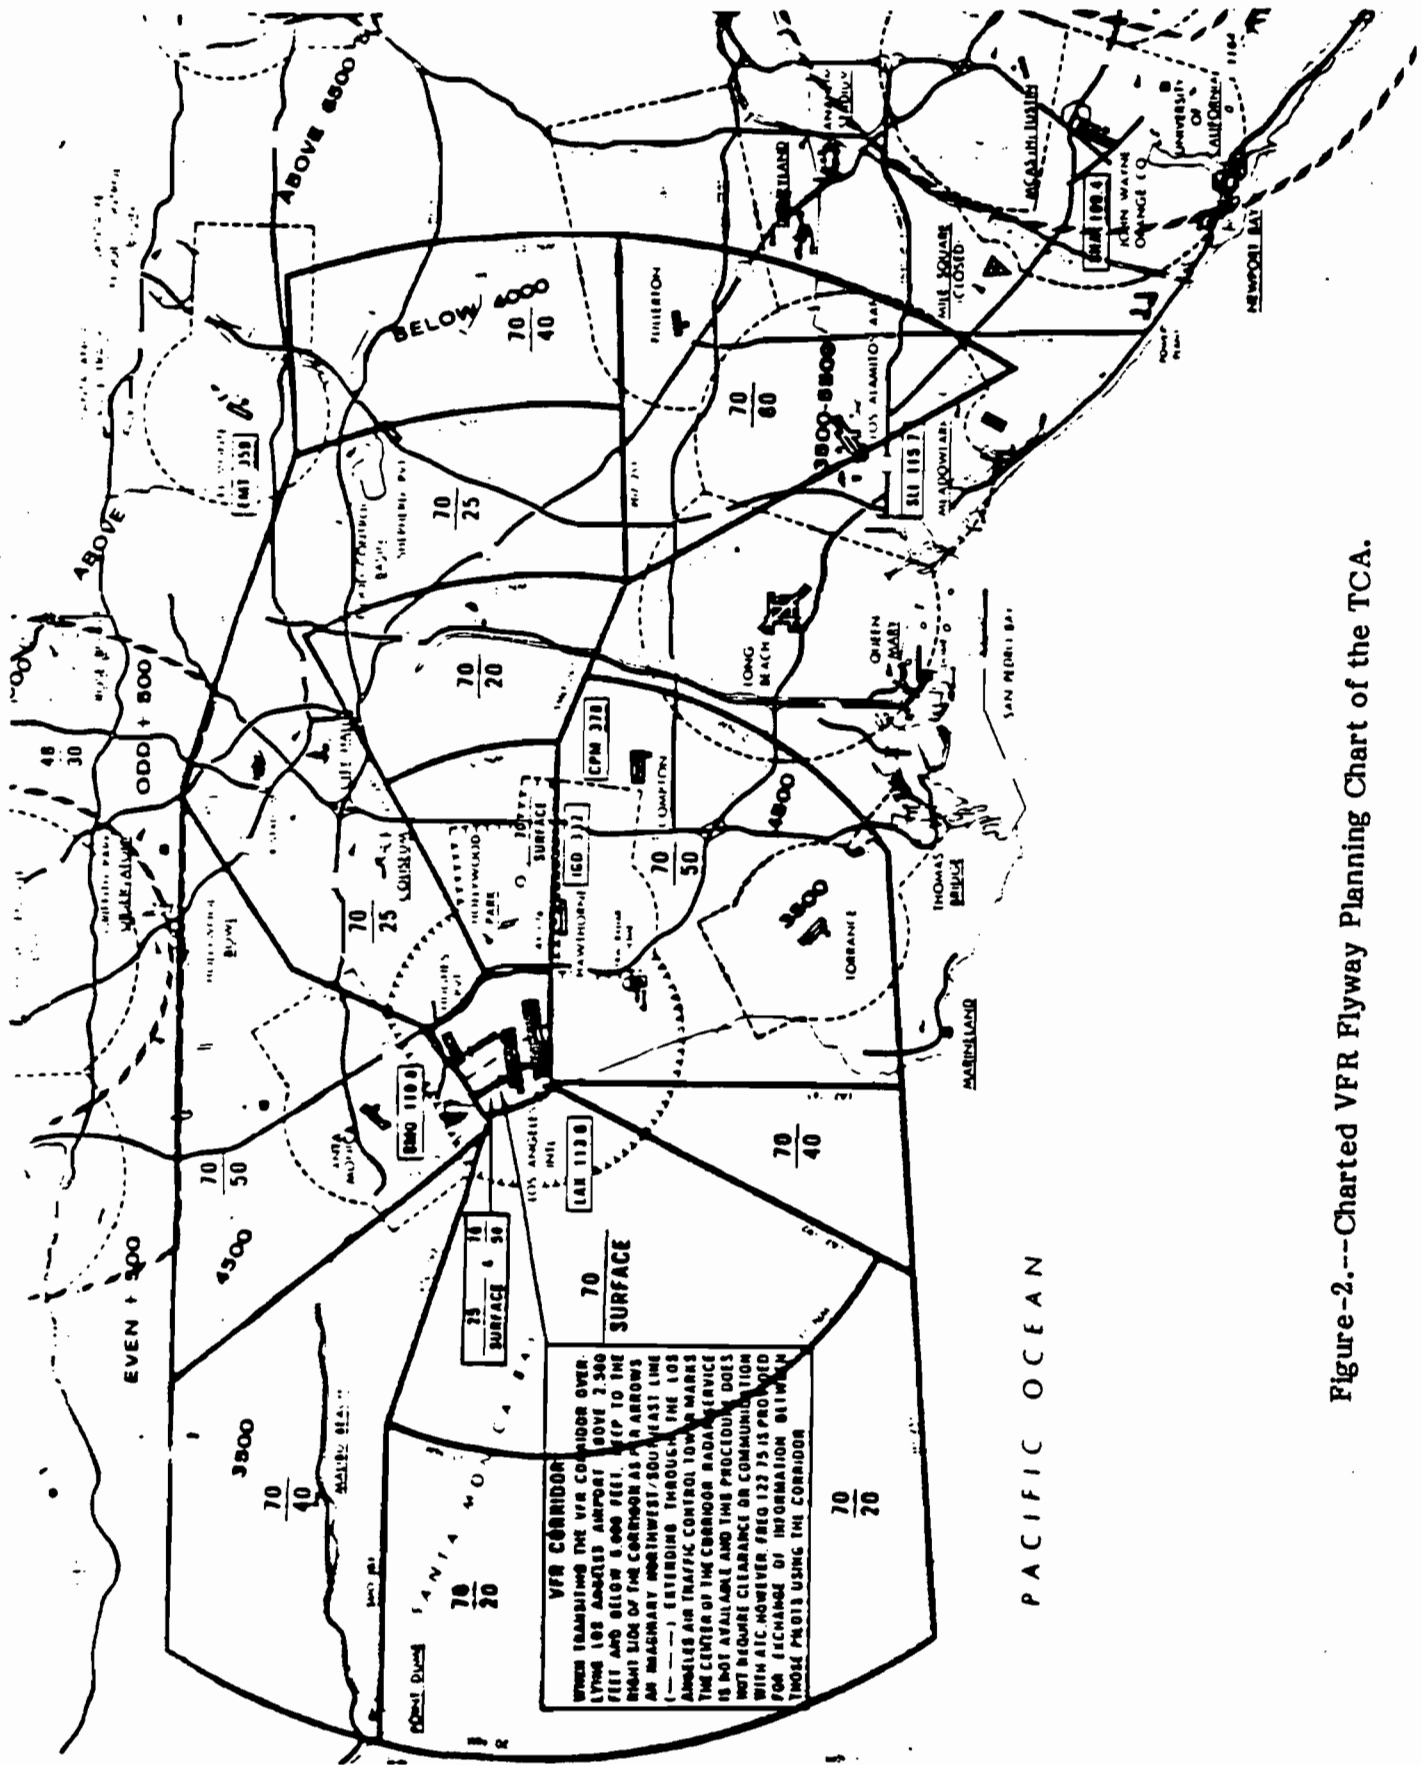
Figure-2.--Charted VFR Flyway Planning Chart of the TCA.

The lateral and vertical dimensions of the Los Angeles TCA are depicted on the Los Angeles VFR Terminal Area Chart. On one side of the chart, the TCA is superimposed on a Lambert Conformal Conic Projection map (figure 1); the chart's overleaf contains a Charted VFR Flyway Planning Chart of the TCA (figure 2). In addition to depicting the numerous airports in the Los Angeles area, the plan view also depicts prominent landmarks within and adjacent to the TCA. For example, the planning chart shows that Disneyland and the Anaheim Stadium are just east of the TCA's eastern boundary. It also depicts and names the freeways located within and around the TCA. Finally, the planning chart depicts the north-south VFR flyway over L.A. International and the altitudes to be flown when using this flyway (figure 2).

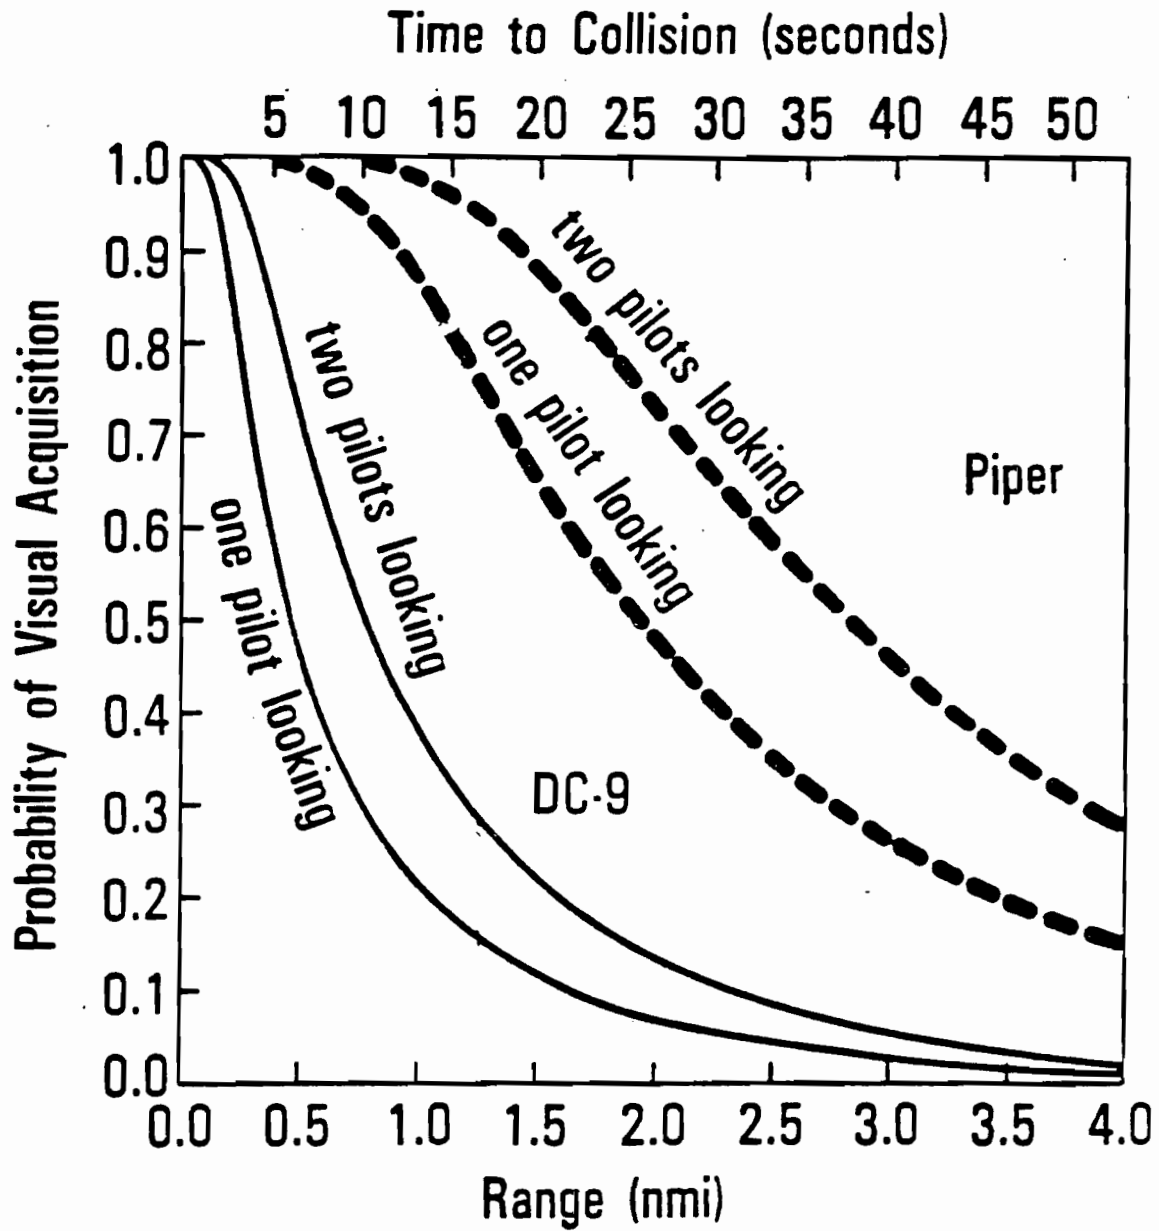
Figure 3.--Probability of seeing the other aircraft as a function of time until collision.

The data cited herein were developed by a project leader on the Air Traffic Control Division, Lincoln Laboratories, MIT, who had conducted research on human visual performance and flight testing of collision avoidance systems. At the Safety Board's request, the project leader constructed Probability of Visual Acquisition Graphs based on the extrapolation of pertinent data contained in the facts and circumstances of the collision between the Piper PA-28 and flight 498 with the data described above. (See figures 3 and 4.) The graphs are based on the closure rate between flight 498 and the Piper and on the results achieved by pilots having an unobstructed view of the intruder. The graphs do not account for such limiting factors as cockpit structure and the possibility that the airplanes might be positioned so that they can be seen with only one eye. However, the information in this report is of significance in that it provides a baseline for further evaluation.

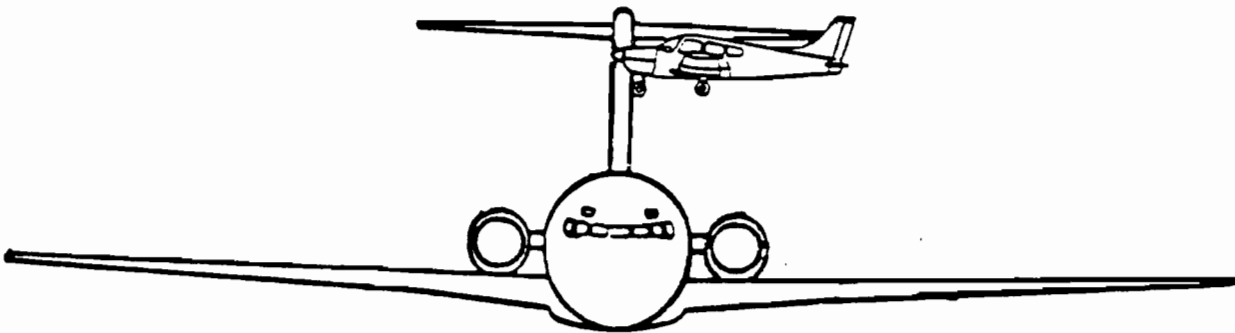
Figure 6.--Collision geometry as viewed from above the DC-9.

The damaged areas on the DC-9 vertical and horizontal stabilizers contained propeller slice marks, paint transfer marks from the nose wheel area and vertical stabilizer of the Piper, and embedded pieces from the cabin roof area of the Piper. The location and angles of these marks and damage on the DC-9, when matched to their respective locations on an intact Piper PA-28, showed that the front of the Piper had struck the left side of the DC-9 vertical stabilizer and that the impact angle was perpendicular to the longitudinal axis of each airplane. (See figure 6.) The impact angle was generally consistent with the flight tracks of the airplanes shown on the radar data plots.

Estimated positions of aircraft at impact, based on the propeller damage and scratch marks on the DC-9 Vertical and Horizontal Stabilizers.
