PB92-910402
NTSB/AAR-92/02
(SUPERSEDES NTSB/AAR-90/01)

AIRCRAFT ACCIDENT REPORT

EXPLOSIVE DECOMPRESSION--
LOSS OF CARGO DOOR IN FLIGHT
UNITED AIRLINES FLIGHT 811
BOEING 747-122, N4713U
HONOLULU, HAWAII
FEBRUARY 24, 1989

**Adopted: March 18, 1992
Notation 5059C**

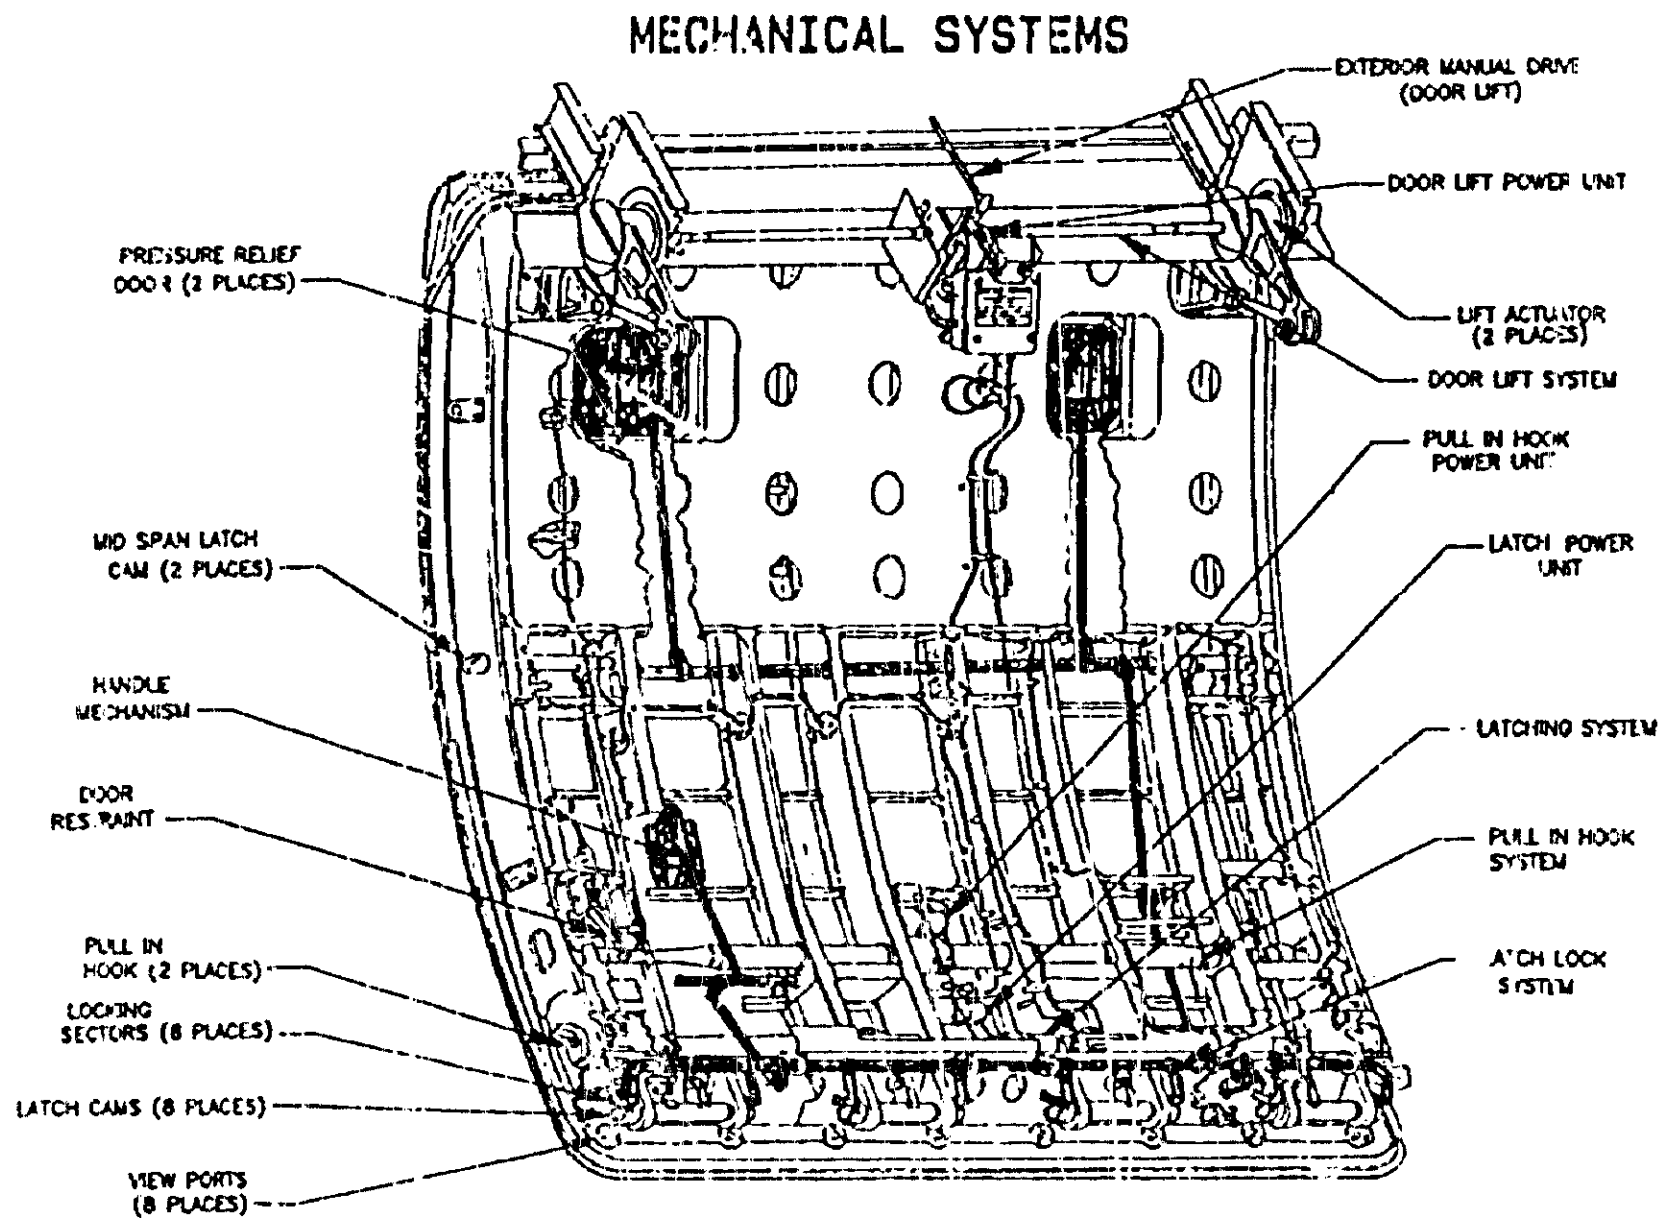
Figure 4.--Boeing 747 lower lobe forward cargo door.

The cargo door and its associated hardware are designed to carry circumferential (hoop) loads arising from pressurization of the airplane. These loads are transmitted from the piano hinge at the top of the door, through the door itself, and into the eight latches located along the bottom of the door. The eight latches consist of eight latch pins attached to the lower door sill and eight latch cams attached to the bottom of the door. The cargo door also has two midspan latches located along the fore and aft sides of the door. These midspan latches primarily serve to keep the sides of the door aligned with the fuselage. There are also four door stops which limit inward movement of the door. There are two pull-in hooks located on the fore and aft lower portion of the door, with pull-in hook pins on the sides of the door frame. (See figure 4 for cargo door components).

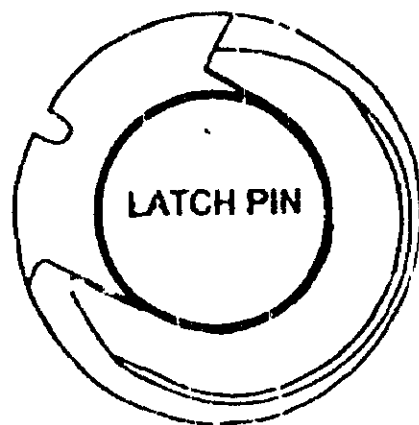
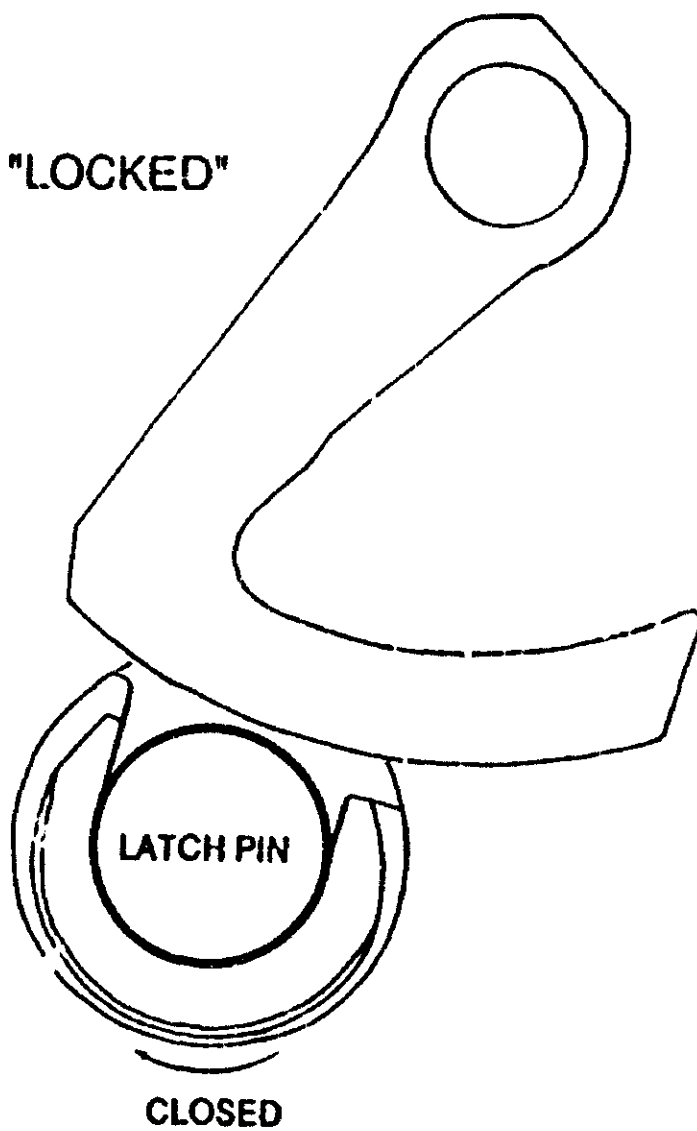
Figure 5.--Cargo door latch cam and lock sector in unlocked and locked positions.

The cargo doors on the B-747 have a master latch lock handle installed on the exterior of the door. The handle is opened and closed manually. The master latch lock handle simultaneously controls the operation of the latch lock sectors, which act as locks for the latch cams, and the two pressure relief doors located on the door. Figure 5 depicts a lock sector and latch cam in an unlocked and locked condition.

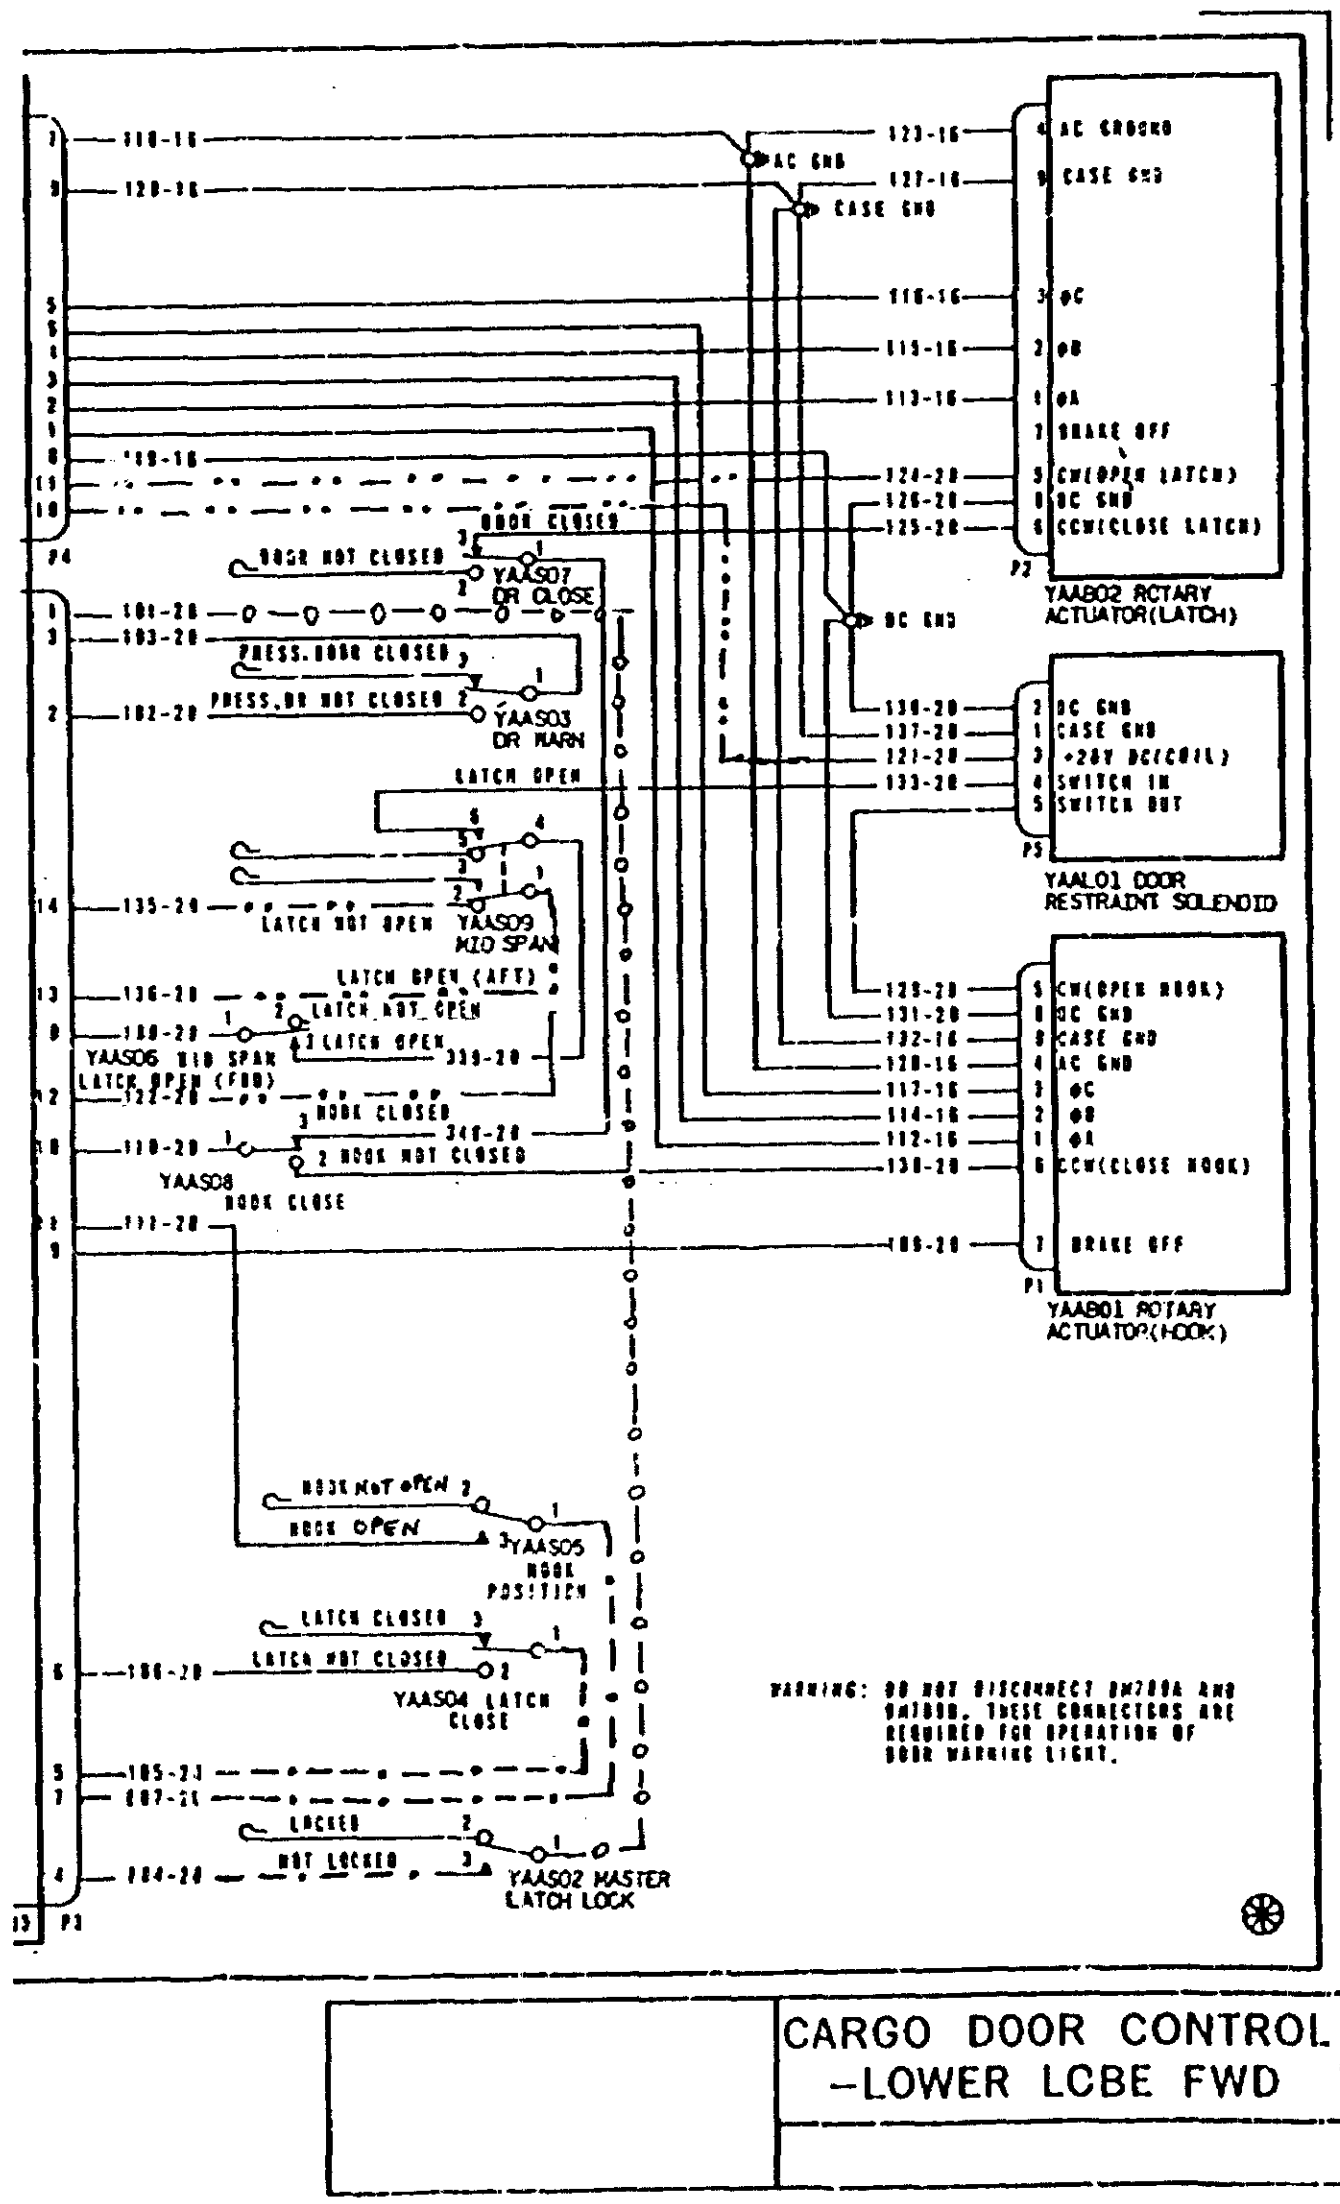
Figure 17.--Diagram of cargo door electrical circuitry.

The cargo door was recovered with all of its position sensing switches installed in their proper locations. The electrical junction box was found attached to the door but damaged. The switches recovered and examined were: S2 Master Latch Lock; S3 Door Warning; S4 Latch Close; S5 Hook Position; S6 Fwd Mid-Span Latch Open; S7 Door Close; S8 Hook Close; and S9 Aft Mid-Span Latch Open. Figure 17 provides a diagram of the cargo door's electrical circuitry.

Conductive contact of (-o-o-o-o) or (---.---.---) coded wire with (-.---.---) coded wire could potentially result in providing a 28VDC circuit path to the latch actuator open circuit. Direct wire-to-wire paths are coded in Figure 17 as defined above. The two-wire short circuit paths are identified as wire pairs consisting of wire 101-20 shorting with any of the following wires; 108-20, 121-20, 122-20, 124-20, 135-20, or 136-20.

If the S2 master latch lock switch fails in the "Not Locked" position, there are additional wire pairs that provide short circuit paths. These are coded in Figure 17 as (---.---.---) to (-.---.---) wire pairs.
