National Transportation Safety Board

RESPONSE TO PETITION FOR RECONSIDERATION

AIRCRAFT ACCIDENT REPORT

RUNWAY COLLISION
UNITED EXPRESS FLIGHT 5925
AND BEECHCRAFT KING AIR A90
QUINCY MUNICIPAL AIRPORT
QUINCY, ILLINOIS
NOVEMBER 19, 1996

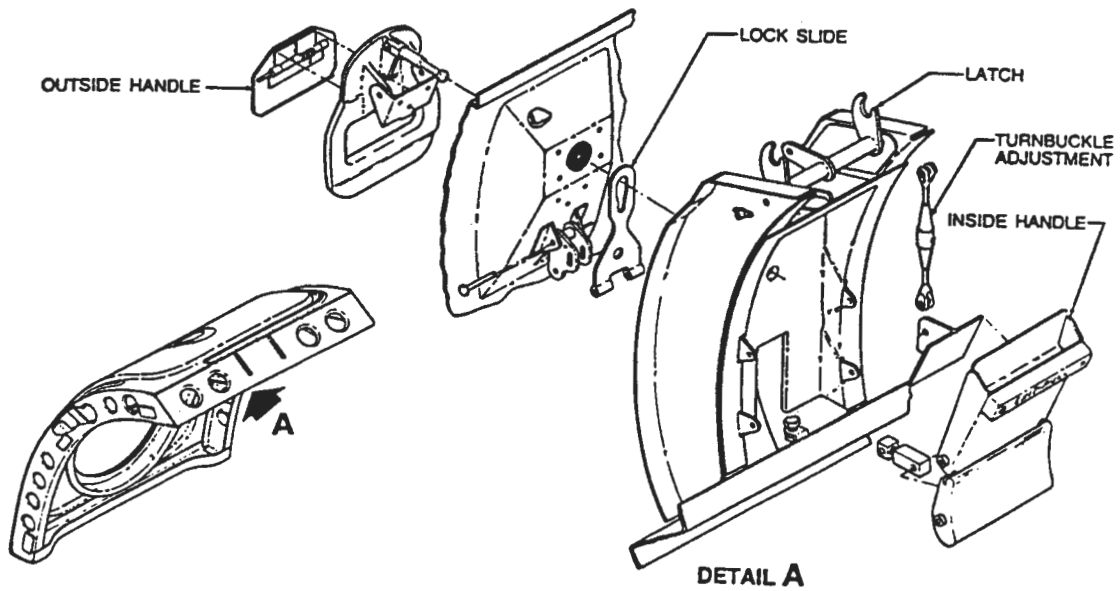
Figure 5.—Diagram of overwing exit hatch.

Two overwing exit hatches are located on the right side and one on the left side of the Beech 1900C passenger cabin. From the inside, the doors are released with a pull-down handle, placarded "EXIT - PULL." From the outside, the doors are released with a flush-mounted, pull-out handle. The exit hatches are nonhinged, plug-type doors that completely remove from the fuselage frame into the cabin when the latches are released. (See figure 5.) Windows at the overwing exits have a placard with instructions to "push seat backs to clear exit."

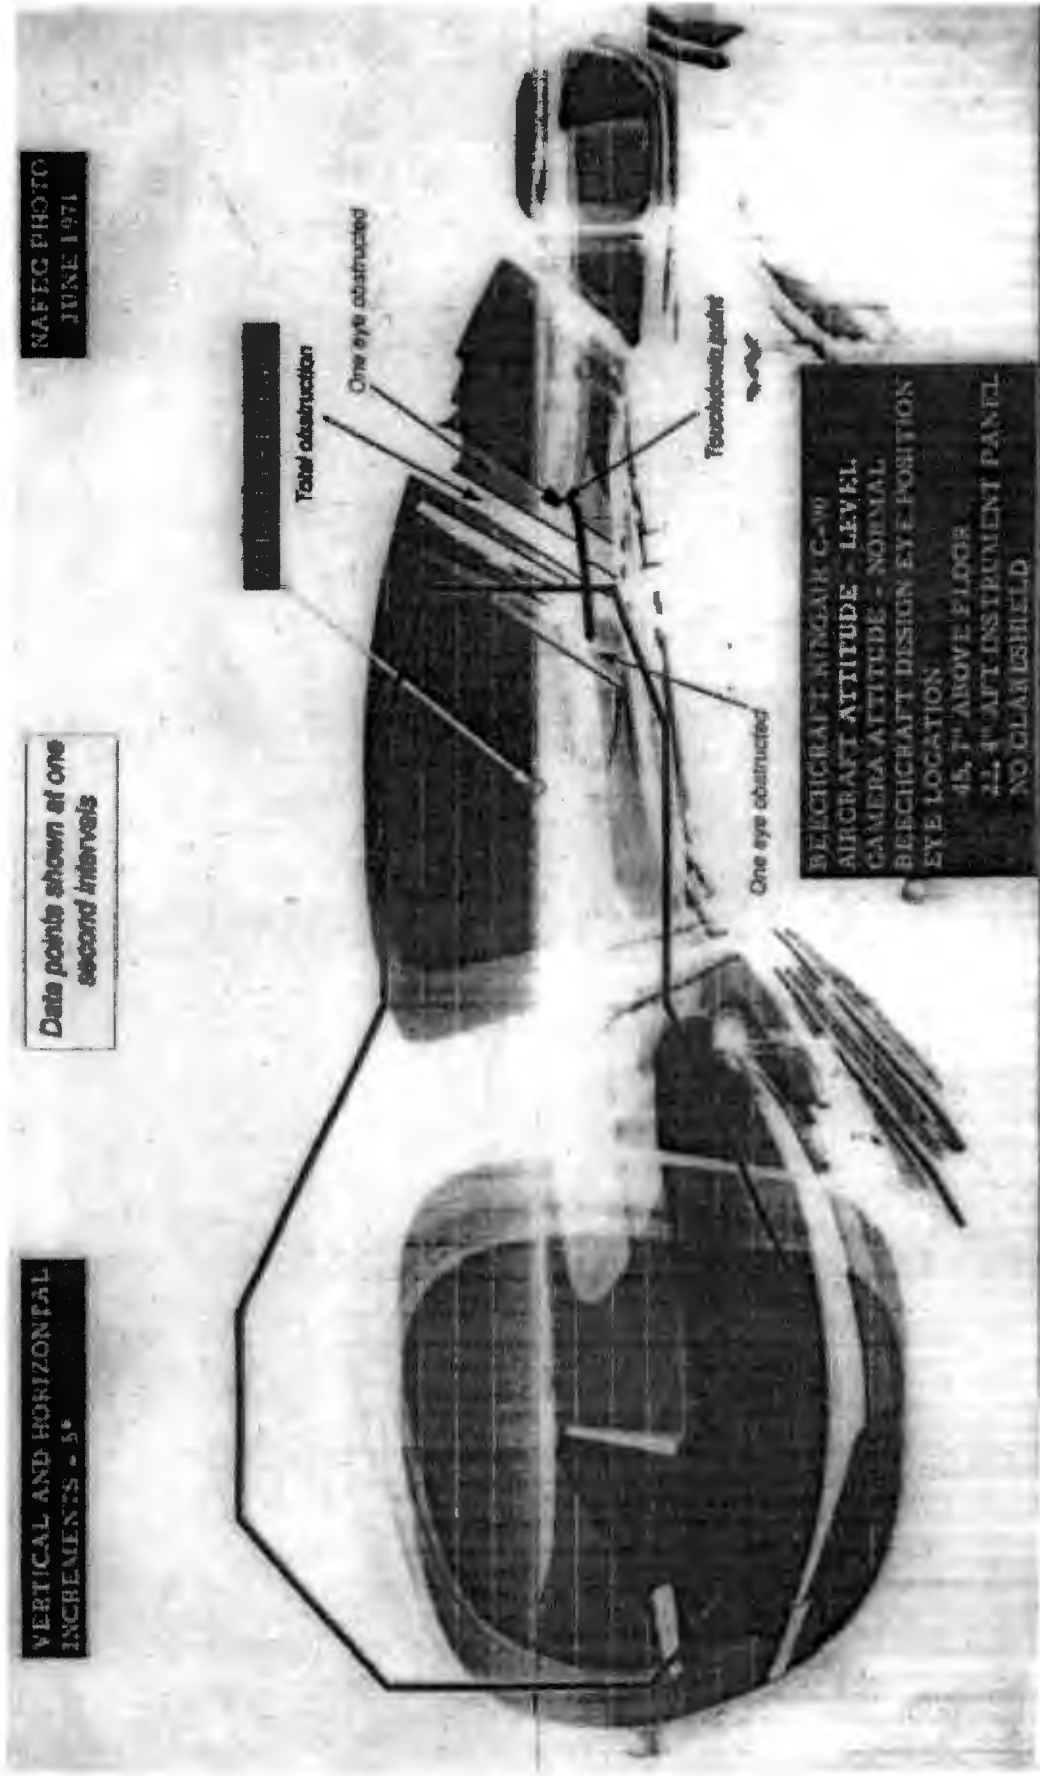
Figure 6.—Beech 1900C captain's view of King Air.

As shown in figure 6, the Safety Board's study using its VIZPC computer program indicated that the view of the King Air from the Beech 1900C captain's position would have been partially obstructed by the center post and windshield wipers during the airplane's final approach and would have been totally obscured by the center post for 6 seconds, starting about 17:00:43. Approximately 10 seconds before touchdown,³⁶ at 1700:49, until the time of the

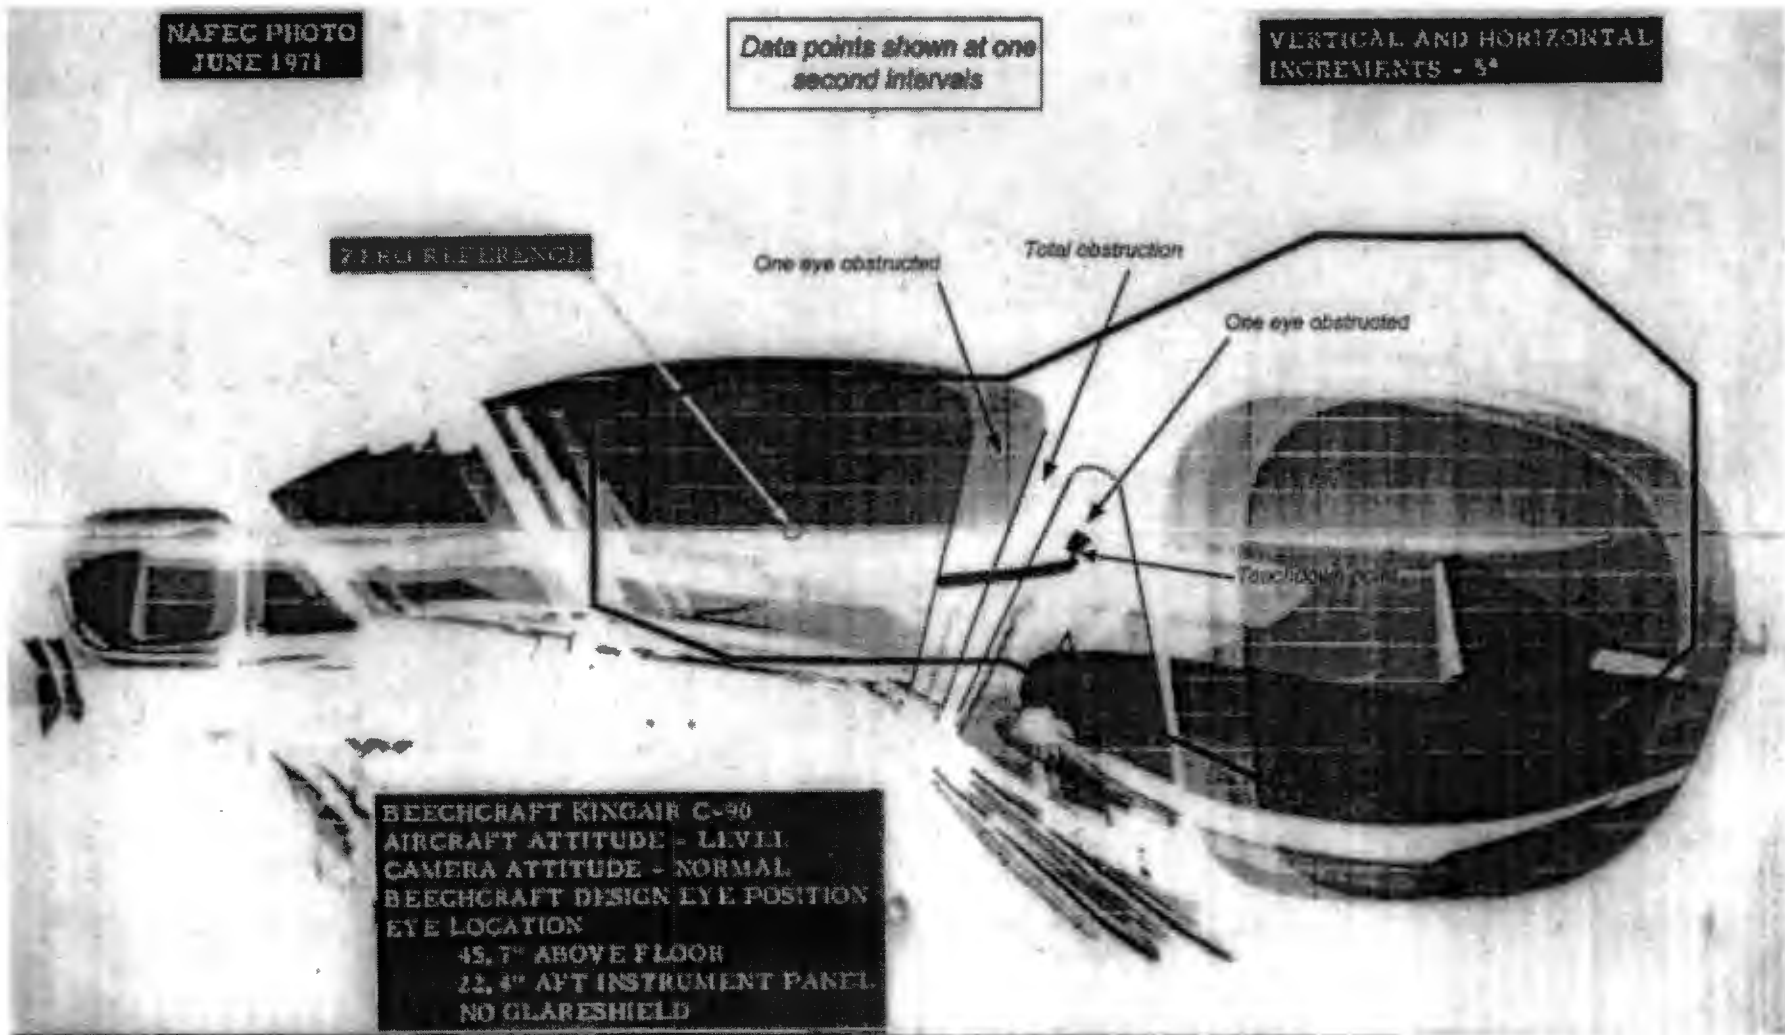
Figure 7.—Beech 1900C first officer's view of King Air.

As shown in figure 7, the view from the Beech 1900C first officer's position would have been partially obstructed by the first officer's side posts for nearly 30 seconds before touchdown until impact, including 6 seconds starting at 17:00:42 when the first officer's view of the King Air would have been totally obstructed by the front windshield side post.

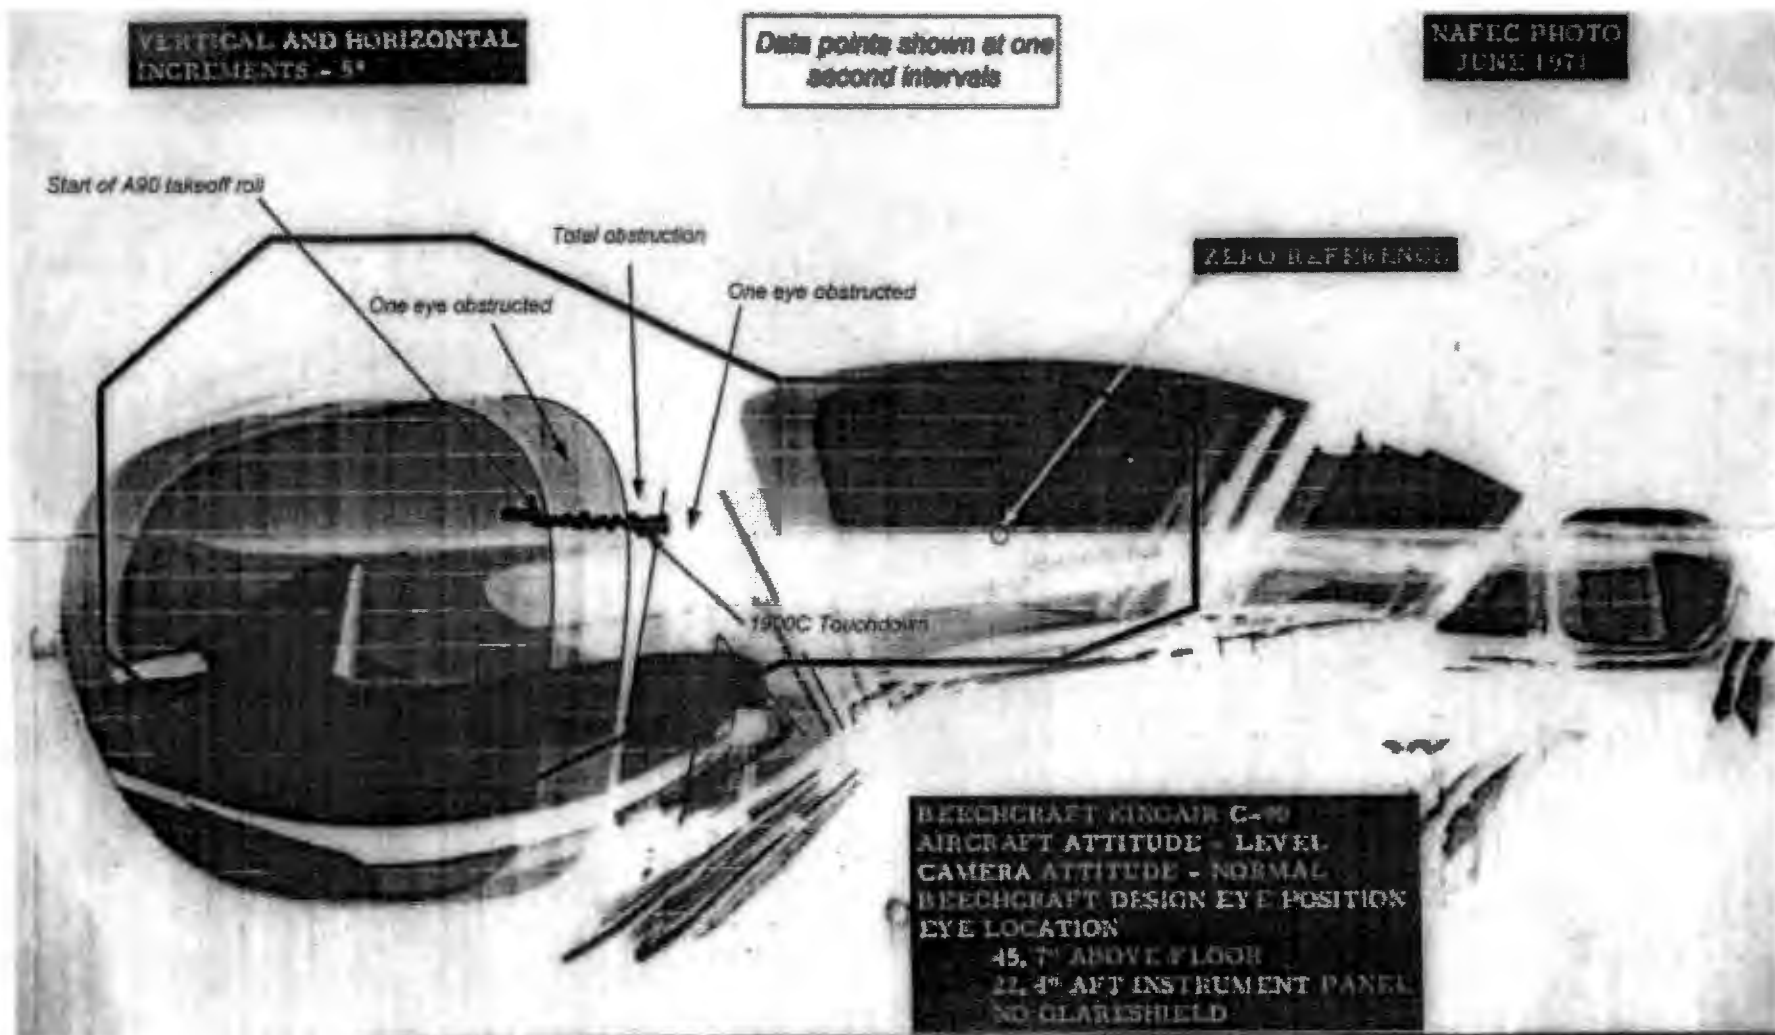
Figure 8.—King Air left seat occupant's view of Beech 1900C.

The VIZPC study also indicates that while the King Air was stationary near the end of runway 04, the left seat occupant's³⁷ view of the Beech 1900C would have been unobstructed at nearly 72° to the left, as viewed through the side window of the King Air. (See figure 8). About 17:00:40, 4 seconds before the King Air began its takeoff roll, the view of the Beech 1900C from the left seat occupant's position would have become partially obstructed at nearly 68° to the left, and fully obstructed at 17:00:54, about 55° to the left, when the King Air would have been accelerating during the roll; this time is immediately before the touchdown of the Beech 1900C. The view of the Beech 1900C from the left seat occupant's position would have been fully obstructed from 17:00:54 until impact at 17:01:09, except for 2 seconds at 17:01:02 when the view would have been partially obstructed.

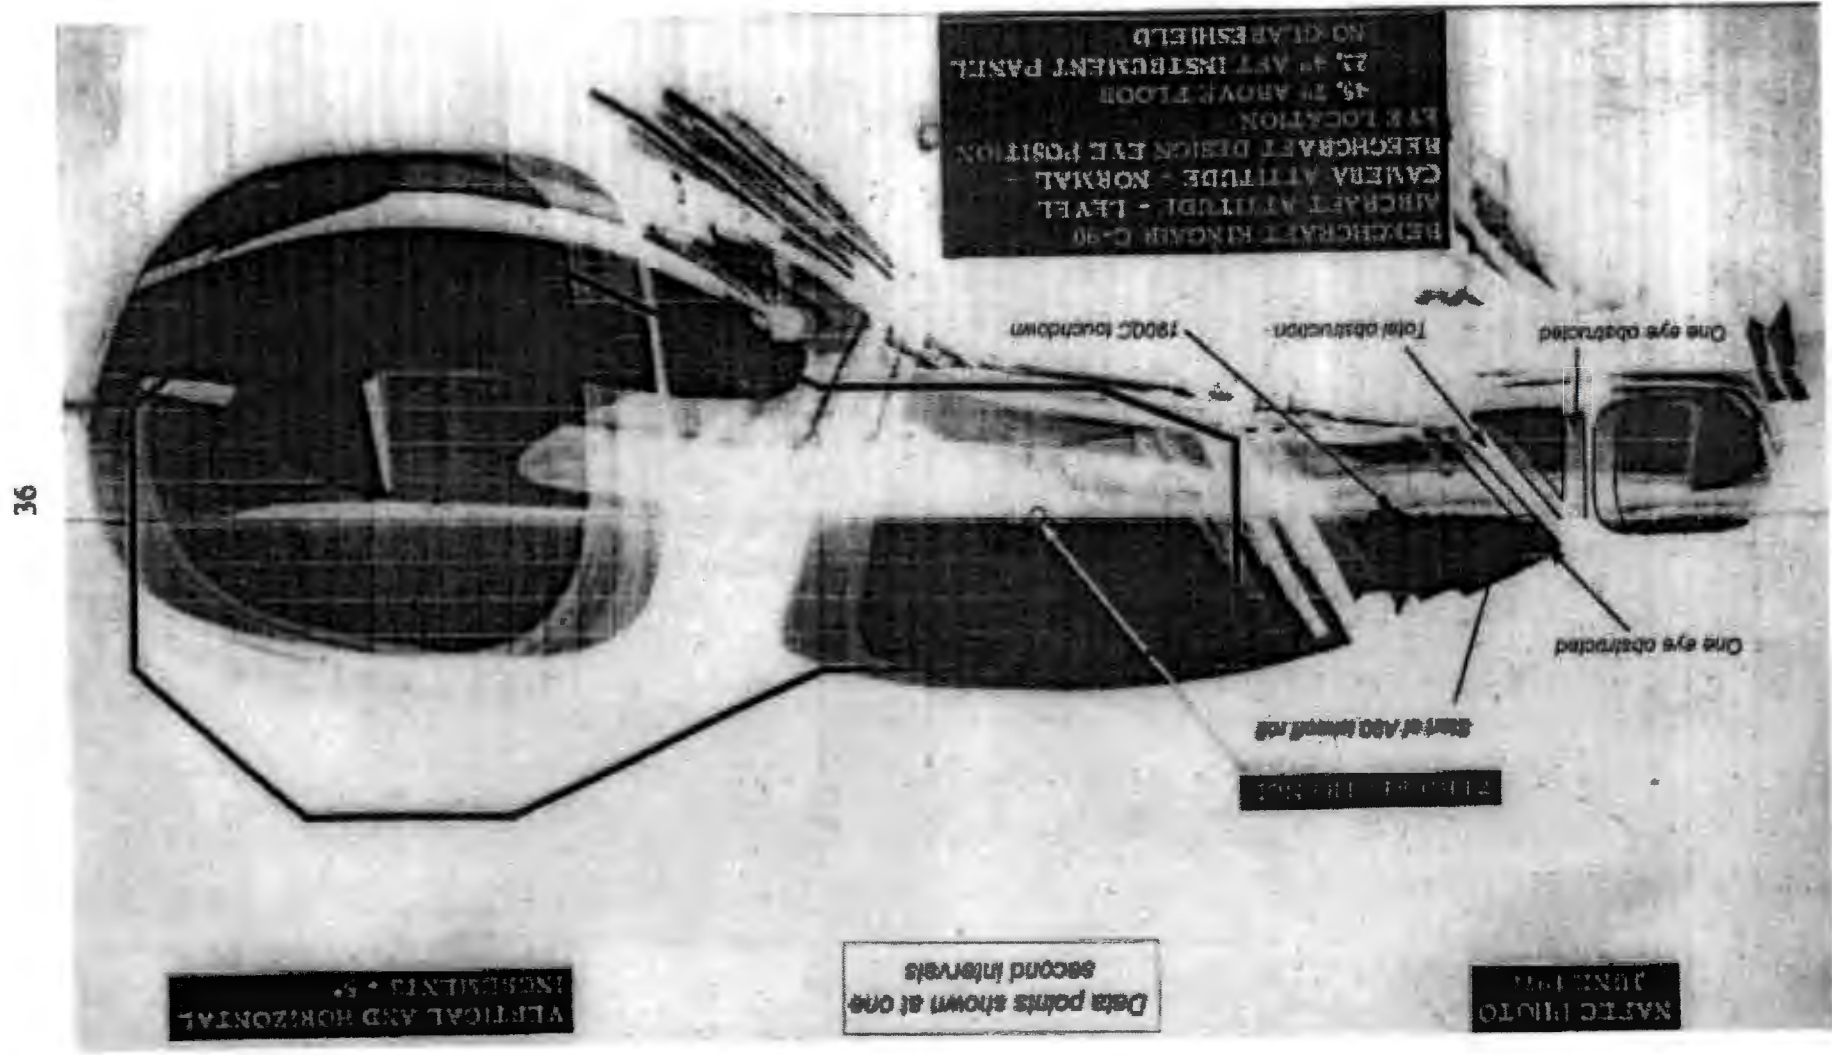
Figure 9.—King Air right seat occupant's view of Beech 1900C.

As shown in figure 9, the King Air right seat occupant's view of the Beech 1900C would have been partially obstructed by the left seat occupant's side posts until just before the start of the King Air's takeoff roll. At 17:00:39, the Beech 1900C would have emerged into clear view in the left front windshield. It was noted that when the right seat occupant's view would have been obstructed, the left seat occupant's view would have been clear, and vice versa. At the start of engine throttle back by the King Air pilot, the Beech 1900C would have been about 50° to the left of the King Air. This position would have been fully obstructed from the King Air left seat occupant's position, but in clear view from the right seat occupant's position.
