September 26, 2024

Aviation Investigation Report AIR-24-06

Mitigate Safety Concerns Involving Boeing 737 Airplanes with Collins Aerospace SVO-730 Rudder Rollout Guidance Actuators

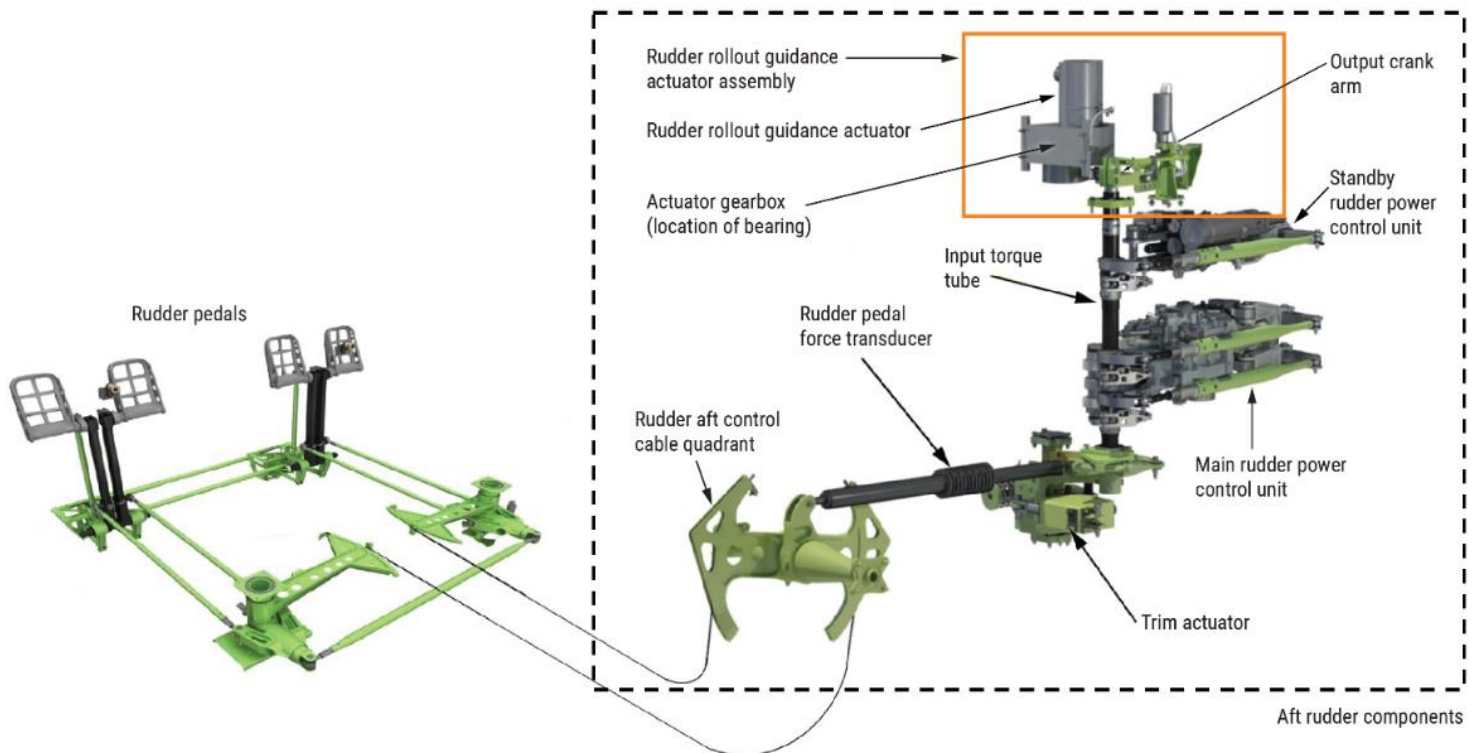
United Airlines received the incident airplane from Boeing on February 20, 2023. The airplane was equipped with a Collins Aerospace SVO-730 rudder rollout guidance actuator, which was electrically disabled based on the operator's delivery requirements for the autoflight system.⁵ Although the actuator was disabled, it remained mechanically connected to the upper portion of the airplane's aft rudder input torque tube by the actuator's output crank arm and a pushrod, as shown in figure 1.⁶

Figure 1. Rudder control system with rudder rollout guidance actuator (Source: Boeing. Image copyright Boeing. Reproduced with permission).
