Highway Accident Report

**Collision Between Truck-Tractor
Semitrailer and School Bus
Near Mountainburg, Arkansas
on May 31, 2001**

**NTSB/HAR-02/03
PB2002-916203
Notation 7490
Adopted September 4, 2002**

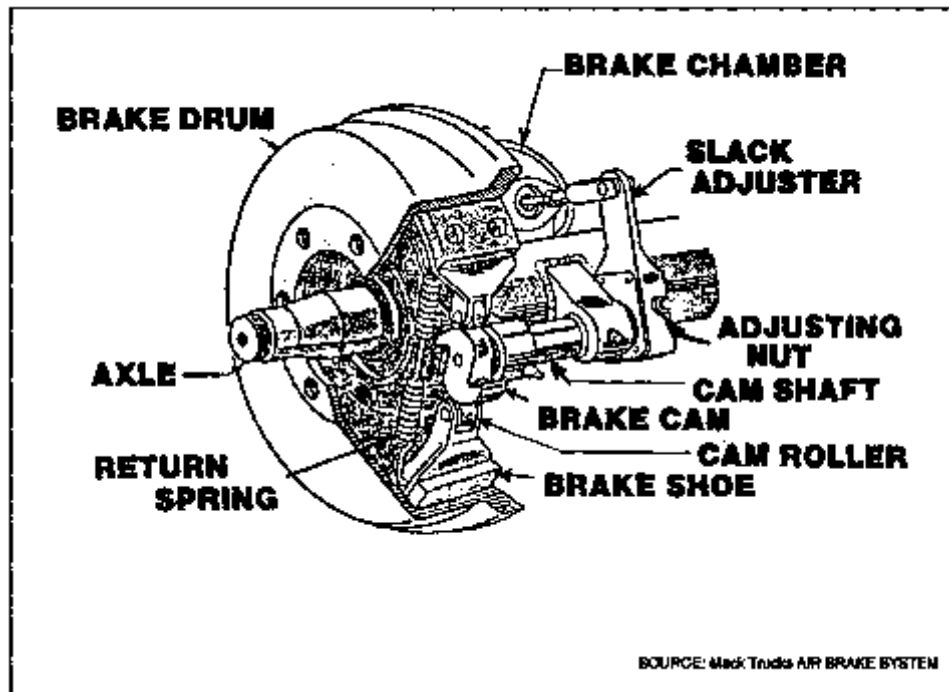
Figure 6. Brake diagram.

Brakes. A Safety Board postaccident examination revealed that all three tractor axles had air brakes (see figure 6) with standard S-cam/drum foundation (service) brakes (see figure 7) fitted with manual slack adjusters.⁸ The semitrailer (hopper) had air brakes with standard S-cam/drum foundation brakes; its two axles had automatic slack adjusters. The third axle of the tractor and both trailer axles had emergency-parking spring brakes.

During postaccident inspection, investigators measured the brake stroke for each of the brakes with 90 psi of air supplied.¹⁰ Of the 10 brakes on the tractor semitrailer, 8 were found to be out of adjustment or nonfunctional.

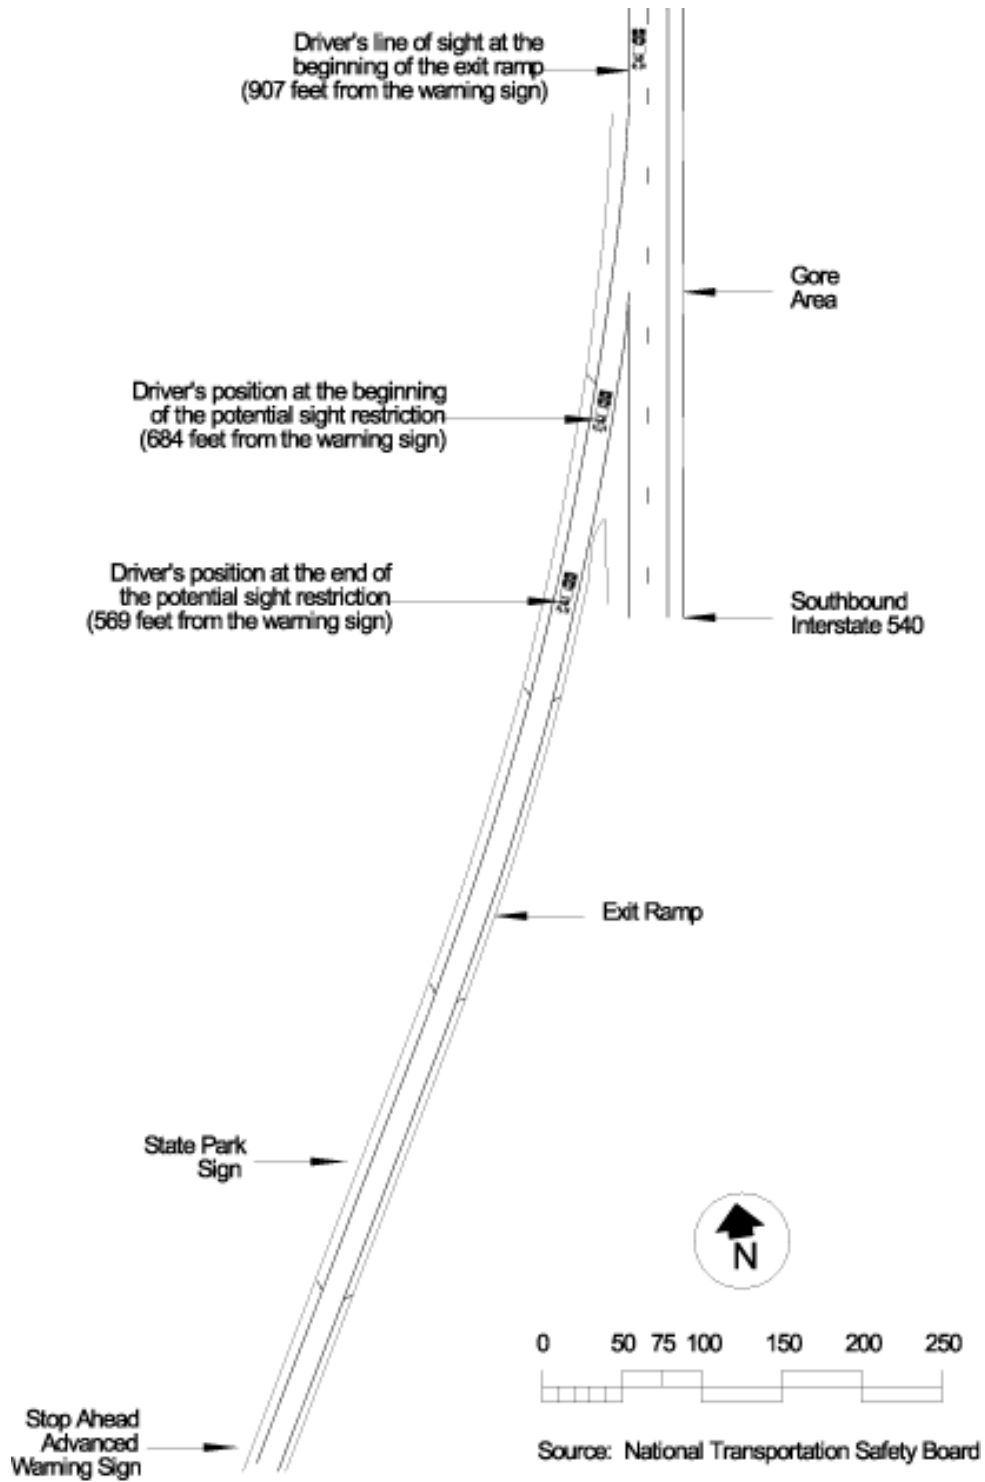
Figure 13. Ramp sight distance.

Safety Board investigators conducted sight distance tests after the accident. At a driver eye height of 74 inches³⁵ above the pavement, a motorist could see the stop sign from the transition area³⁶ to the end of the ramp, a distance greater than that prescribed by the American Association of State Highway and Transportation Officials (AASHTO). The “State park” sign then in place north of the “stop ahead” sign could impede a motorist’s view of the “stop ahead” sign from a distance of 684 feet until the driver was about 569 feet from the “stop ahead” sign (see figure 13). Since the accident, Arkansas has moved the “State park” sign to the other side of the ramp, where it does not impede a driver’s view of the “stop ahead” sign, and has added “stop ahead” signs. When the ramp was constructed, it was cut into existing terrain, and a grass berm runs parallel to and east of the ramp. A stop sign for traffic exiting I-540 onto SH-282 is in place at the intersection. Safety Board visibility test results showed that, when stopped at the intersection, a driver has a clear line of sight to the east exceeding 582 feet. A driver on westbound SH-282 is not able to see traffic on the exit ramp until the driver is 51 feet east of the intersection.
