Sinking of US Cargo Vessel SS *El Faro*
Atlantic Ocean, Northeast of Acklins and Crooked Island,
Bahamas
October 1, 2015

NTSB/MAR-17/01
PB2018-100342
Notation 57238
Adopted December 12, 2017

Marine Accident Report

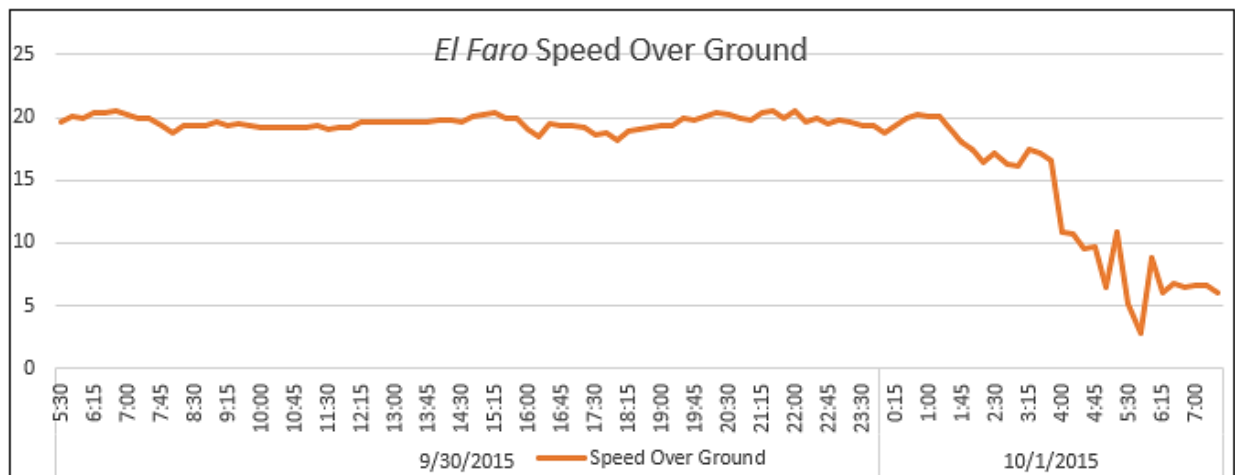
Figure 7. Vessel’s speed over ground from 0530 on September 30 until sinking. (Based on VDR parametric data)

Figure 7 plots the ship’s speed over ground, which is the ship’s motion relative to the earth’s surface, as measured by GPS. The VDR recorded this information from the morning of September 30 to the time of the sinking. On October 1, as shown in the figure, the ship’s speed over ground slowly decreased after 0100, then dropped precipitously about 0400.

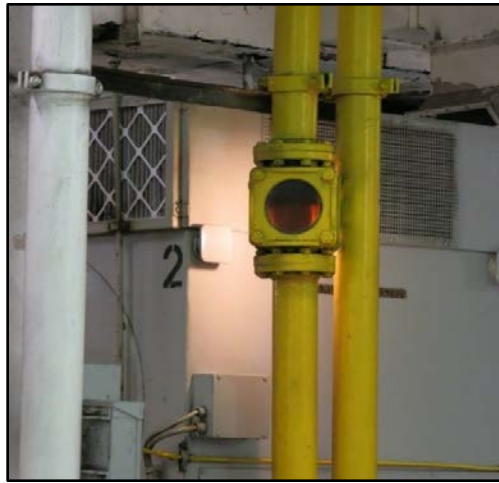
Figure 12. Bull's-eye for monitoring lube oil flow from gravity tank. (Photo from *El Yunque*)

From the engine room, overflowing oil, indicating proper operation of the lube oil service pumps, could be monitored through an illuminated port (“bull’s-eye”) in the supply line that returned oil to the sump (figure 12). An engineer who had served aboard TOTE’s *Ponce*-class vessels (last in 2012) told the third marine board that in rough weather, flow in the bull’s-eye might be interrupted by sloshing oil in the gravity tank. In the event of a pressure loss, about 8 minutes

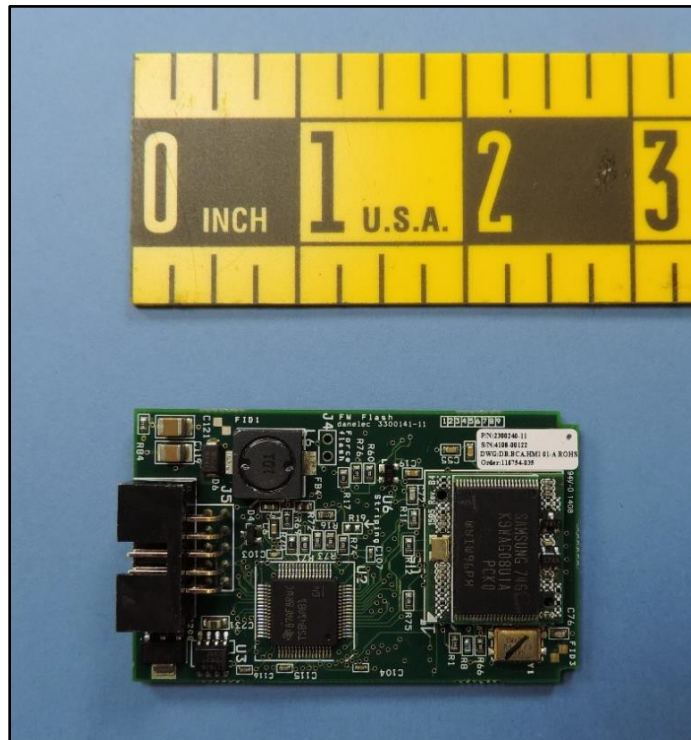
The VDR data were stored on a flash memory chip inside a protective capsule. On August 8, 2016, after the capsule was recovered from *El Faro's* wreckage, it was submerged in a bath of distilled water aboard the Navy vessel *Apache*, then disassembled and inspected for possible damage to the internal recording medium. Inside the capsule, layers of protective materials housed an inner capsule containing the circuit board assembly that stored the nonvolatile memory (figure 16).⁸² The circuit board assembly was inspected for visible signs of damage or corrosion (figure 17) before being transported to the NTSB laboratory in Washington, DC, on August 12.

Figure 17. Circuit board assembly from inner VDR capsule.

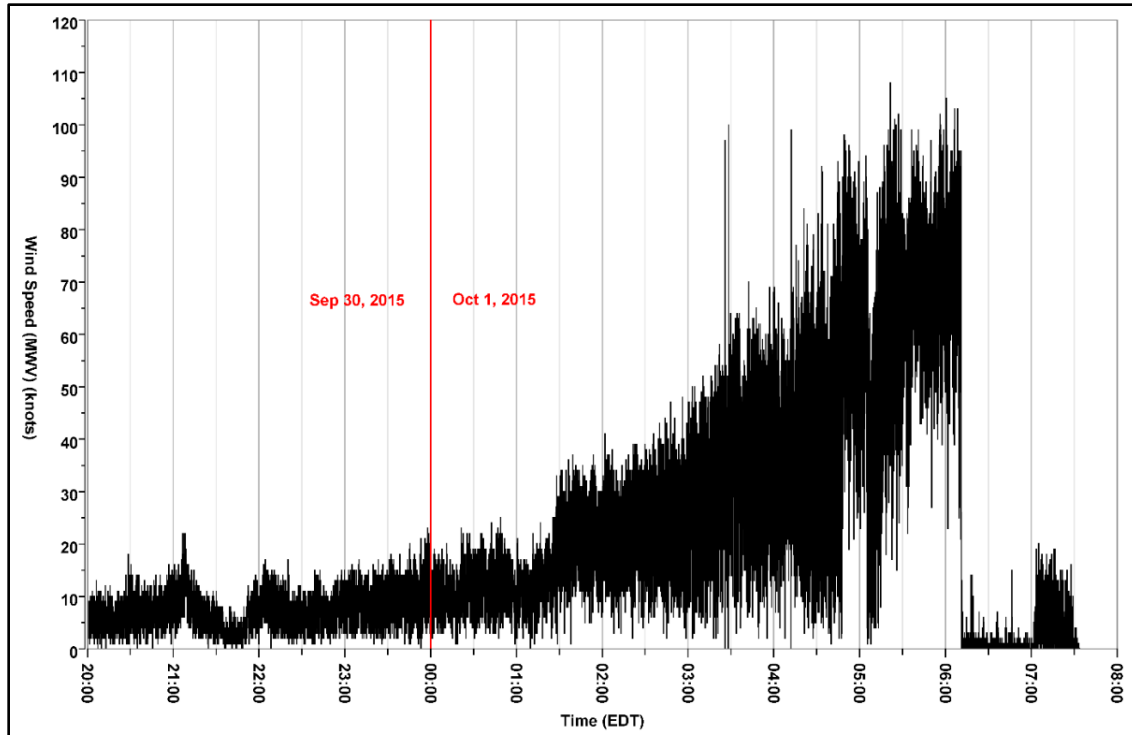
The vessel's anemometer displayed wind data on the bridge. Wind speed and direction were recorded by the VDR.⁹¹ Figure 18 shows raw wind speed data captured by the VDR from 2000 on September 30 until the sinking. Throughout the VDR recording, however, over 99 percent of the anemometer data samples indicated a relative wind direction of between 180° and 193°. On the VDR recording, *El Faro*'s captain, chief mate, and second mate questioned the reliability of the wind speed and stated that the wind direction was "not good" and that "we don't have (any) anemometer."

Figure 18. Raw VDR wind speed data, from 2000 September 30 to data loss.

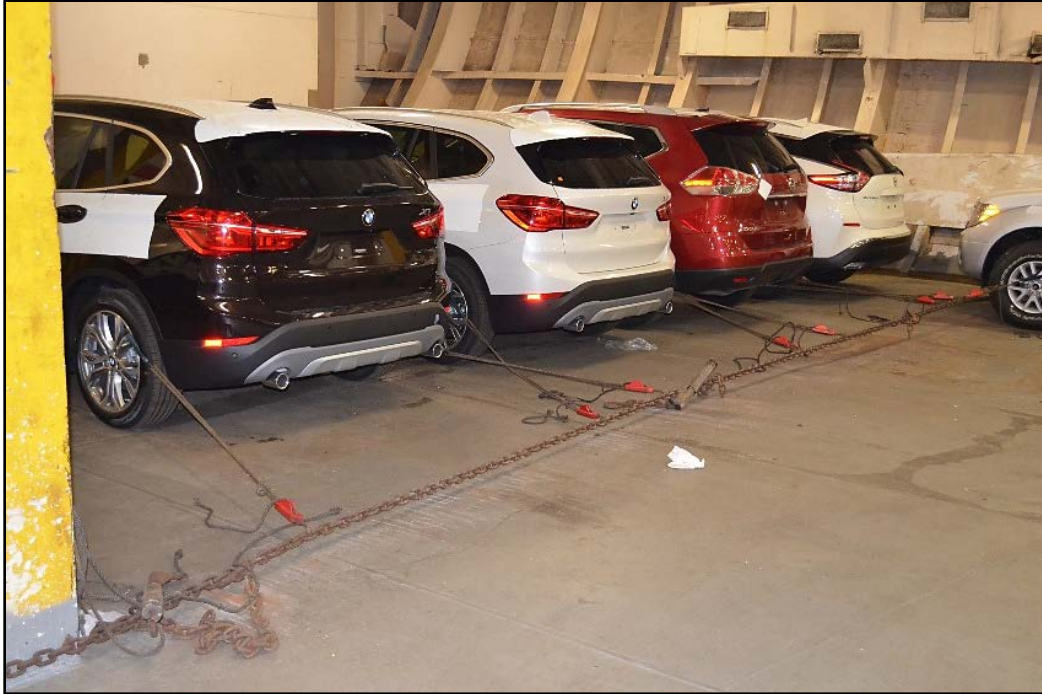
Automobiles, considered semistandardized cargo, were to be lashed using portable securing devices consisting of fiber rope or nylon strapping attached to steel tensioners that were fitted with hooks at both ends. Four lashings were to be run, one from each corner of a vehicle, to the fixed D-rings or cloverleaves on the deck (figure 21). A variation of that securing arrangement, not included in the cargo-securing manual, was to run lashings from the four corners of the automobile to a long chain. The long chain ran across the width of the ship and was secured to D-rings at either end. Some of the chains passed through a D-ring before being secured to additional D-rings at each end. A lashing variation observed on *El Yunque* in October 2015 is shown in figure 22. One of the longshoremen who had lashed the automobiles on *El Faro* before the accident voyage testified when shown a photo of the lashings on *El Yunque* that they had used that arrangement on *El Faro*.

Figure 22. Two automobiles lashed to one length of chain. (Photo from hold 5 of *El Yunque*)

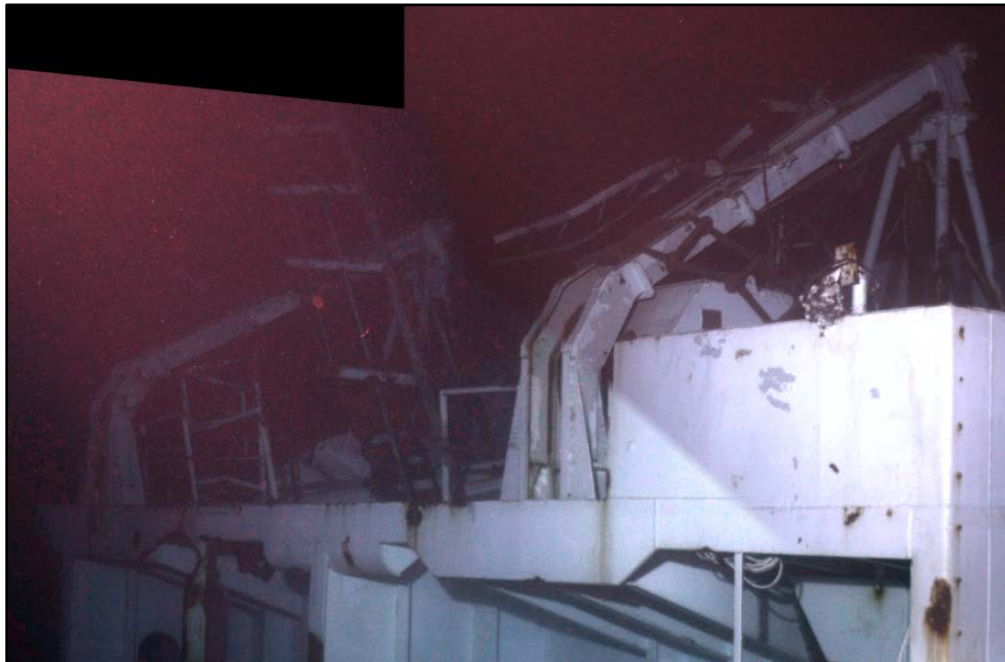
The gravity davits (cranelike devices for lowering boats into the water) for the starboard lifeboat were discovered intact during the second mission (figure 25). The arm for the forward davit was displaced and resting on the deck, but the arm's cable was still attached to the track. The gravity davits for the port lifeboat showed greater damage, with the aft track and davit broken and hanging (figure 26).

Figure 25. Intact gravity davits for starboard lifeboat, with forward davit in foreground. (Photomosaic image from mission 2)

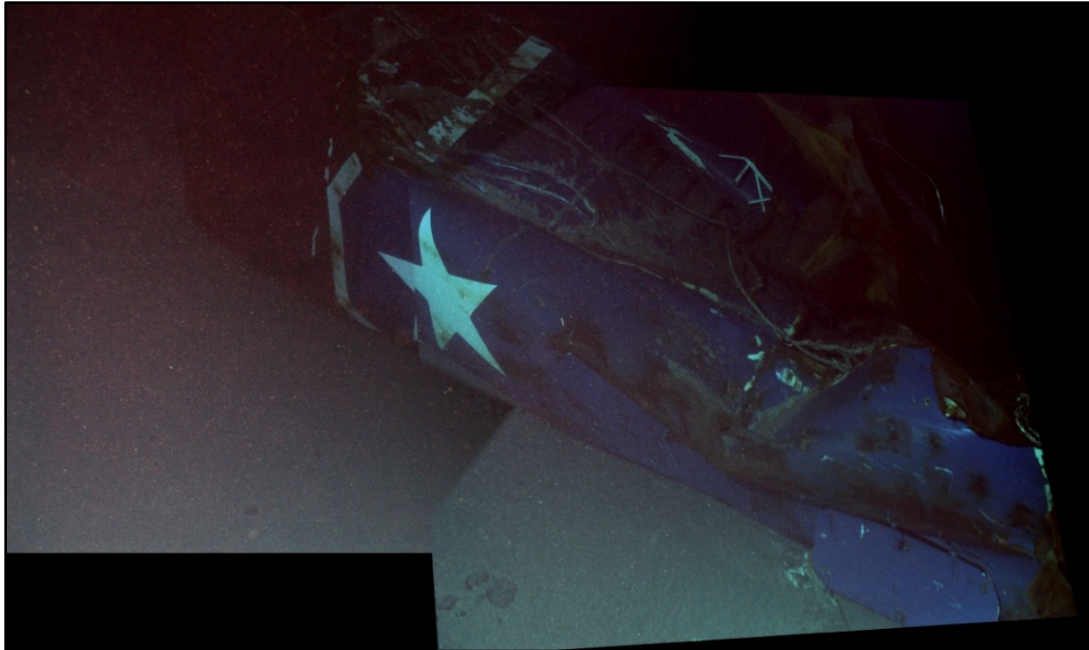
El Faro's exhaust stack was discovered during the second mission about 2,625 feet (0.43 nm) north of the main hull (figure 28). It was largely intact, though the forward face was missing its steel plating and the stack was scratched, dented, and deflected inward. The boiler uptake funnel was missing from the top of the stack.

Figure 28. Exhaust stack lying on seafloor, Sea Star (company) symbol clearly visible. (Photomosaic image from mission 2)

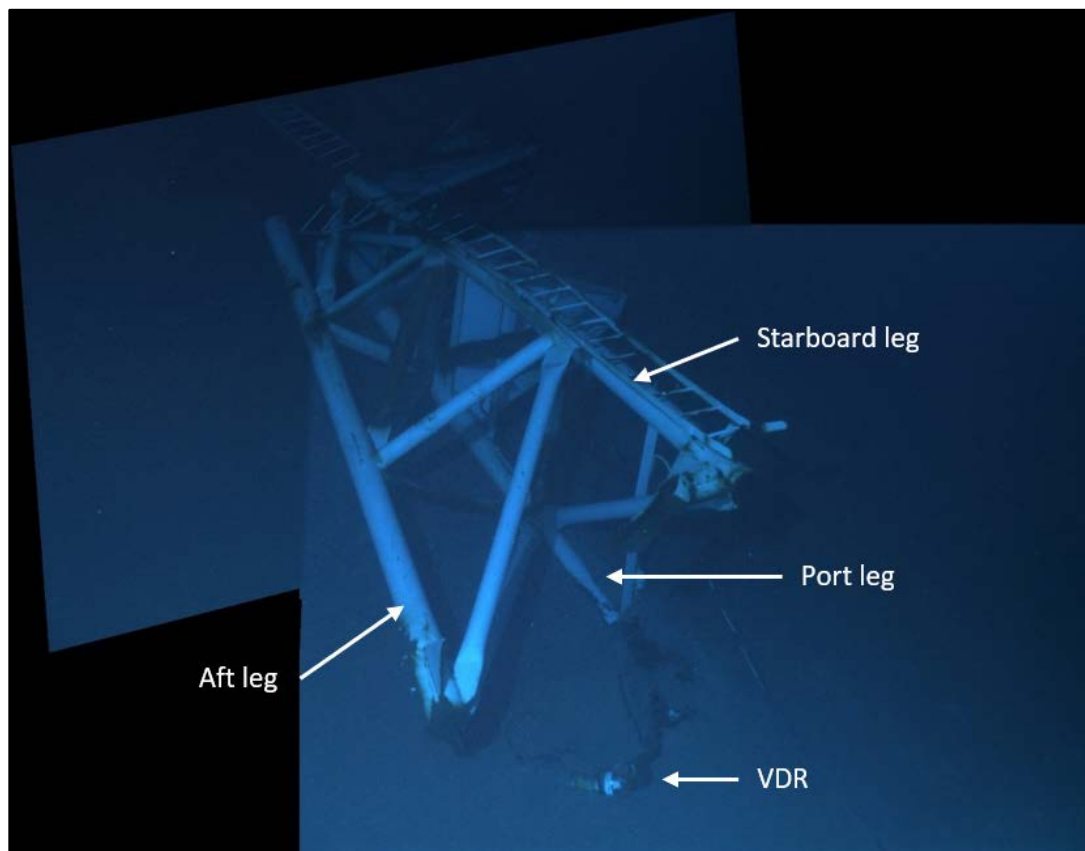
The tripod mast and VDR capsule were discovered on the seafloor about 1,640 feet (0.28 nm) north of the main hull (figure 29). The large structural members were intact, but the overall structure was bent aft. The VDR was attached to the port leg and buried in mud.

Figure 29. Mast and VDR capsule on seafloor. (Photomosaic image from mission 2)

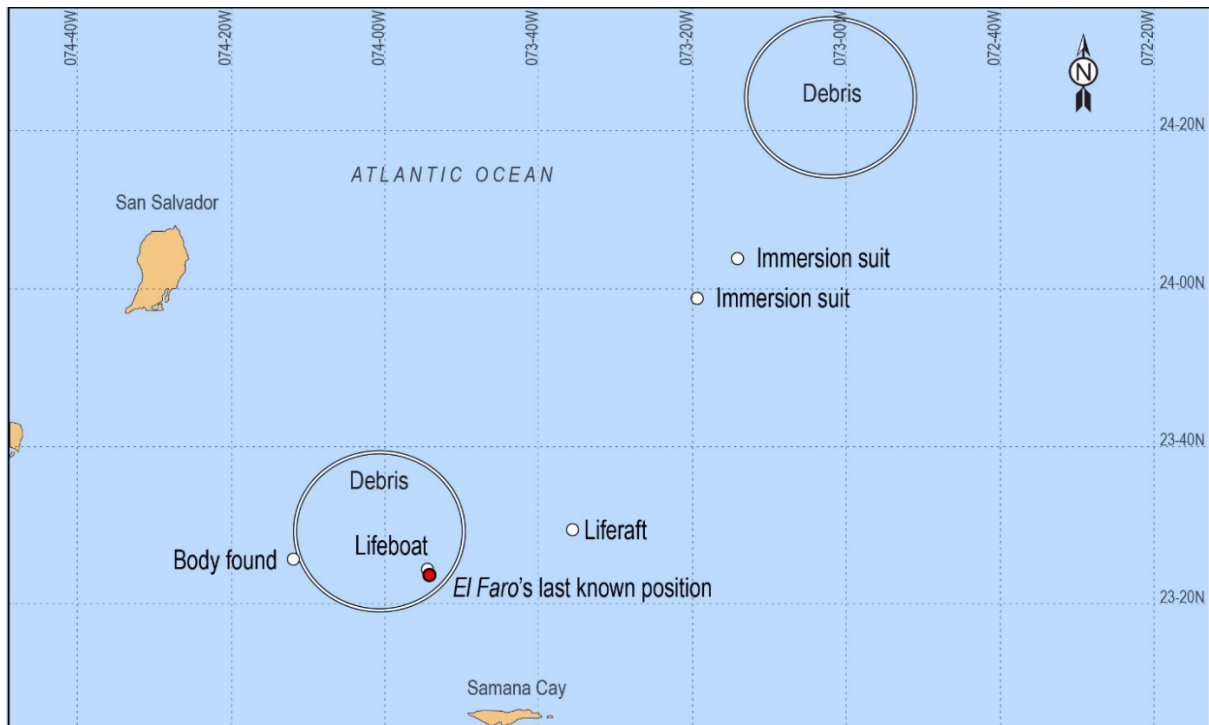
Also on October 3, a Coast Guard HC-130 aircraft located a debris field 120 nm northeast of Crooked Island. A Coast Guard MH-60 helicopter relocated the debris field and found three liferings, one of which was stenciled "El Faro." The helicopter located a second debris field 90 nm northeast of Crooked Island, consisting of small unidentified objects believed to be packing material. Three cutters, the *Northland*, the *Resolute*, and the *Charles Sexton*, were en route to the search area as weather and seas permitted.

The Navy P-8 reported two liferafts in separate locations. At 1806, the cutter *Northland* found one of the liferafts at 23.4866N, 073.5883W, about 18 nm northeast of *El Faro*'s last known position. The ship's rescue swimmer searched the partially inflated liferaft for any sign of survivors.¹⁴⁶ Finding no one on board, the *Northland* sank the liferaft, to prevent its rediscovery and an ensuing duplicate search for survivors or remains, and proceeded to the position of the second liferaft. The Coast Guard later determined that the second reported liferaft was actually the starboard lifeboat.

Figure 47. Two debris fields located during search-and-rescue operations and *El Faro's* last known position from VDR data. Distance between debris fields was about 77 nm. Degrees of latitude are 60 nm apart. Distance between degrees of longitude varies with distance from equator, where it is about 60 nm. (Adapted from Coast Guard graphic)

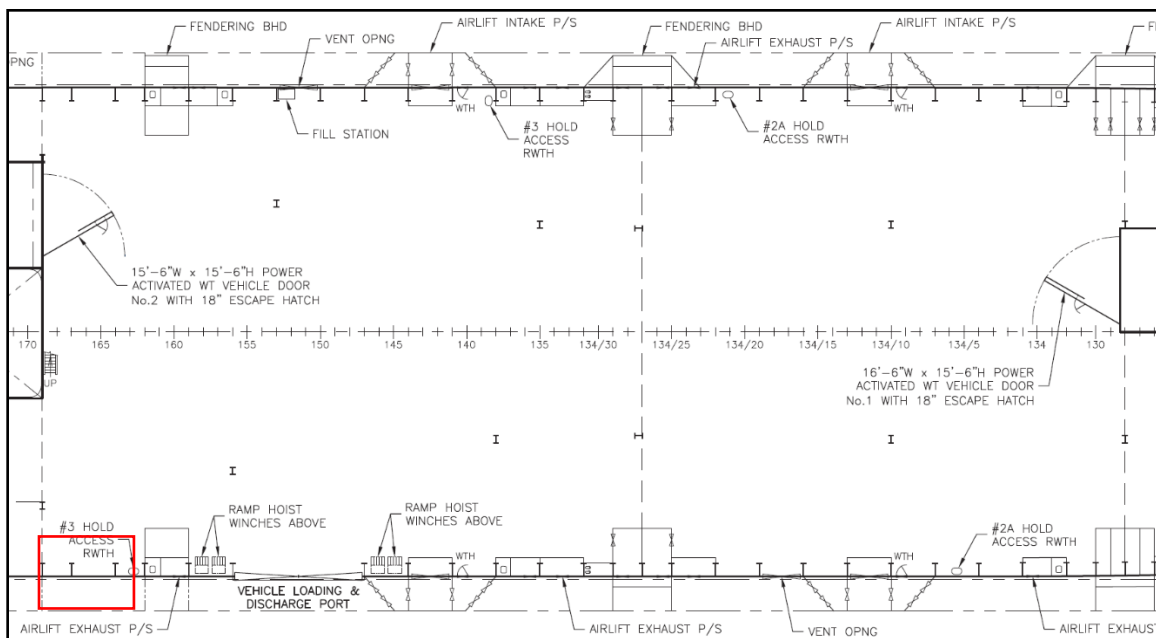
The VDR recording indicates that the vertical-access scuttle on the starboard side of the second deck that led to hold 3 was open during the accident. General arrangement drawings (such as figure 56) show that the second deck had two scuttles (called RWTHs [raised watertight hatches]) on the drawings), through the second deck to hold 3, at frame 163 on the starboard side and at frame 138.5 on the port side. Hold 2A also had two such accesses. Figures 57 and 58 show the scuttle on the starboard side of the second deck to hold 3 and the scuttle on the port side to hold 2A.

Figure 56. Second deck plan showing scuttles. (Starboard scuttle to hold 3 outlined in red)

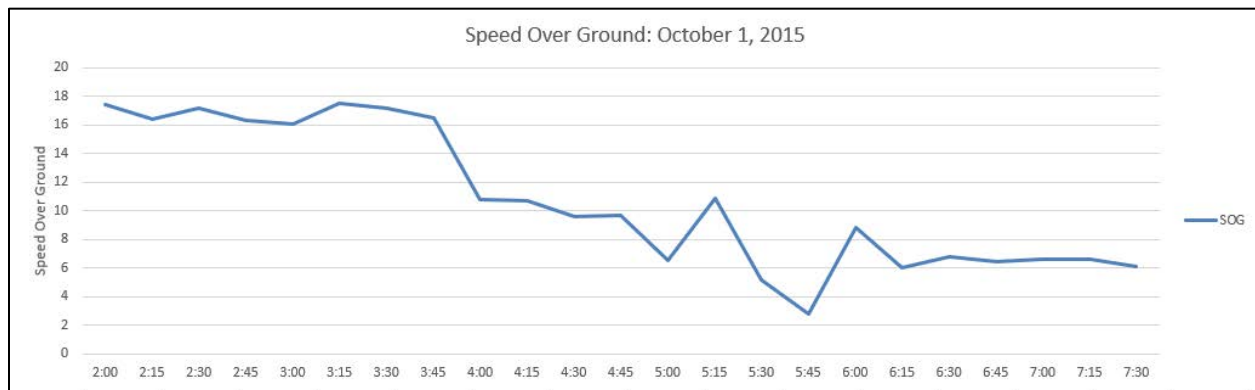
El Faro sank an hour and a half after it lost propulsion. From the time it left port the evening of September 29, the ship traveled at near-maximum speed, between 19 and 20 knots, for almost 30 hours. But it began to slow and develop a wind-driven starboard list when it came out of the protective lee of San Salvador Island about 0130 on October 1 and encountered the steadily increasing force of the wind. The ship's speed dropped quickly to 18 knots and fell more or less

steadily from then on, as shown in figure 62. (Engine speed, or propeller rpm, was not recorded by the vessel's VDR, but parametric data captured the ship's speed over ground.)

Figure 62. Ship's speed over ground from 0200 to 0730 on October 1.

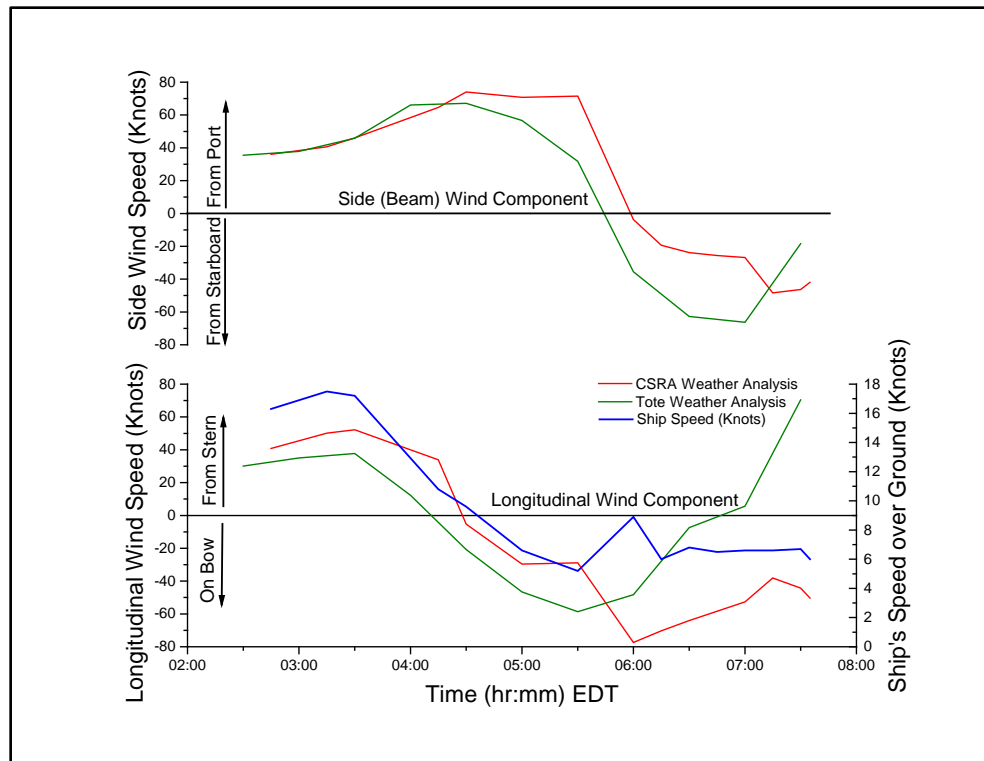
The graph in figure 63 demonstrates the relationship between ship's speed over ground and wind speed and direction, based on poststorm weather analyses. It shows that the increasing winds on the port side between 0400 and 0600 account for the vessel's starboard heel, while the shift of wind to the bow helps explain part of the vessel's slowing after 0400. The NTSB concludes that the initial list was caused by an increasing wind on the vessel's beam generated by Hurricane Joaquin.

Figure 63. Ship's speed over ground relative to wind direction. Wind directions obtained from NTSB-chartered dynamic analysis (by CSRA Inc.) and TOTE weather analysis submission.
