# **NATIONAL TRANSPORTATION SAFETY BOARD**

## **PIPELINE ACCIDENT REPORT**

**NATIONAL FUEL GAS COMPANY  
NATURAL GAS EXPLOSION AND FIRE  
SHARPSVILLE, PENNSYLVANIA  
FEBRUARY 22, 1985**

NTSB/PAR-85/02

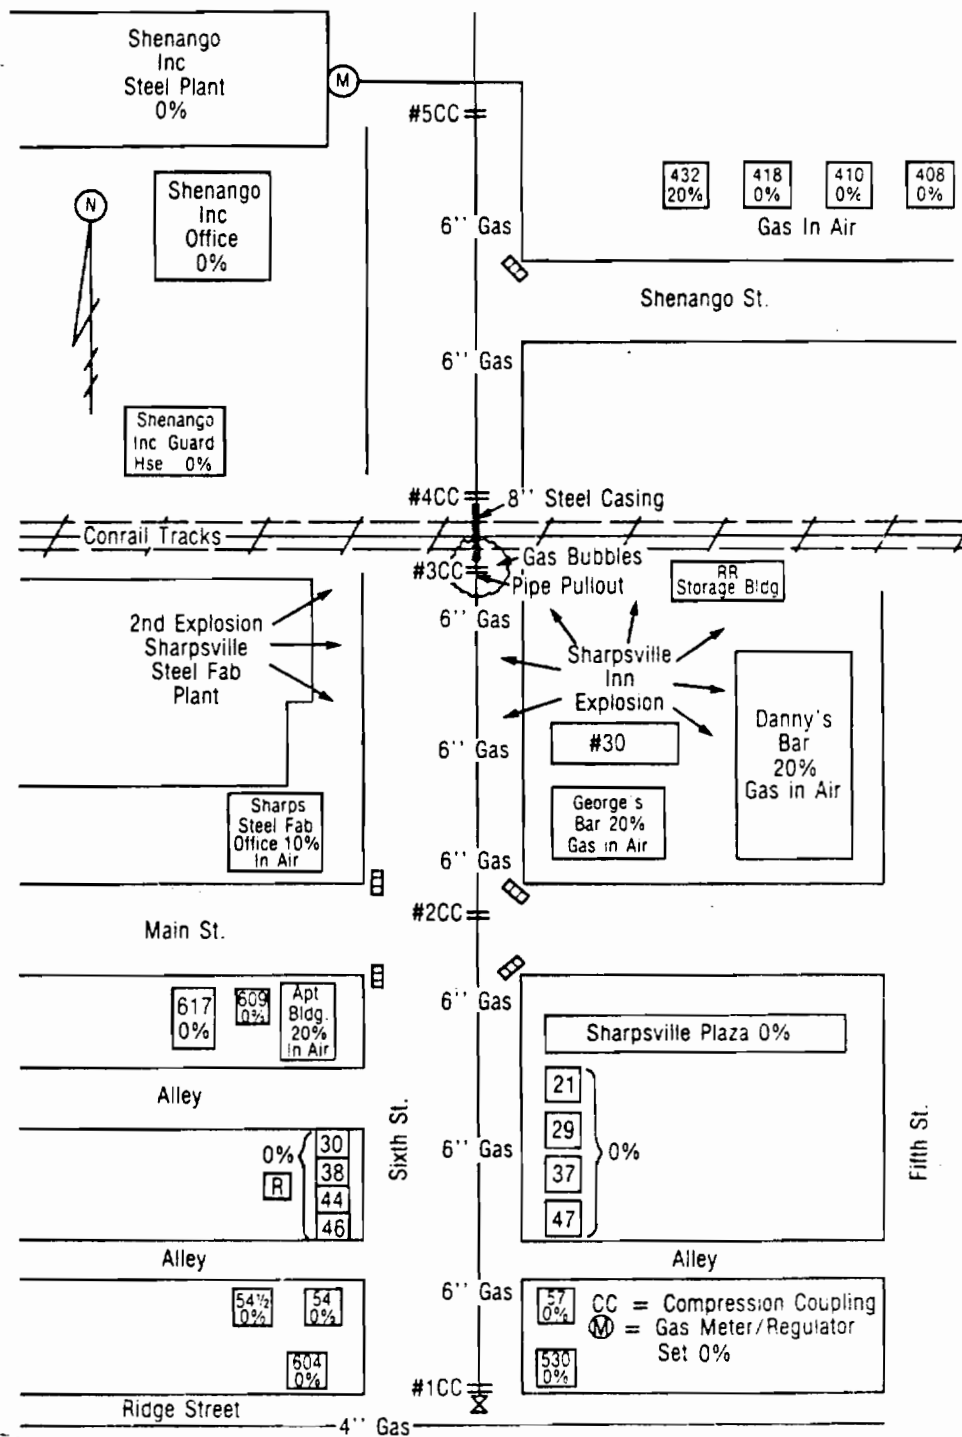
Figure 1.—Plan view of accident site.

At 3:15 a.m., the Sharpsville Inn exploded and then burned. The police cruiser, which was parked at the northwest corner of the inn, was blown 35 feet across the first set of railroad tracks where it landed upright but damaged. The patrolman in the cruiser was slightly injured and badly shaken. He radioed the police dispatcher about the explosion and requested firefighters. He then drove the cruiser to the intersection of North Sixth and Main Streets where he established a traffic control unit to restrict sightseers and to keep the area open for the firetrucks. (See figure 1.)

The first firefighter arrived at 3:19 a.m. As he unreeled a hose from the firetruck, an explosion occurred in a steel company building across the street from the Sharpsville Inn. (See figure 1.) The blast knocked down the firefighter and blew out some windows and steel panels in the steel company building, but no fire resulted. (See figure 2.) One other firefighter was injured later in fighting the fire. The firechief arrived and immediately called in a pumper and a rescue unit from Sharpsville as well as one pumper each from the Hermitage and South Pymatuning Fire Departments. The combined units fought fires in the Sharpsville Inn, the two-story apartment at 30 North Sixth Street (adjacent to the inn), and in the Sharpsville Distributors building at 506 West Main Street. The fires were declared under control by 5:30 a.m. on February 23, 1985. After the fires were extinguished, two bodies were found in the rubble of the Sharpsville Inn.

After the relighting process was begun, a gas company crew began to excavate in North Sixth Street south of the railroad tracks where the blowing gas had been observed. The plastic gas main was uncovered. A coupling used to join the lengths of plastic pipe was located 37 inches south of the open end of an 8-inch-diameter steel casing pipe in which the 6-inch-diameter plastic gas main was installed under the railroad tracks. The plastic pipe had pulled 3/4 inch out of the north end of the coupling. (See figures 1 and 3.)
