PB93-916502
NTSB/PAR-93/01

NATIONAL TRANSPORTATION SAFETY BOARD

PIPELINE ACCIDENT REPORT

HIGHLY VOLATILE LIQUIDS RELEASE
FROM UNDERGROUND STORAGE CAVERN
AND EXPLOSION
MAPCO NATURAL GAS LIQUIDS, INC.
BRENHAM, TEXAS
APRIL 7, 1992

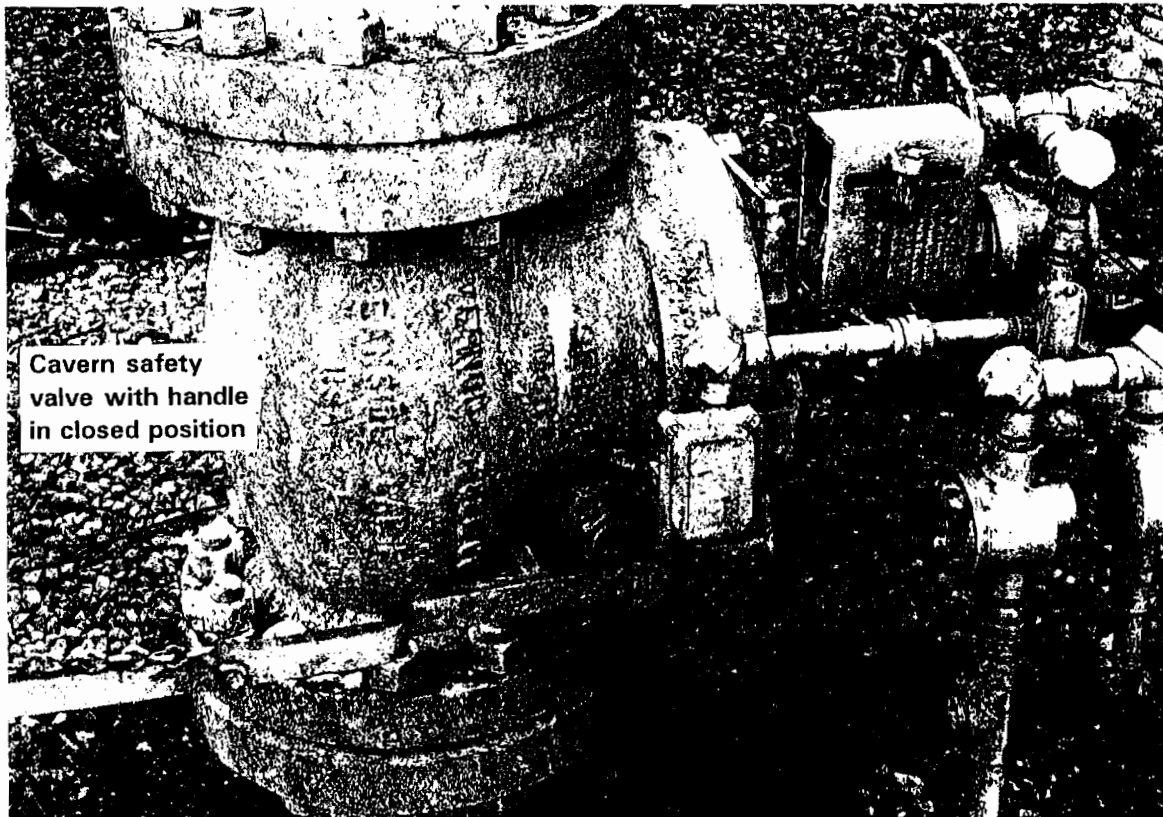
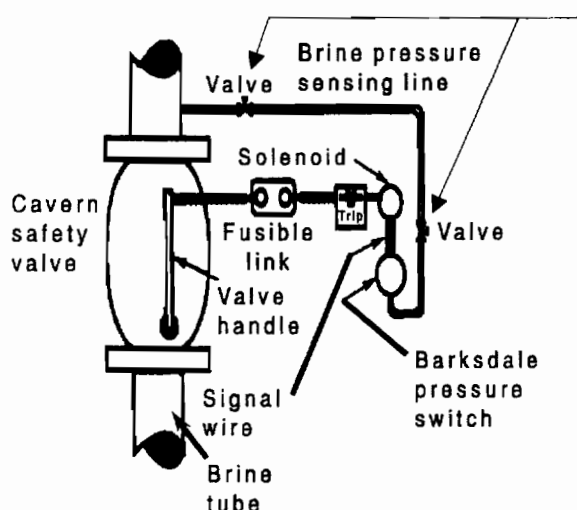
Figure 10. Components of the cavern safety valve system.

In the closed position, the cavern safety valve prevents HVLs from flowing from the cavern to the brine ponds. The manufacturer's literature advised that valve operation could be controlled by a fusible link, a manual cable, or a pneumatic or solenoid actuator.

For the system to function correctly, both manual valves in the brine pressure sensing line must be open.

A chain containing a fusible link (165° F) holds the spring-loaded cavern safety valve in the open position. The chain is connected to a lever on an electrically operated valve.

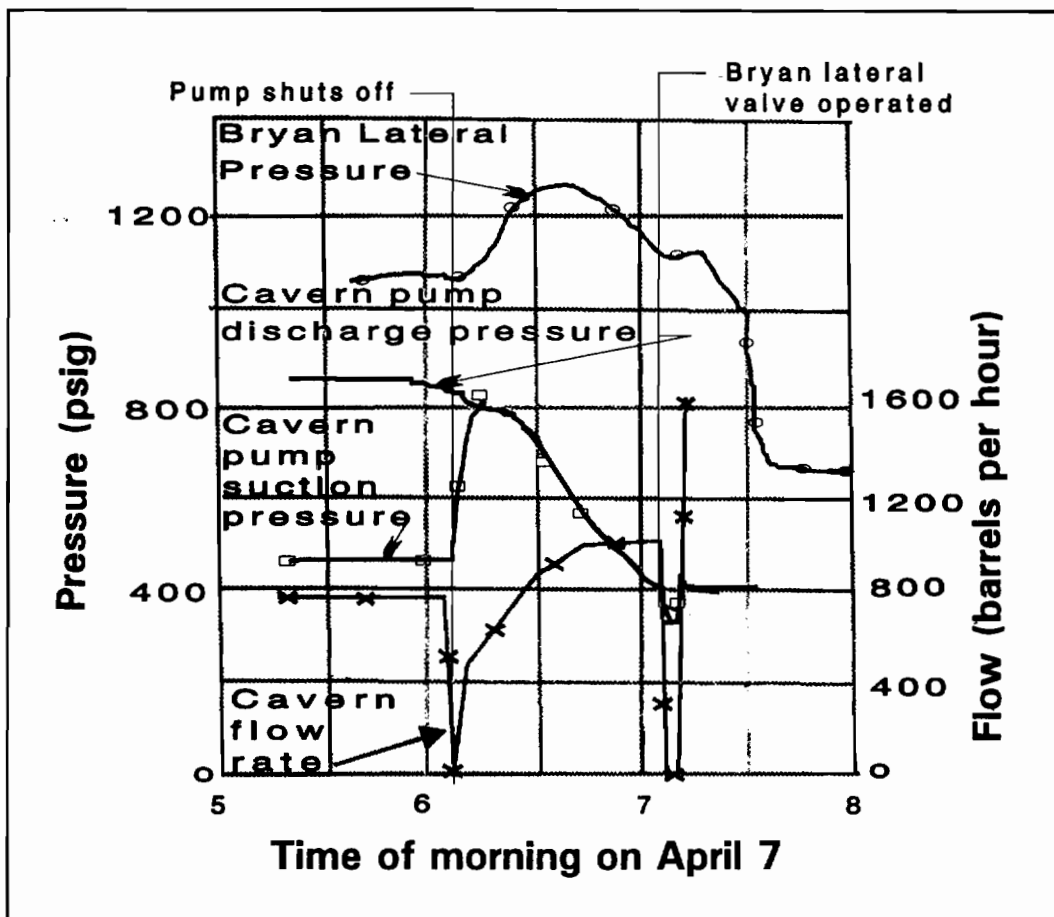
Figure 16. Graph of pressure and flow rates the morning of the accident.

Pressure graphs show that the computer outage that occurred about 3:45 a.m. at the dispatch center had no impact on operations and that readings from Brenham station were normal until shortly before 6 a.m. At that time, the cavern pump discharge pressure began decreasing, while the pump suction pressure remained constant (see figure 16). The Safety Board believes that the reduction in the pump discharge occurred when product began to enter the weep hole and brine in the brine tube began to be displaced. Because a downstream control valve was regulating the pump suction pressure, that pressure remained constant at this time. As more HVLs entered the brine tube and mixed with the brine, the specific gravity of the brine was lowered, causing less pressure to be applied to the product in the cavern.

The HVL vapors rose through the brine tube and were released to the atmosphere through the brine ponds. When a concentration of HVL vapors sufficient to activate the station's gas detectors reached one or more of them, the HAZGAS alarm at the dispatch center was activated, and the station's pump shut-down system shut down the cavern pump. This caused a temporary cessation of HVL flow into the cavern and initiated a rapid increase in the cavern pump suction pressure and in the Bryan Lateral pressure because the plants were still pumping Y-Grade HVLs into the lateral. (Refer to 6:10 a.m. entry on figure 16).

So much HVL entered the brine line that the brine was displaced, allowing the HVLs nearing the bottom of the brine tube to flow directly into the tube. The Safety Board cannot determine precisely when this occurred because cavern and brine tube pressures were not recorded. However, figure 16 shows that the pressure at the pump was high enough (more than 790 psig) to allow the flow into the cavern to continue for about 20 minutes after the cavern pump shut down. By 6:30 a.m., pump pressure was too low for flow to continue under normal conditions. Nonetheless, flow did continue because pressure in the brine tube had been reduced by the infusion of HVLs through the weep hole; thus, less pressure was needed to flow HVLs into the cavern.
