NATIONAL TRANSPORTATION SAFETY BOARD

RAILROAD ACCIDENT REPORT

DERAILMENT OF ILLINOIS CENTRAL GULF RAILROAD
FREIGHT TRAIN EXTRA 9629 EAST (GS-2-28)
AND RELEASE OF HAZARDOUS MATERIALS
AT LIVINGSTON, LOUISIANA
SEPTEMBER 28, 1982

NTSB/RAR-83/05

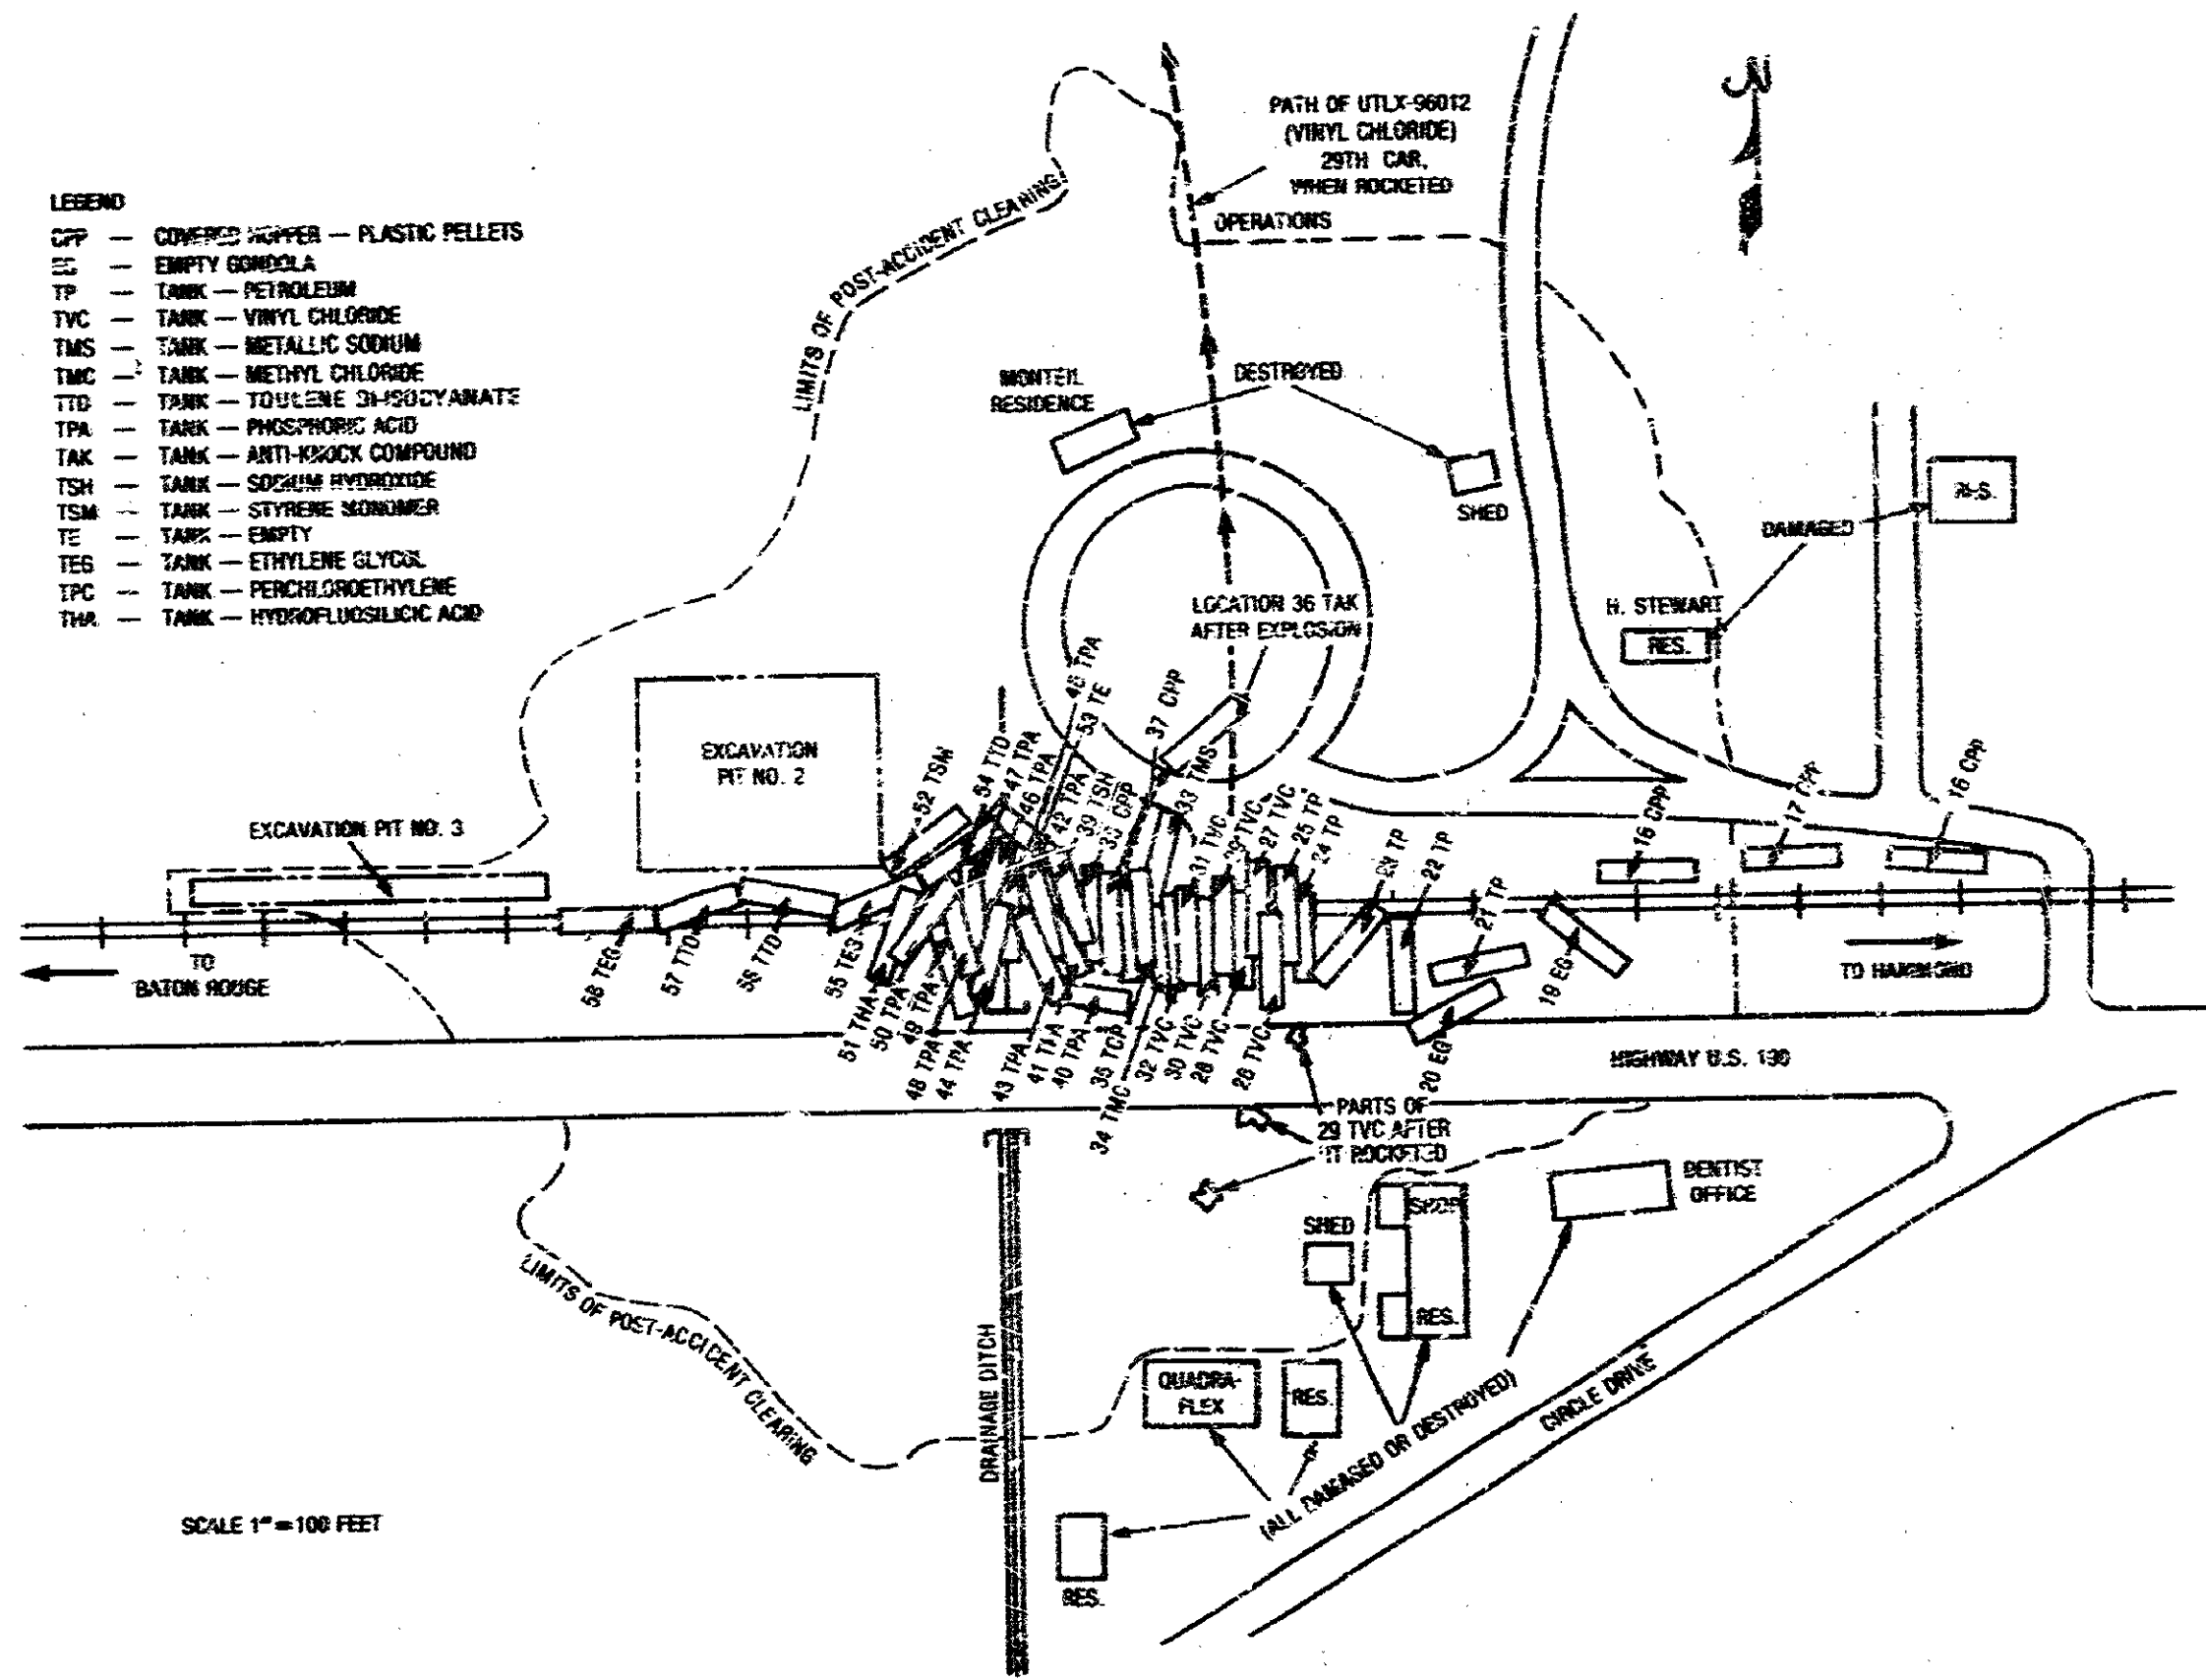
Figure 3.-- Derailment site and wreckage distribution.

The forwardmost cars to derail, the 16th through 18th head cars, were 68-foot "jumbo" covered hoppers loaded with plastic pellets. These came to rest north of and in line with the track, with the 16th car completely overturned and the others on their north sides. (See figure 3.) The trucks of the 18th car had forced the north rail out of alignment, causing the three cars to tip over and fall from the track structure. There was very little forward movement of these cars after they turned over. The cars were not substantially damaged, and most of their contents was salvaged.

The 24th through 38th head cars were separated from their trucks and came to rest perpendicular to the track alignment. These cars were tightly bunched together, more or less side by side. This group consisted of 13 loaded tank cars, including seven vinyl chloride cars, and two "jumbo" covered hoppers loaded with plastic pellets. All were damaged beyond economical repair, and the contents of all but four cars were lost.

The 39th through 56th cars were tank cars, all but one of which were loaded with chemical products. These cars stopped in various attitudes, with most of them stopped diagonally to the track alignment. All were heavily damaged, and, except for the 56th car, all the loaded cars were punctured or breached and lost all or most of their contents. The 57th and 58th cars were chemical-laden tank cars which remained coupled together and in line with the track. They sustained only minor damage and did not lose any of the product they contained.
