PB89-916305
NTSB/RAR-89.05

**NATIONAL
TRANSPORTATION
SAFETY
BOARD**

RAILROAD ACCIDENT REPORT

**COLLISION AND DERAILMENT
OF MONTANA RAIL LINK FREIGHT TRAIN
WITH LOCOMOTIVE UNITS
AND HAZARDOUS MATERIALS RELEASE
HELENA, MONTANA
FEBRUARY 2, 1989**

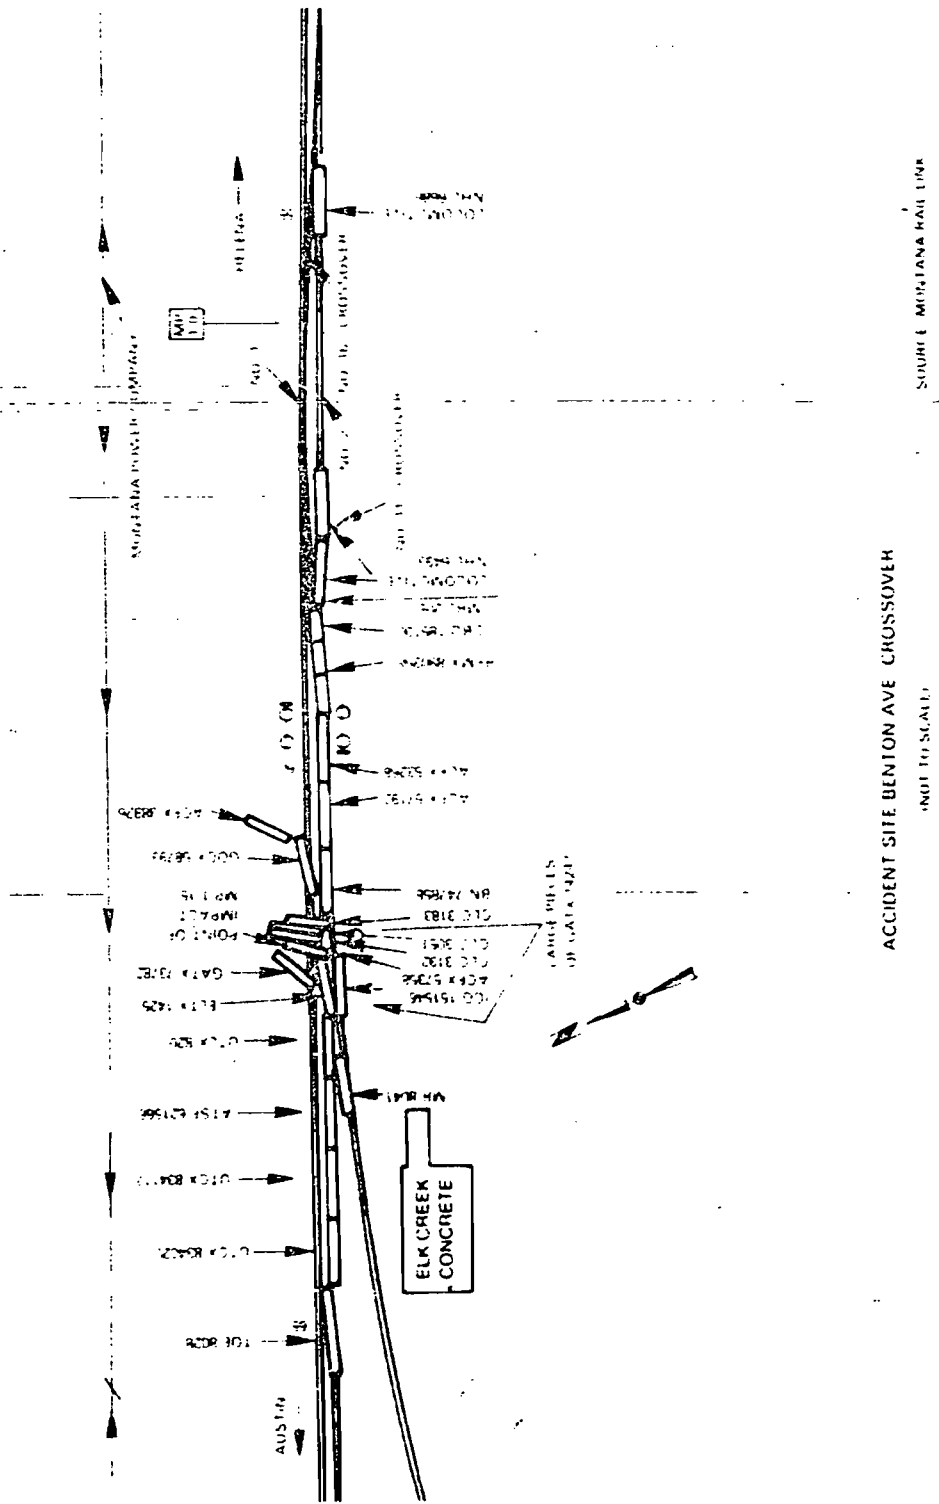
ACCIDENT SITE BENTON AVE CROSSOVER

An assistant trainmaster and yard clerk arrived at the accident site about 0440 and parked their pick-up truck at the Benton Avenue grade crossing. The yard clerk stated he saw an "orange glow" behind a fog "...boiling out of the wreckage...." He later described the glow as coming from behind a tank car positioned at an angle to the tracks. The assistant

²¹The MRL computerized train log shows a recorded time of 04:30:15 for an unauthorized train movement into the track circuit beyond the west crossover east of Benton Avenue crossover.
