# Aviation Investigation Preliminary Report

<b>Location:</b>	Portland, OR	<b>Accident Number:</b>	DCA24MA063
<b>Date &amp; Time:</b>	January 5, 2024, 17:14 Local	<b>Registration:</b>	N704AL
<b>Aircraft:</b>	Boeing 737-9	<b>Injuries:</b>	177 None
<b>Flight Conducted Under:</b>	Part 121: Air carrier - Scheduled

On January 5, 2024, about 1714 Pacific standard time, Alaska Airlines flight 1282, a Boeing 737-9, N704AL, returned to Portland International Airport (PDX), Portland, Oregon, after the left mid exit door (MED) plug departed the airplane leading to a rapid decompression. The airplane landed on runway 28L at PDX without further incident, and all occupants (2 flight crewmembers, 4 cabin crewmembers, and 171 passengers) deplaned at the gate. Seven passengers and one flight attendant received minor injuries. The flight was operated under Title 14 *Code of Federal Regulations*(CFR) Part 121 as a scheduled domestic passenger flight from PDX to Ontario, California (ONT).

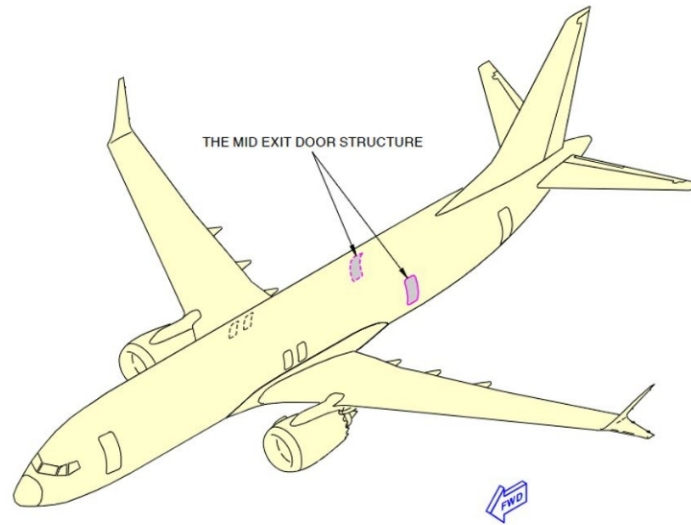
**Figure 2.** Diagram showing the mid exit door locations. (Source: Boeing. Image Copyright © Boeing. Reproduced with permission.)

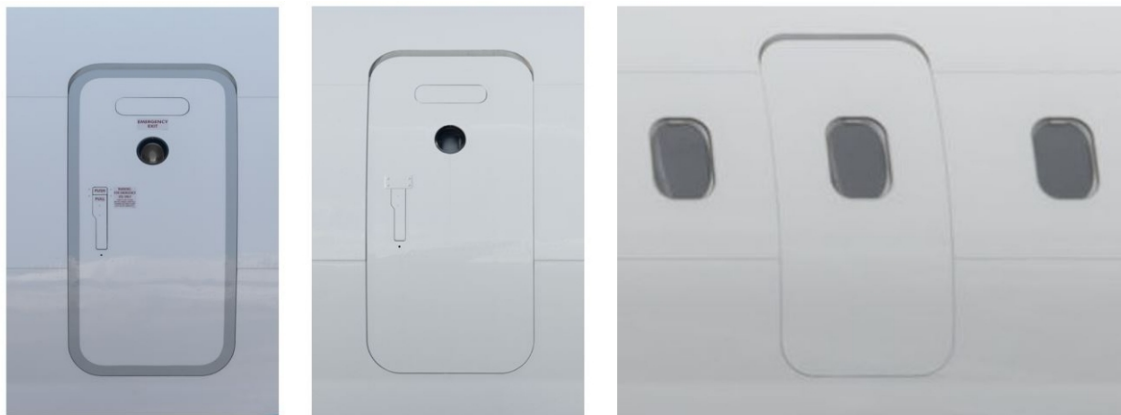
**Figure 3.** Three types of mid exit doors. (Source: Boeing. Image Copyright © Boeing. Reproduced with permission.)

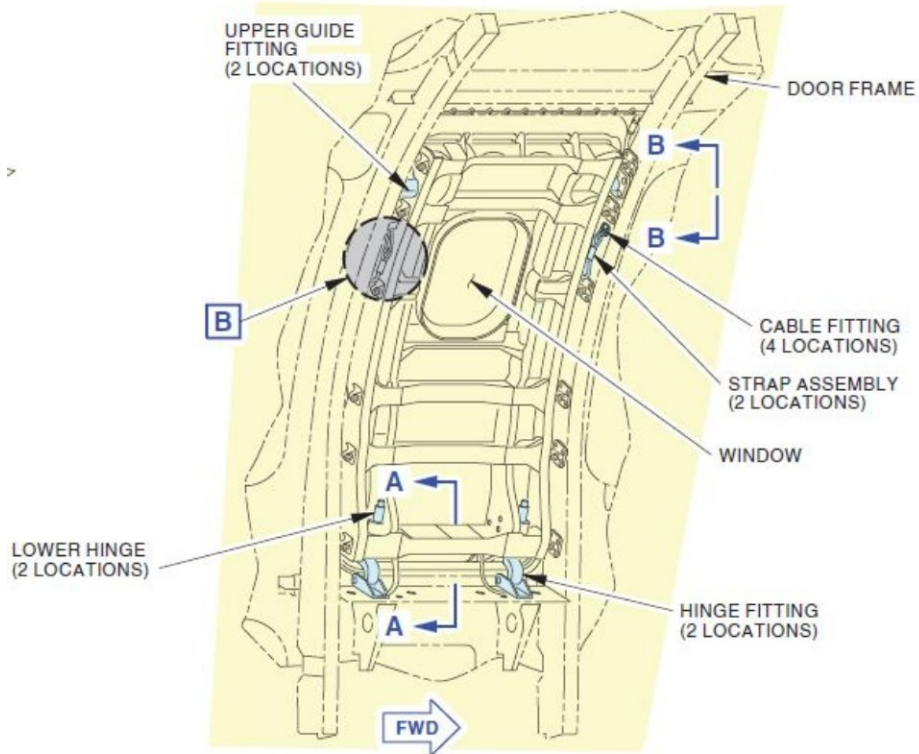
The MED plug is primarily constructed of aluminum and is installed in the fuselage by means of two upper guide fittings and two lower hinge fittings (see figures 4 and 5). The two upper guide fittings are located on the upper sides of the plug and engage with two upper guide rollers that are fixed to the upper sides of the fuselage opening (see figure 6). Two lower hinge guide fittings are fixed to the lower section of the plug and engage with the two lower hinge fittings that are attached to the bottom of the fuselage opening at the lower hinge bracket assemblies.

**Figure 4.** 737-9 Mid Exit Door Plug. (Source: Boeing. Image Copyright © Boeing. Reproduced with permission.)

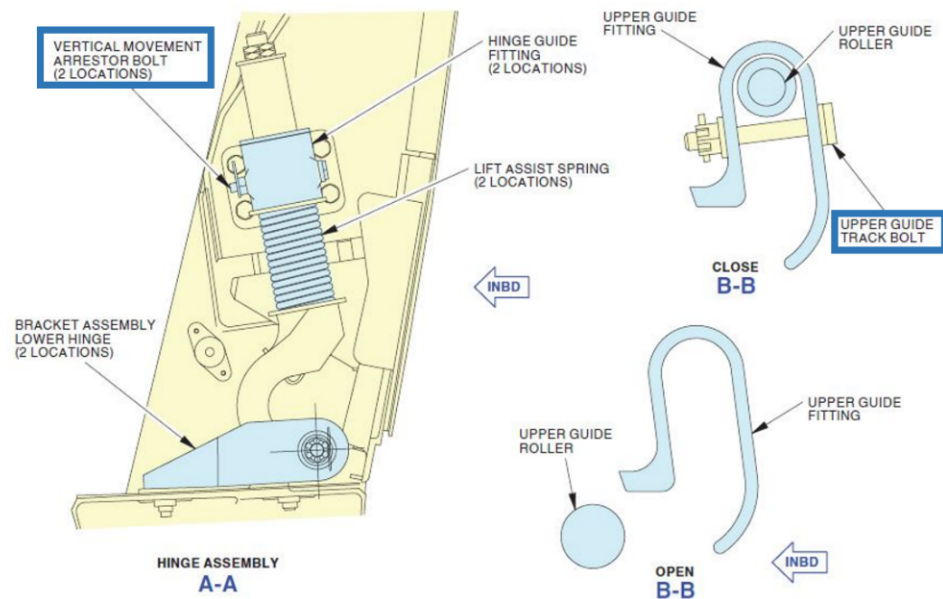
Once the plug is in place, it is secured from moving vertically by a total of four bolts. There is a bolt installed through each upper guide fitting and each lower hinge guide fitting. Once these bolts are installed, they are secured using castle nuts and cotter pins. Outboard motion of the plug is prevented by 12 stop fittings (6 along each forward and aft edge) installed on the fuselage door frame structure.

**Figure 5.** 737-9 Mid Exit Door Plug – Arrestor and Track Bolts. Boxes added for emphasis. (Source: Boeing. Image Copyright © Boeing. Reproduced with permission.)

The two vertical movement arrestor bolts, two upper guide track bolts, forward lower hinge guide fitting, and forward lift assist spring were missing and have not been recovered. See figure 5 for example of installed locations.

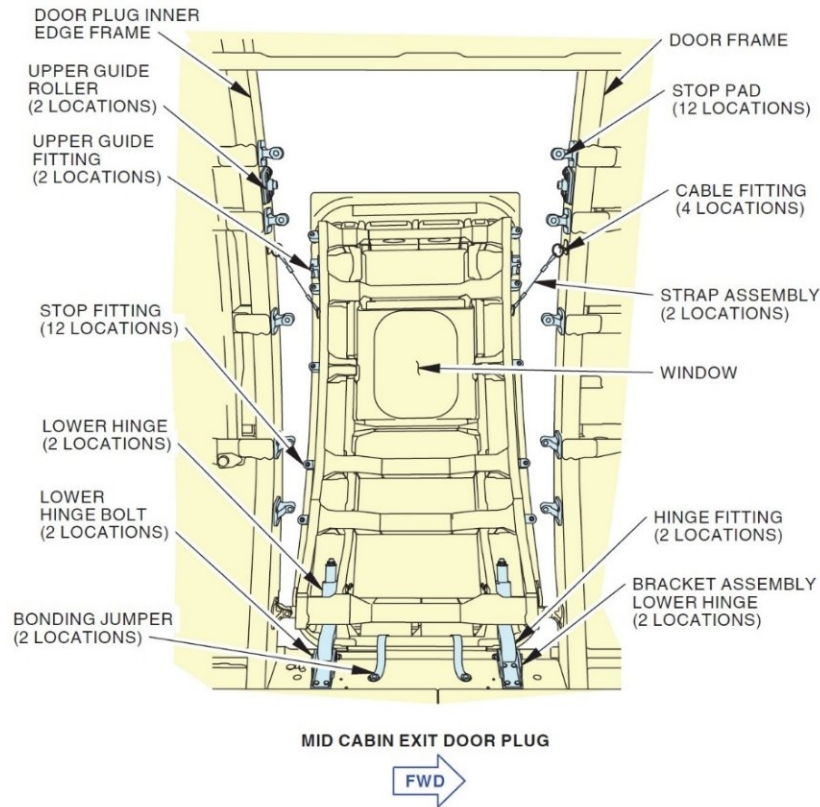
The door plug is only intended to be opened for maintenance and inspection, which requires removing the vertical movement arrestor bolts and upper guide track bolts. The strap assemblies below the second stop pad from the top restrict the plug from opening further than 15°, suitable for maintenance and inspection purposes (see figure 6).

**Figure 6.** 737-9 Mid Exit Door Plug – Components. (Source: Boeing. Image Copyright © Boeing. Reproduced with permission.)
