Results of early phase of series production of ATLAS SCT barrel hybrids and modules

Abstract

A status of early series production of the barrel hybrids and modules of the ATLAS Semiconductor Tracker (SCT) is reported. 120 hybrids (with ASIC's) and 98 modules were fabricated in Japan by the mid. August 2002 and gone through extensive quality assurance tests. Defective channels were found much less than 1% in hybrids and still less than 1% in modules. No increase of defective channels was observed, in hybrids after 100-hours burn-in at an elevated temperature, and in modules after thermal cycling and 24-hrs long-term test at the operation temperature of the experiment.

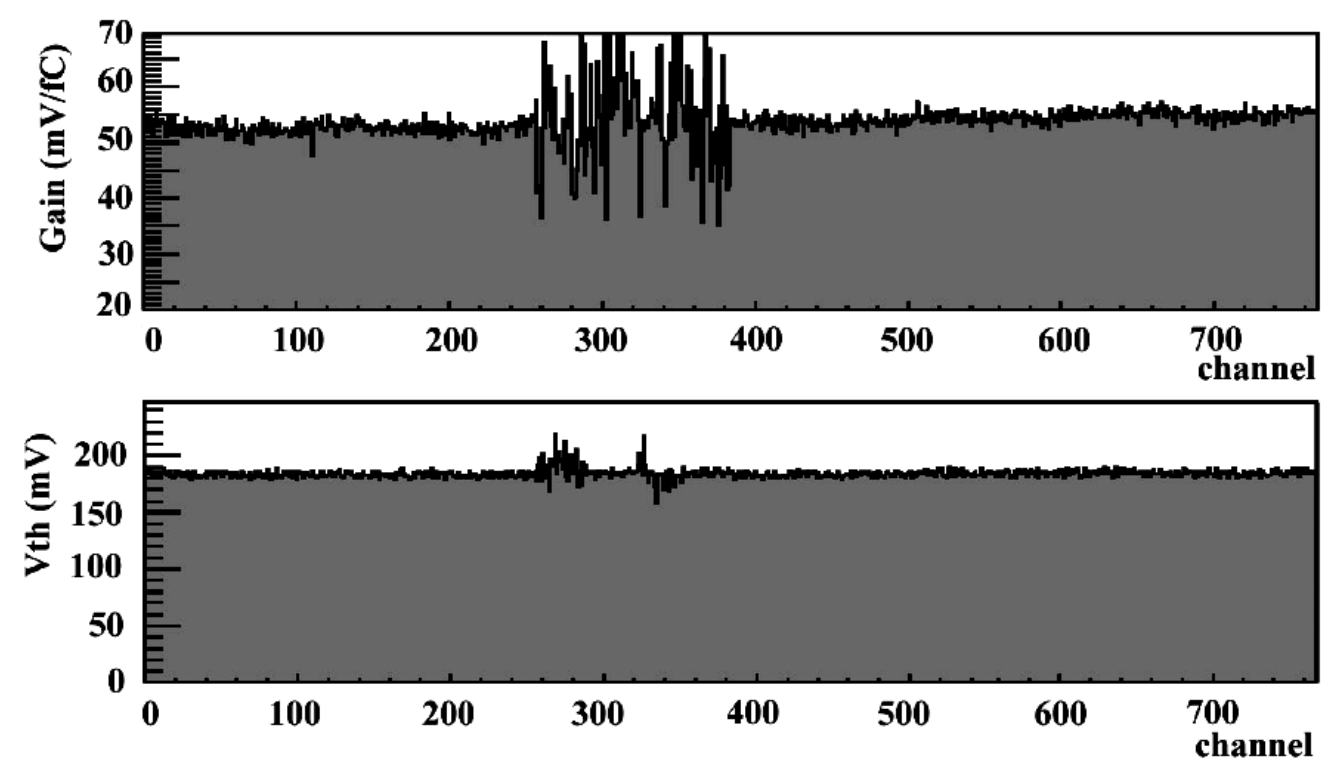
Out of the electrical tests, defects in ASIC's were classified. The channels that were defective and subsequently masked by the channel mask registers in front of the pipeline buffers were, completely inefficient (DEAD), always on (STUCK), or un-trimmable (UNTRIMMABLE) channels. These channels were eventually become dead by masking. The channels that had a bit error in the pipeline buffers or after and showed prevailing hits were STUCKCELL channels. This defect is severe because it produces unnecessary traffic. The ASIC's which had all 128 channels DEAD, STUCK, or UNTRIMMABLE, were classified as DEAD ASIC's. The ASIC's which had one or more STUCKCELL channels were classified as STUCKCELL ASIC's. Other classes of faulty ASIC's were found. ASIC's which had very large spread of gain in all channels, 30 to 70 mV/fC, were classified as "Large gain spread" ASIC's. ASIC's which threshold uniformity in all channels were worse than expected after trim tuning were classified as "Trim-DAC loading failed" ASIC's. ASIC's which responses were faulty below a threshold because of negative offsets were classified as "Negative offset" ASIC's. ASIC's which had abnormal calibration line were classified as "Abnormal calib line" ASIC's. Figure 2 shows an example of such "Large gain spread" and "Trim-DAC loading failed" ASIC's.

Figure 2: Example of "Large gain spread" (top plot) and "Trim-DAC loading failed" ASIC's (bottom plot). There are 6 ASIC's in a plot.

By the middle of August 2002, we have fabricated 120 hybrids with ASIC's and 98 modules in Japan. We obtained 102 hybrids without defective ASIC's and 93 electrically good modules. The rate of hybrids with defective ASIC's was 9.7% and would be reduced to a smaller value by improving the ASIC screening that eliminates "Large gain spread", "Trim-DAC loading failed", "Negative offset", and "Abnormal calib line" ASIC's.

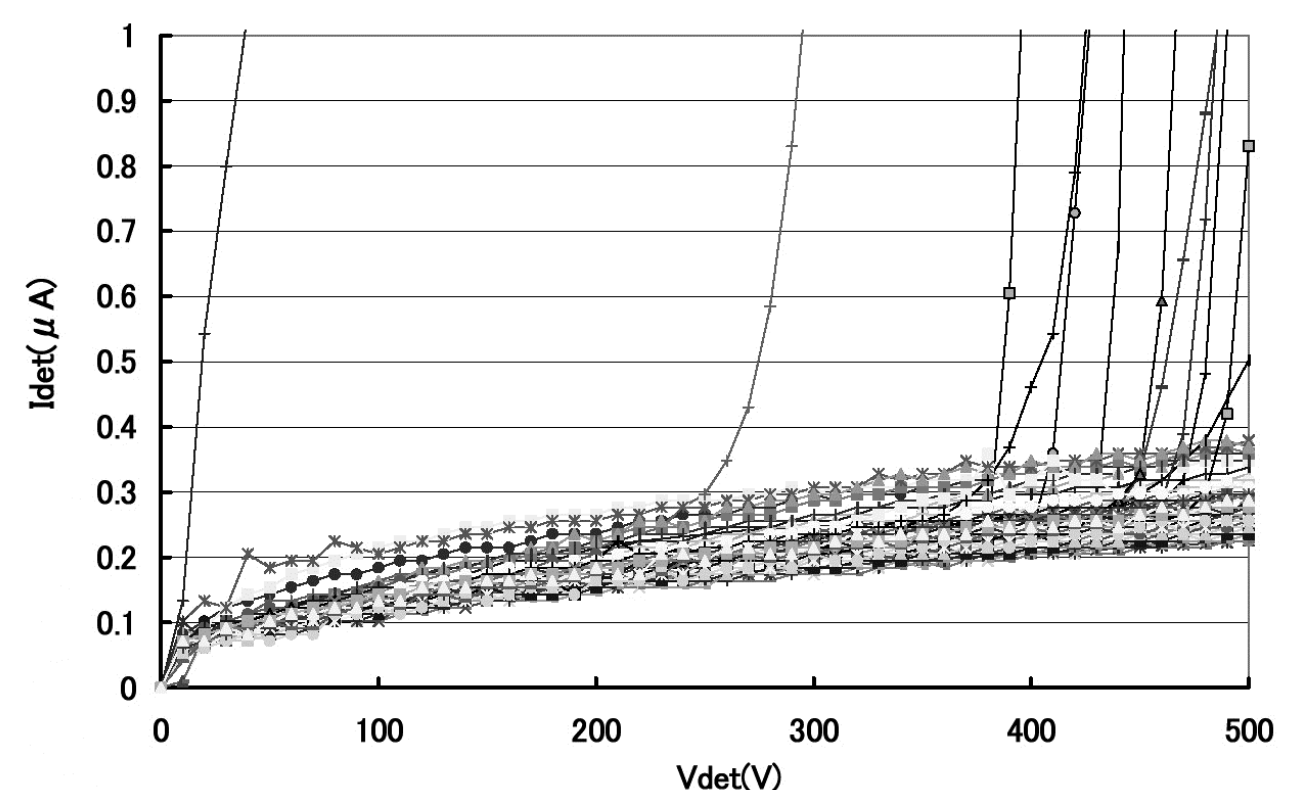
Behaviour of leakage current was measured for the bias voltage up to 500 V at a temperature of 15 ˚C. Figure 4 shows the I-V curves of 95 modules. Most of the modules draw little current, less than 400 nA, smoothly up to 500 V, which were consistent with the sum of four sensors used in the modules. Two modules showed breakdown (we call it "microdischarge") below 350 V and 10 modules above 350 V. The former 2 modules were identified to have damages on the bonding pads that were made at the time of bonding repairing. The microdischarges above 350 V were accepted. In experiment, the bias voltages required are below 200 V initially, and after type inversion and growth of full depletion voltage due to radiation damage, the microdischarge will not occur for the voltages to deplete the sensors in 10 yrs of operation. This has been confirmed in irradiated sensors. Also, the increased currents decayed down to normal currents after applying the bias voltages, e.g., 500V, for hours, a characteristic of microdischarge.

Figure 4: I-V measurement of the modules
