# Curing early breakdown in silicon strip sensors with radiation

Luise Poley

Measurements performed within the scope of the ATLAS ITk strip tracker

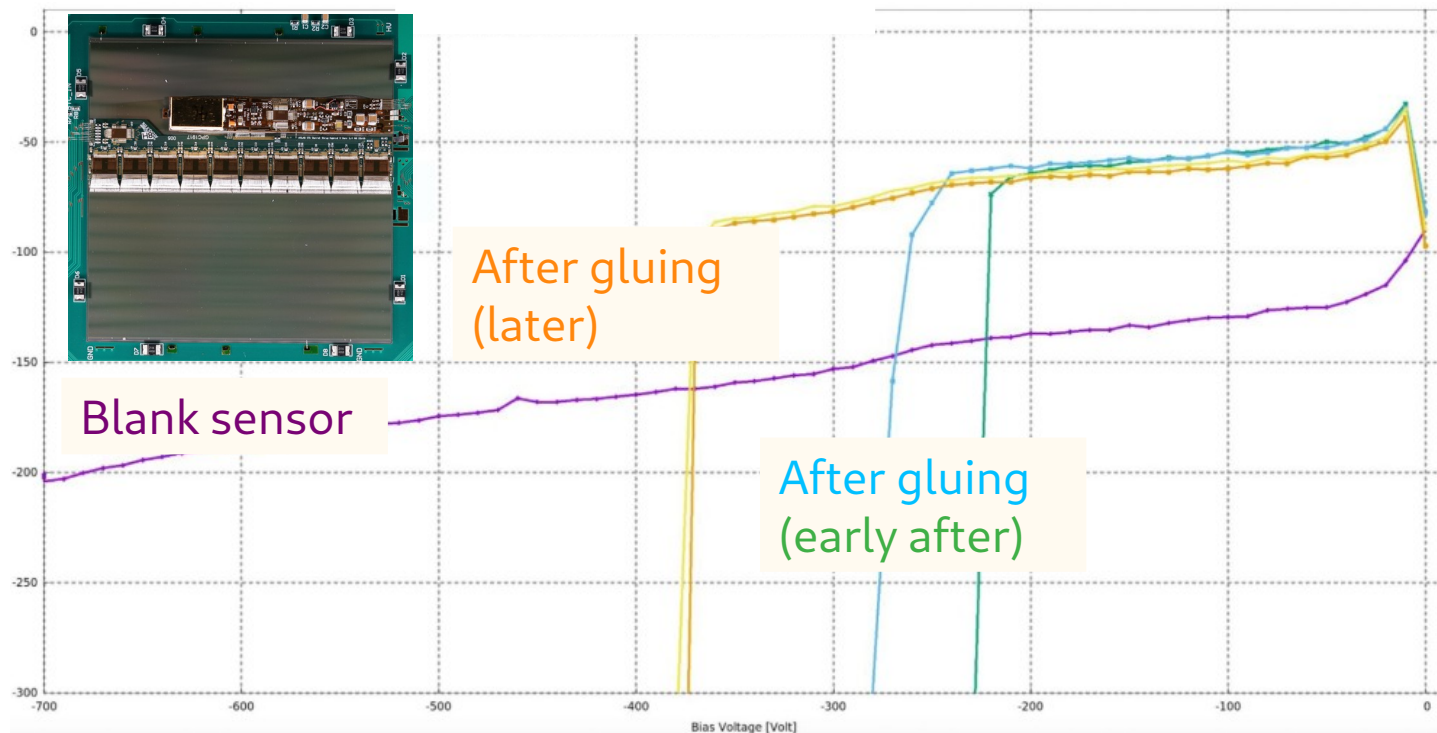
Classic signature after module assembly:  
early breakdown (often due to glue on guard ring;  
exact reason (sensor/module related) unknown)

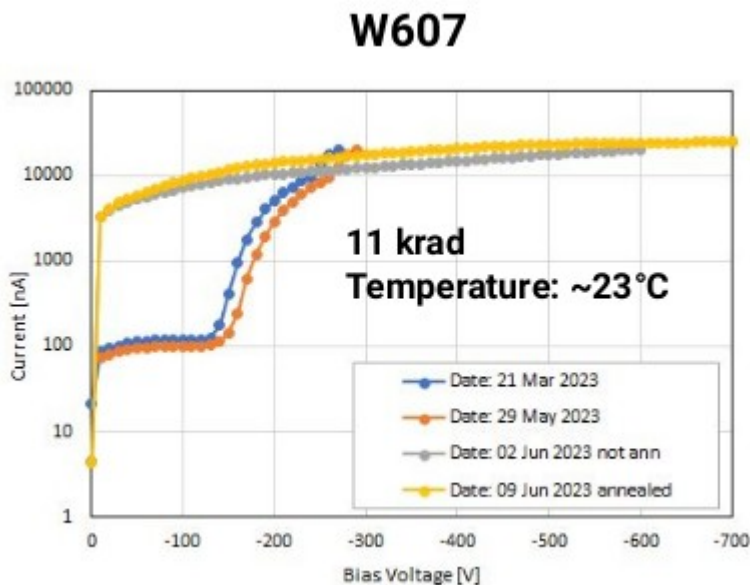
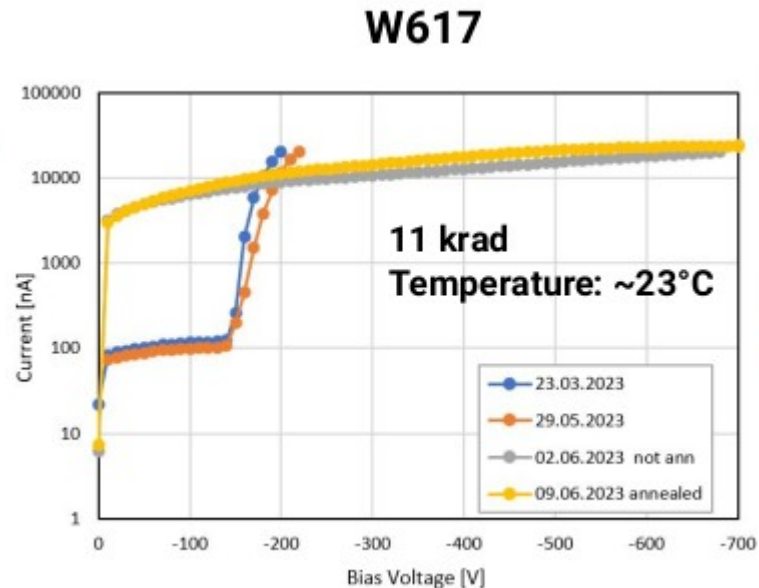
Very promising results from measurements performed by Prague group:  
even low doses improve early breakdown  
(11 krad correspond to one week inside HL-LHC)  
Question: does that also work with glue?

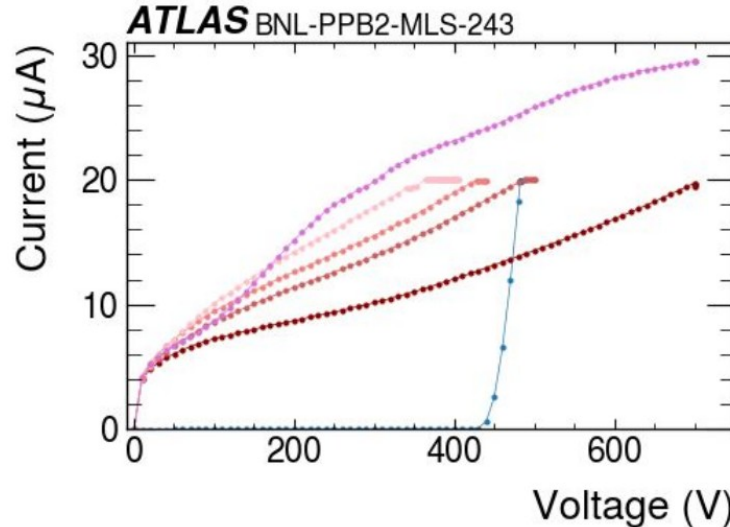
After exposure to 11 krad from gamma source

overall current increase, but no early breakdown

- Before irradiation
- After irradiation
- Day 1
- Day 2
- Day 3
- Day 6

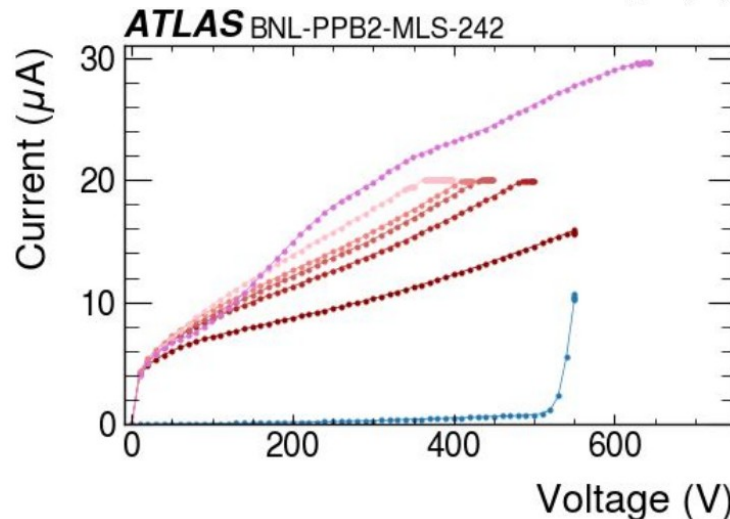
Improvement stable over days

- Before radiation
- After irradiation
- Day 1
- Day 2
- Day 3
- Day 4
- Day 7

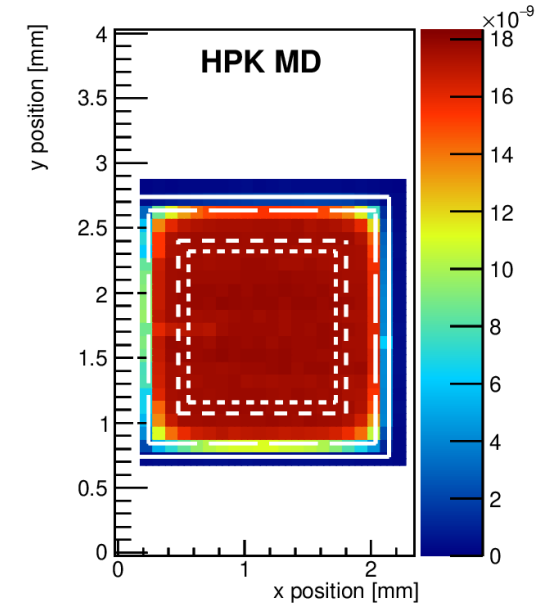
Previous measurements  
of diodes  
depleted diode volume  
shrinks with fluence

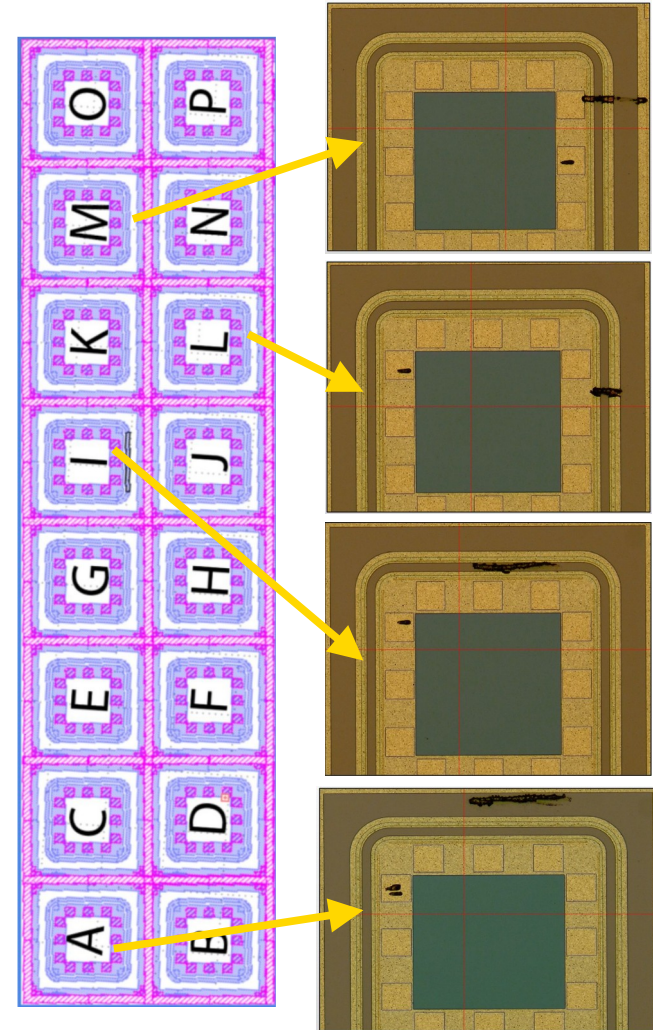
Array of diodes prepared with intentional scratches

→ method developed to cause reproducible scratches  
→ different locations, different depths

Compare breakdown voltage before and after scratching  
Then irradiate to increasing fluences and repeat

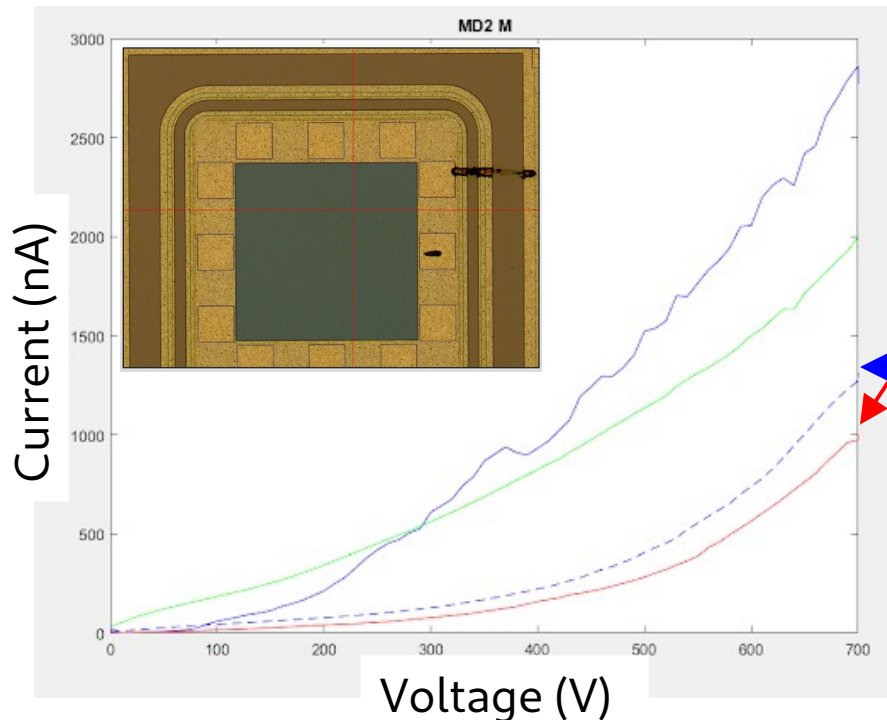
The surprising result:  
even at “homeopathic fluence” of  $10^8 - 10^9 \text{ n}_{\text{eq}}/\text{cm}^2$ ,  
irradiation actually improves leakage current

**Current** after scratching  
**Current** after recovery  
period

**Current** after irradiation  
to  $10^8 \text{ n}_{\text{eq}}/\text{cm}^2$

**Current** after irradiation  
to  $10^9 \text{ n}_{\text{eq}}/\text{cm}^2$

(all at the same  
temperature)

But overall trend: early breakdown improved after irradiation even to low fluence
