Total Ionizing Dose Effects in a Xilinx FPGA

We have measured the effects of total ionizing dose on three Xilinx XC4036XL FPGAs. The FPGAs were irradiated at a dose rate of about 0.5 krad/hr. An average total dose of (41 ± 1) krad(Si) was absorbed before the power supply current began to increase and (60 ± 4) krad(Si) was absorbed before the first error occurred.

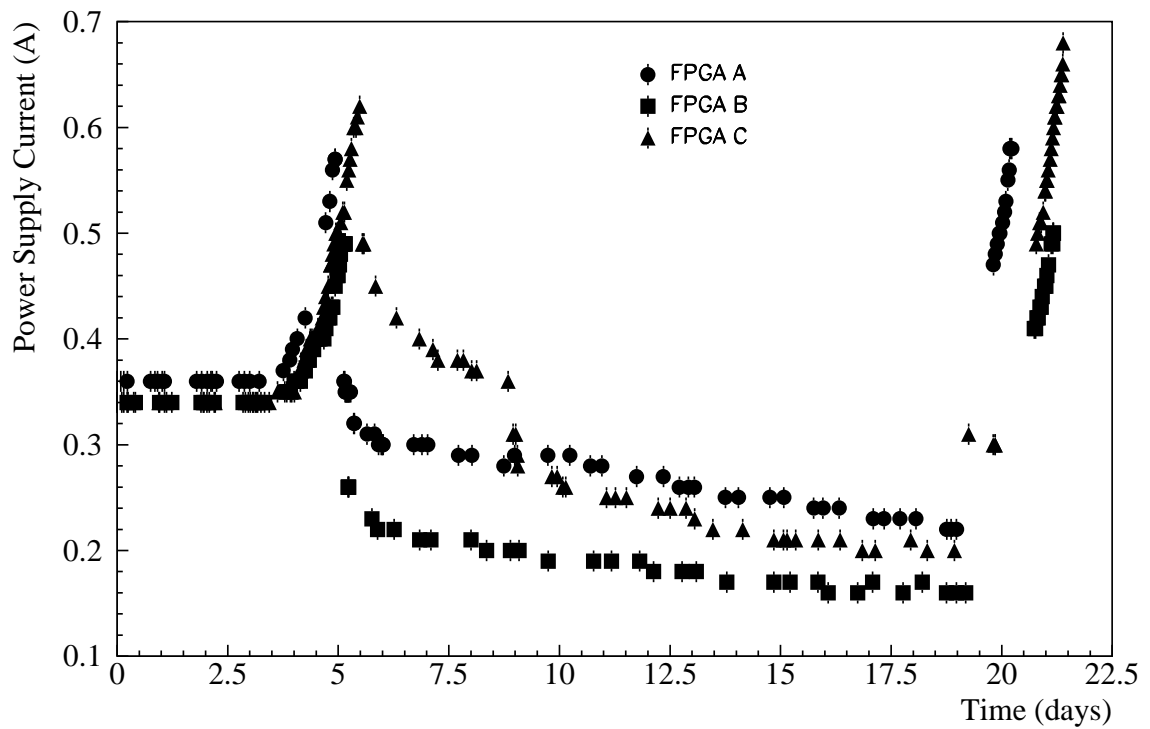
Figure 4: Power supply current versus time during the entire test for FPGA A (circles), FPGA B (squares), and FPGA C (triangles).

Figure 4 shows the power supply current versus time for the entire test. During periods of irradiation (current increasing) the configuration circuit was loaded. During periods of annealing (current decreasing) the configuration circuit was not loaded but the chips were still kept under bias. It should be noticed that the FPGA draws more current when the configuration circuit is loaded and running, independent of radiation effects. When the FPGA was configured a second time for irradiation, the current drawn was immediately higher than for a non-irradiated FPGA.
