Total Ionizing Dose Effects in a Xilinx FPGA

N.J.Buchanan¹, D.M.Gingrich^{1,2}, P.W.Green² & D.M.MacQueen¹

We have measured the effects of total ionizing dose on four Xilinx XC4036XL FPGAs. The FPGAs were irradiated at a dose rate of about 0.5 krad/hr. An average total dose of (40 ± 2) krad(Si) was absorbed before the power supply current began to increase and (60 ± 3) krad(Si) was absorbed before the first error occurred.

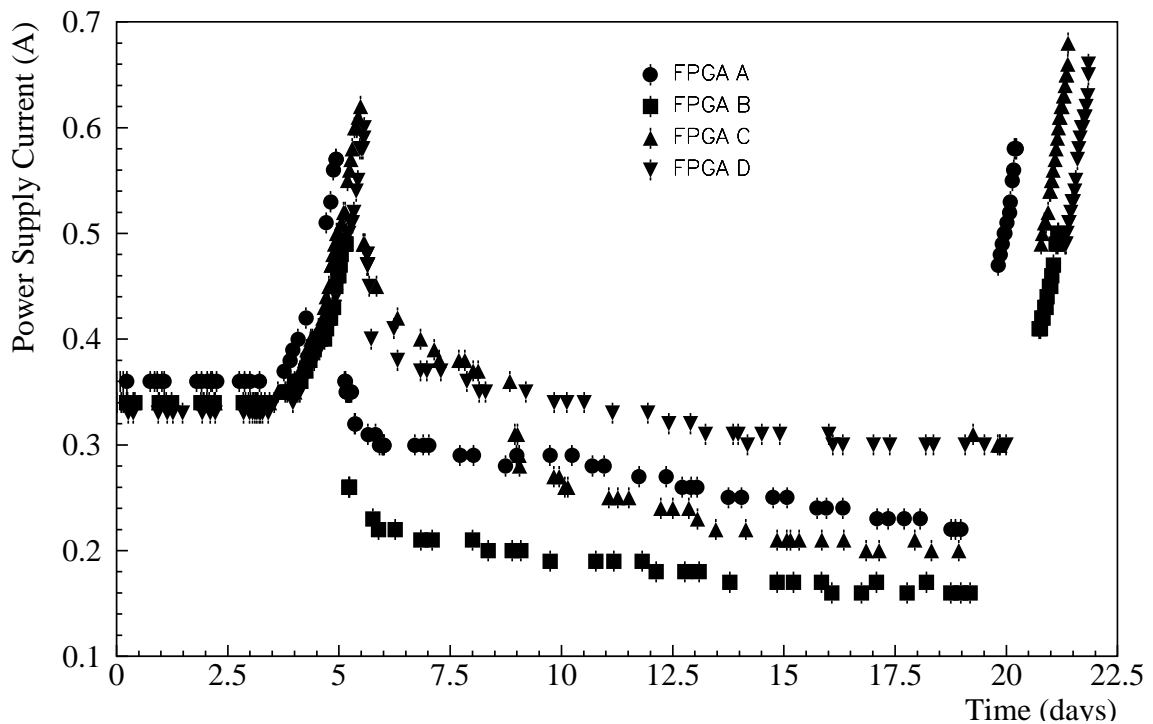
Figure 4: Power supply current versus time during the entire test for FPGA A (circles), FPGA B (squares), FPGA C (triangles), and FPGA D (inverted triangles).

Figure 4 shows the power supply current versus time for the entire test. During periods of irradiation (current increasing) the configuration circuit was loaded. During periods of annealing (current decreasing) the configuration circuit was not loaded but the chips were still kept under bias. It should be noticed that the FPGA draws more current when the configuration circuit is loaded and running, independent of radiation effects. When the FPGA was configured a second time for irradiation, the current drawn was immediately higher than for a non-irradiated FPGA.
