# Curing early breakdown in silicon strip sensors with radiation

In preparation for the forthcoming High-Luminosity phase of the Large Hadron Collider, the ATLAS experiment is working on major upgrades to its detector systems to effectively accommodate the increase in radiation levels and track density. The foremost among these upgrades entails the replacement of the current inner tracking detector with an advanced all-silicon Inner Tracker (ITk). In the outer region of the ITk apparatus is the Strip Detector.

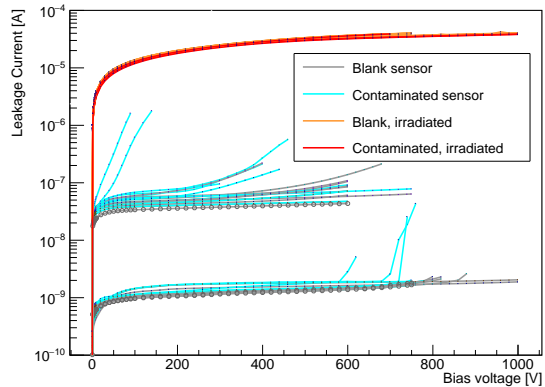
Figure 1: Sensor IV tests before/after gluing and before/after irradiation to 2·10<sup>15</sup> n<sub>eq</sub>/cm<sup>2</sup>, from [7]

During quality assurance tests performed to confirm the viability of gluing printed circuit boards directly onto the sensor, it was discovered that none of the sensors showed a premature breakdown after irradiation to 2·10<sup>15</sup> n<sub>eq</sub>/cm<sup>2</sup> using 23 MeV protons (see figure 1).

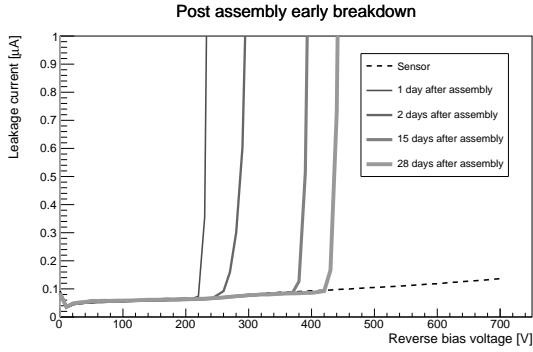
Figure 2: Reduced breakdown voltage measured for an LS sensor after assembly into a module

In order to study potential improvements in modules due to radiation, two ATLAS Long Strip modules with premature breakdown were irradiated. Figure 2 shows a typical example of a module with reduced breakdown voltage after assembly compared to the initial sensor tests.

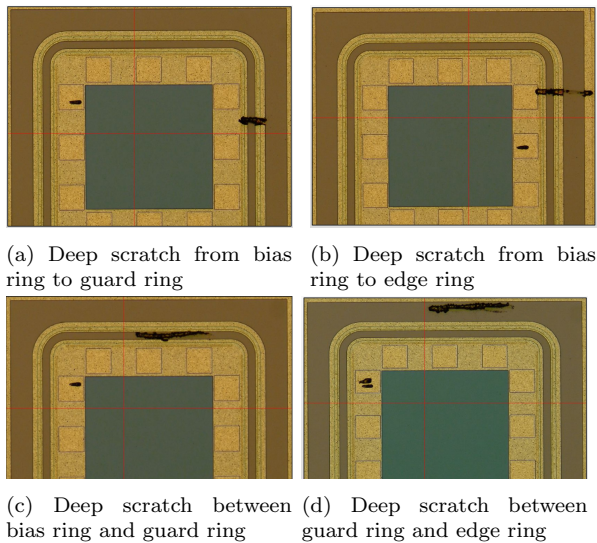
Figure 4: Examples of different scratches on diodes

95 voltage for some sensors, but result in a stable  
 96 performance for others). Therefore, the loca-  
 97 tion and depth (superficial or deep enough to  
 98 produce debris) of the applied scratches was  
 99 varied to compare their impact (see figures 4a  
 100 to 4d) using a tungsten carbide scribe tip.

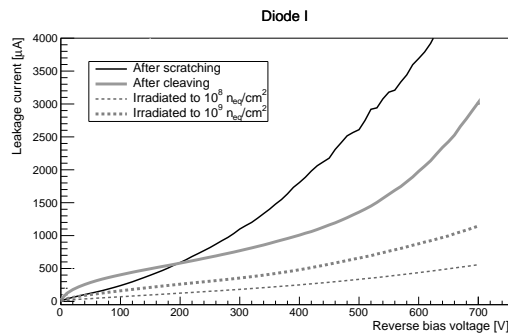
(a) IV tests for diode with scratch between bias ring and guard ring (see figure 4c)

Figure 5: IV characteristics for two diodes before and after irradiation to  $1 \cdot 10^8 \text{ n}_{\text{eq}}/\text{cm}^2$  and  $1 \cdot 10^9 \text{ n}_{\text{eq}}/\text{cm}^2$  with reactor neutrons. Both diodes show a recovery from the initial performance post damage even after being exposed to a low fluence of  $1 \cdot 10^8 \text{ n}_{\text{eq}}/\text{cm}^2$ . Afterwards, the current increases with higher fluence as expected.

148 Figures 5a and 5b show two representative ex-  
 amples for this behaviour. These measure-

149 measurements indicate that, similar to the recovery  
 150 observed for modules after gamma irradiation,  
 151 test structures with intentionally caused pre-  
 152 mature breakdown show an improved break-  
 153 down voltage, even after exposure to low equiv-  
 154 alent fluences.

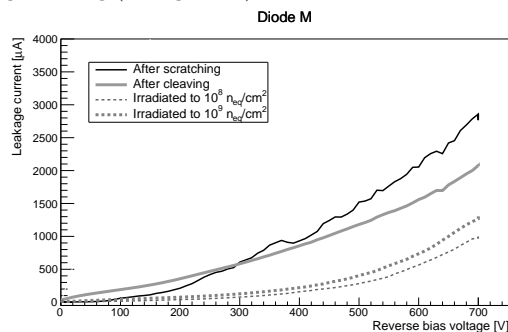
(b) IV tests for diode with scratch from bias ring to edge ring (see figure 4b)

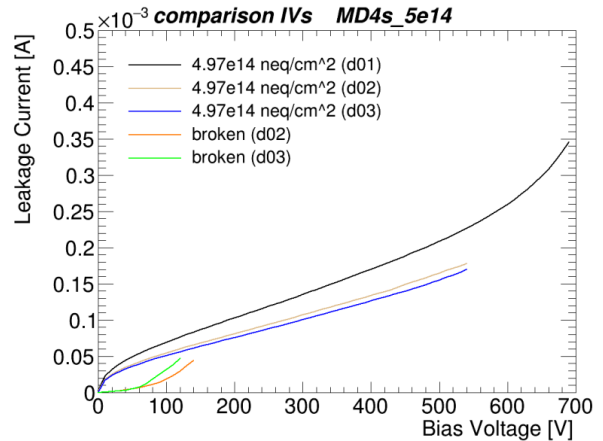
Figure 7: Comparison of 3 diodes (two broken, one intact) before and after irradiation

176 In all cases, the diodes showed a premature  
 177 breakdown after cracking, but showed a com-  
 178 parable IV performance to the intact diode af-  
 179 ter irradiation. Figure 7 shows a representative  
 180 example of the IV tests before and after break-  
 181 ing in comparison with the complete diode be-  
 182 fore and after irradiation.

183 Despite the severe damage they had in-  
 184 curred, all broken damage showed an improve-  
 185 ment of the observed breakdown voltage after  
 186 irradiation that made them comparable to in-  
 187 tact diodes. Additionally, the broken diodes  
 188 showed a lower absolute current than the intact  
 189 diode after irradiation, approximately match-  
 190 ing the reduction in active area by cleaving.
