Advanced condition monitoring of Pelton turbines

Abstract – The ability of hydropower to adapt the electricity generation to the demand is necessary to integrate wind and solar energy into the electrical grid. Nowadays hydropower turbines are required to work under harsher operating conditions and an advanced condition monitoring to detect damage is crucial.

In this paper the methodology to improve the condition monitoring of Pelton turbines is presented. First, the field data obtained from the vibration monitoring of 28 different Pelton turbines over 25 years has been studied. The main types of damage found were due to fatigue, cavitation and silt erosion. By analyzing the vibration signatures before and after maintenance tasks, the symptoms of damage detected from the measuring locations were determined for each case.

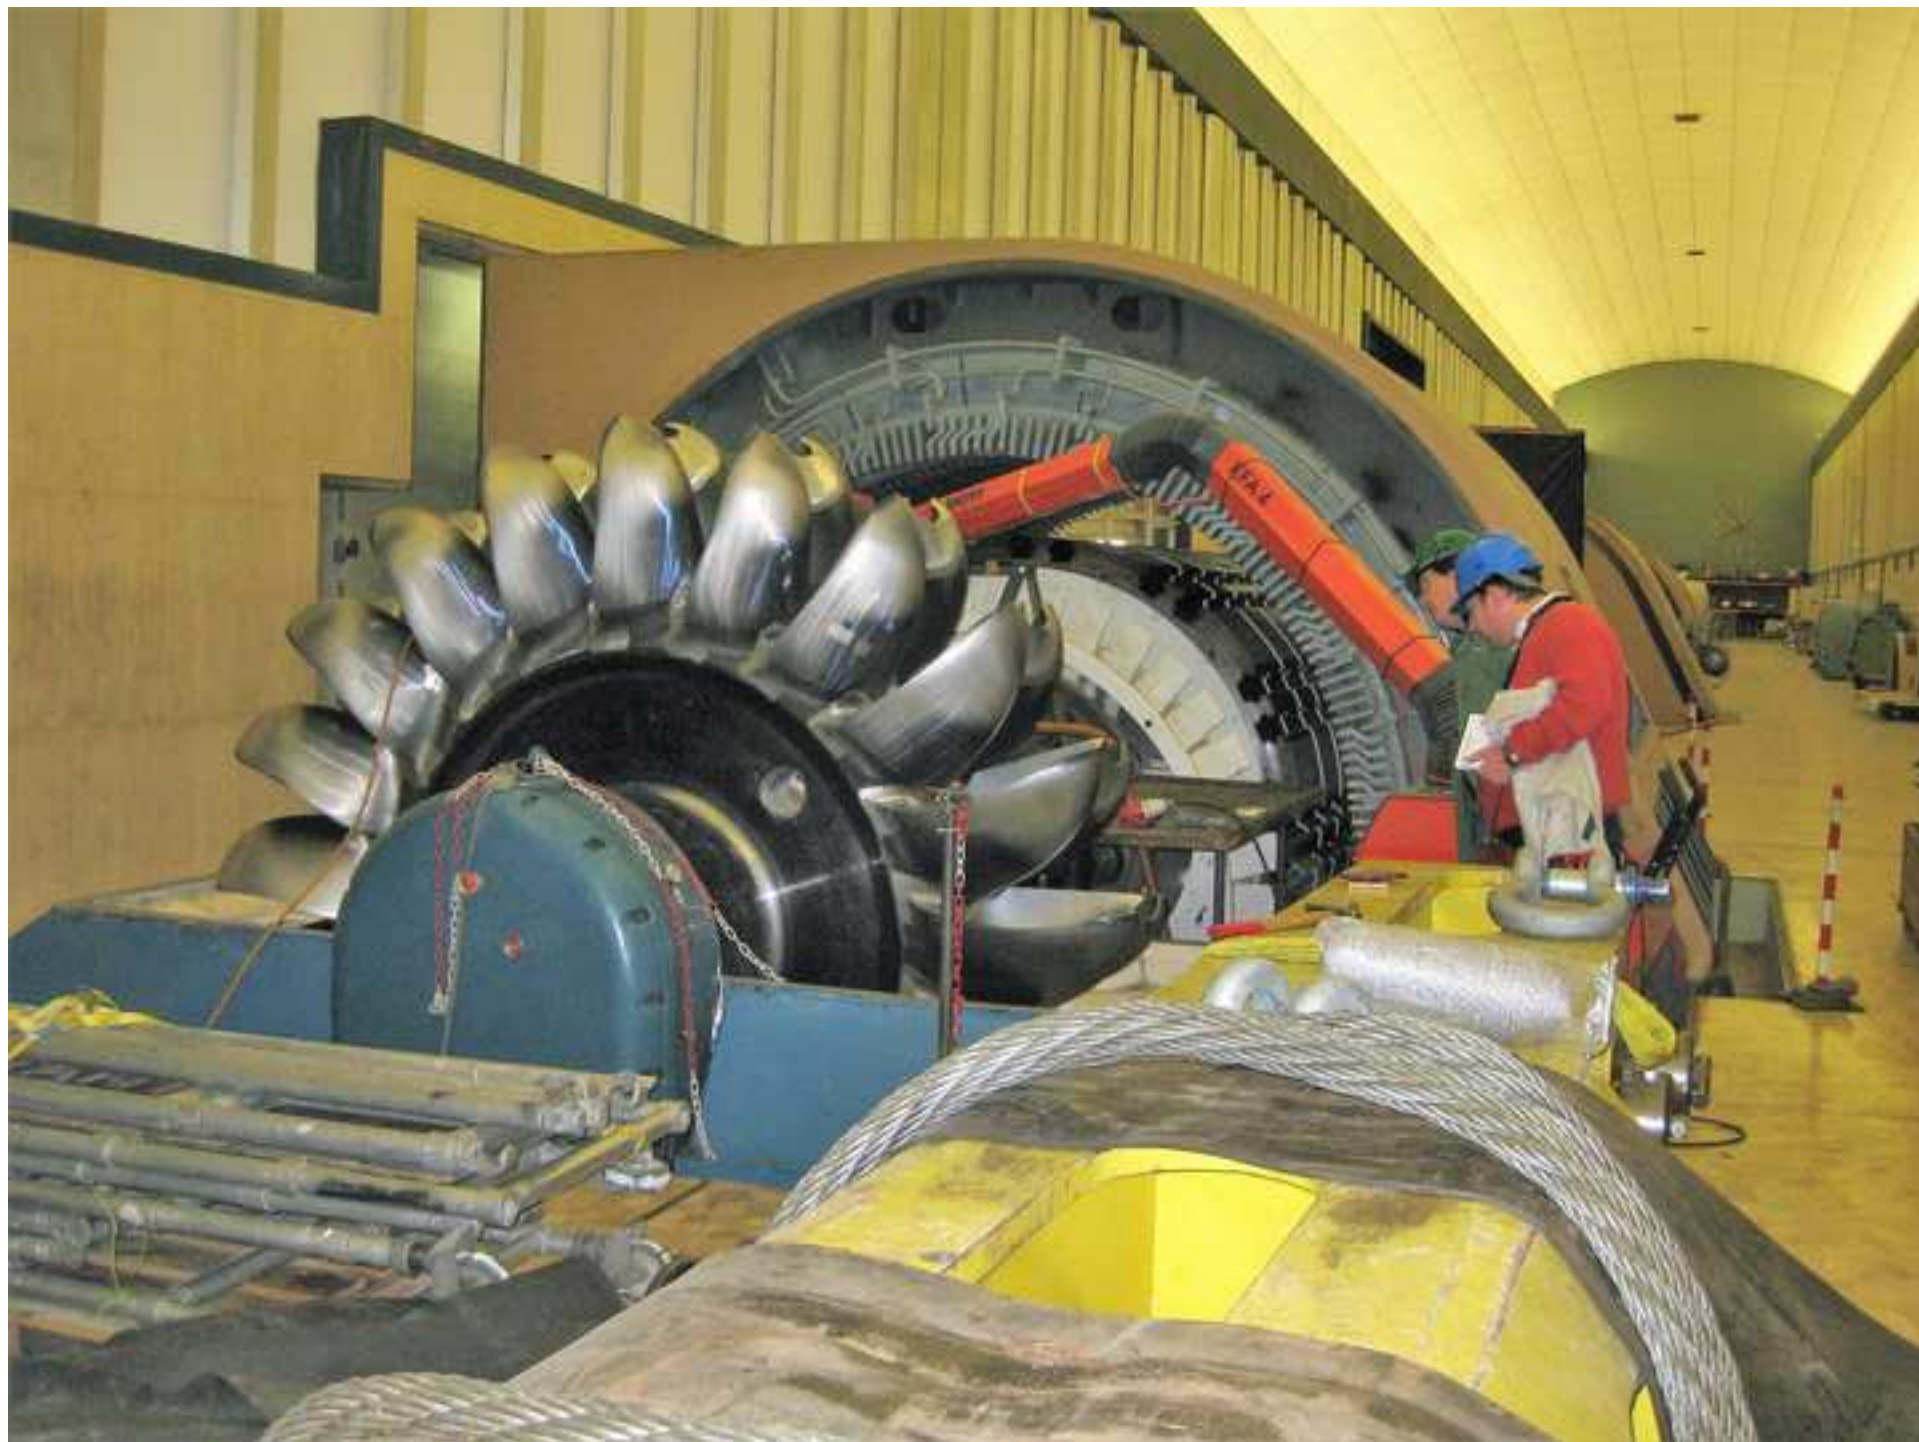
Figure1
[Click here to download high resolution image](#)

Figure 1. Pelton turbine open for inspection. The turbine runner and the electrical generator can be seen.

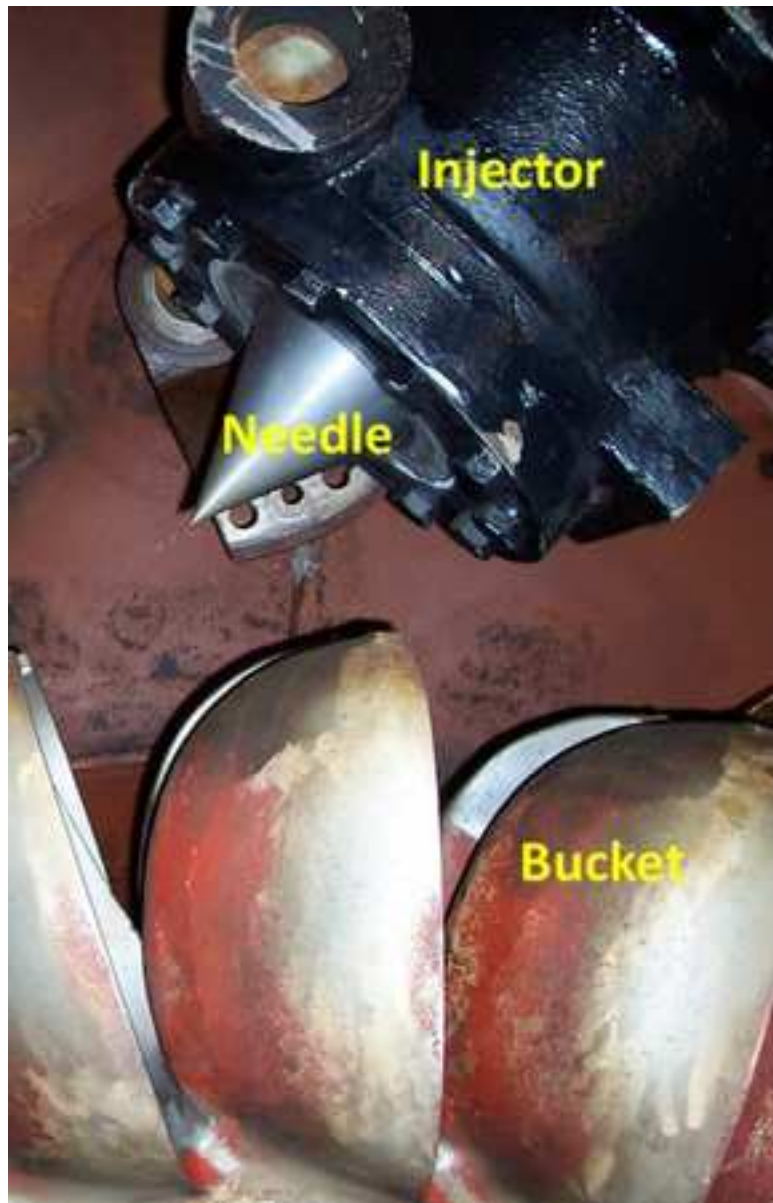
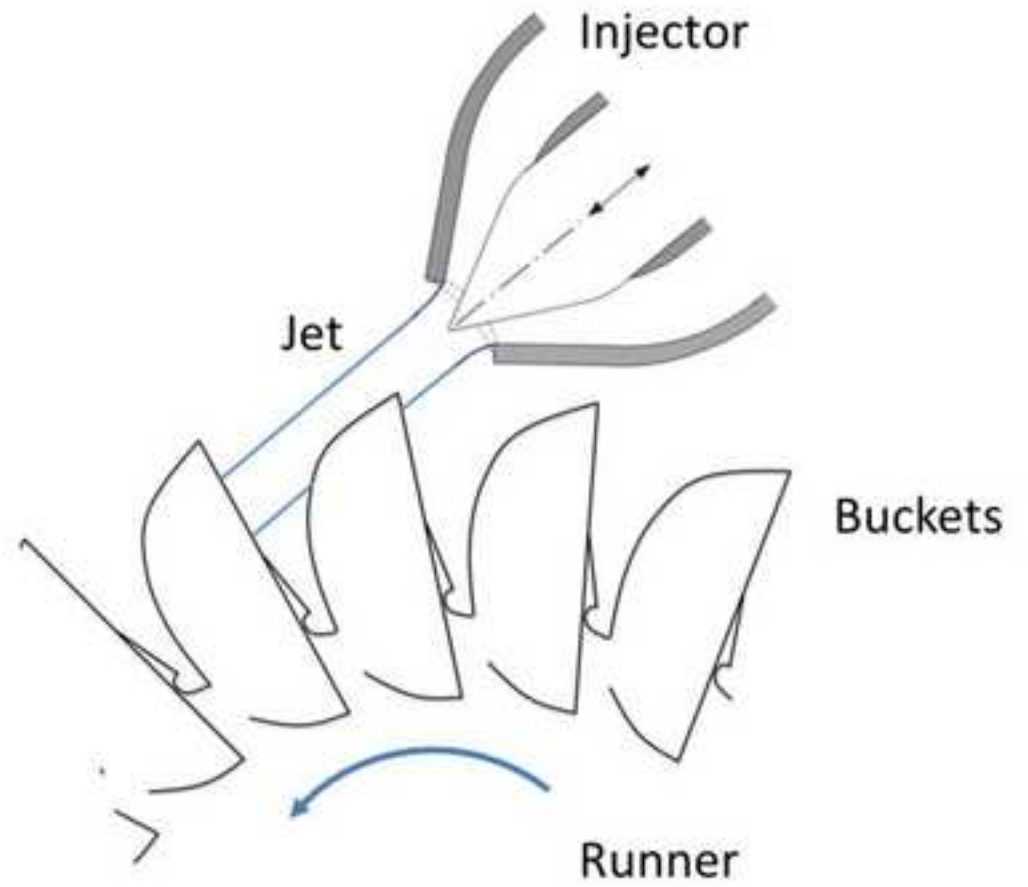
Figure2

Figure 2. Pelton turbine showing injector and buckets

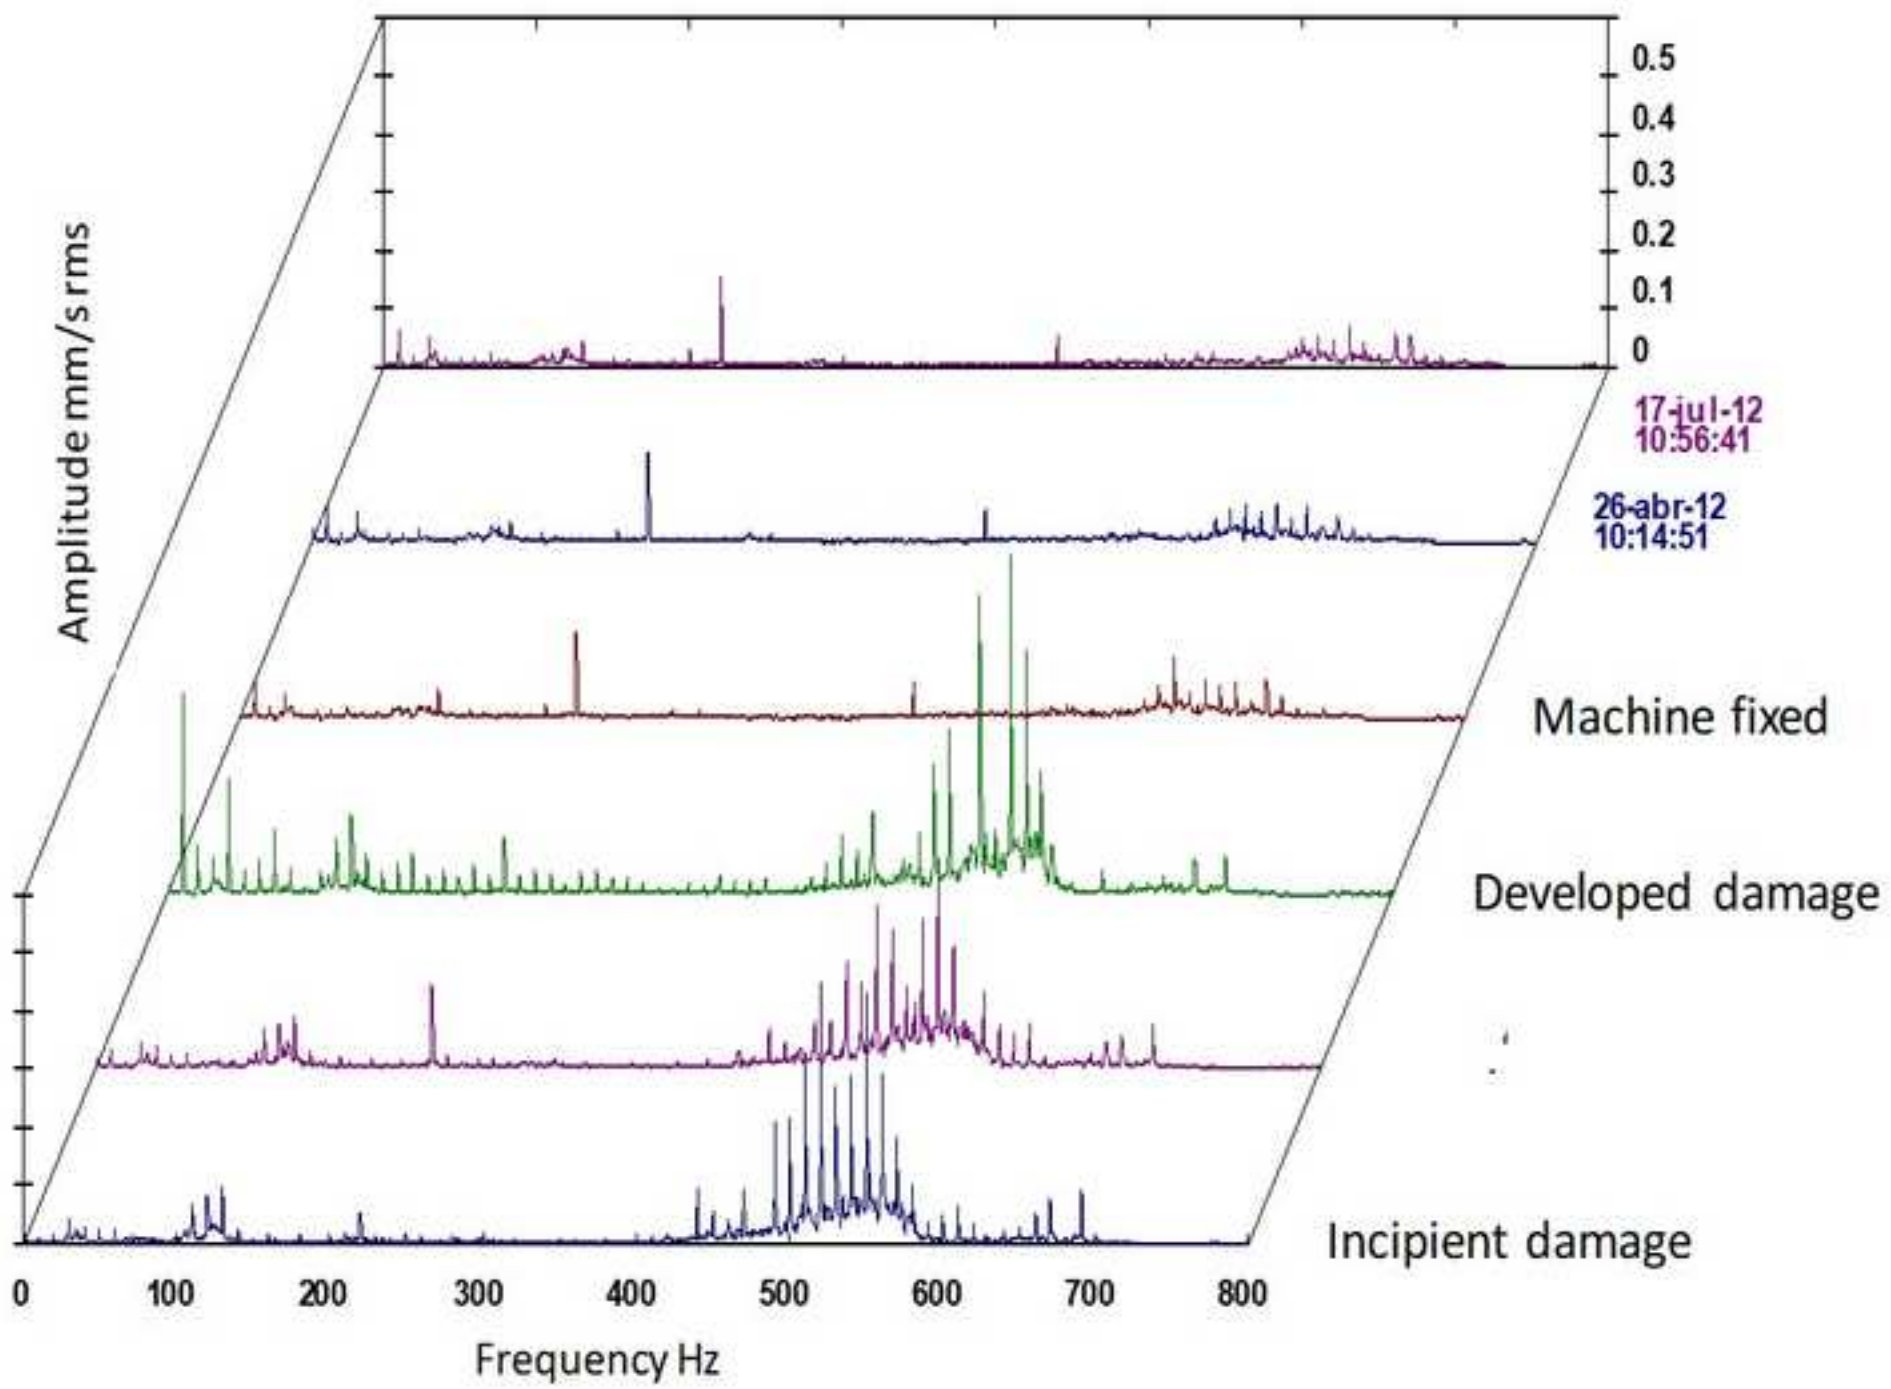
Figure7
[Click here to download high resolution image](#)

Figure 7. Water-fall of vibration spectra measured at different dates

In this paragraph, an example of the procedure used to correlate damage with symptom is explained. In Figure 7, a typical evolution of the vibration signatures of a Pelton turbine is shown. In the first spectrum of the waterfall one can discern high amplitudes of vibration in

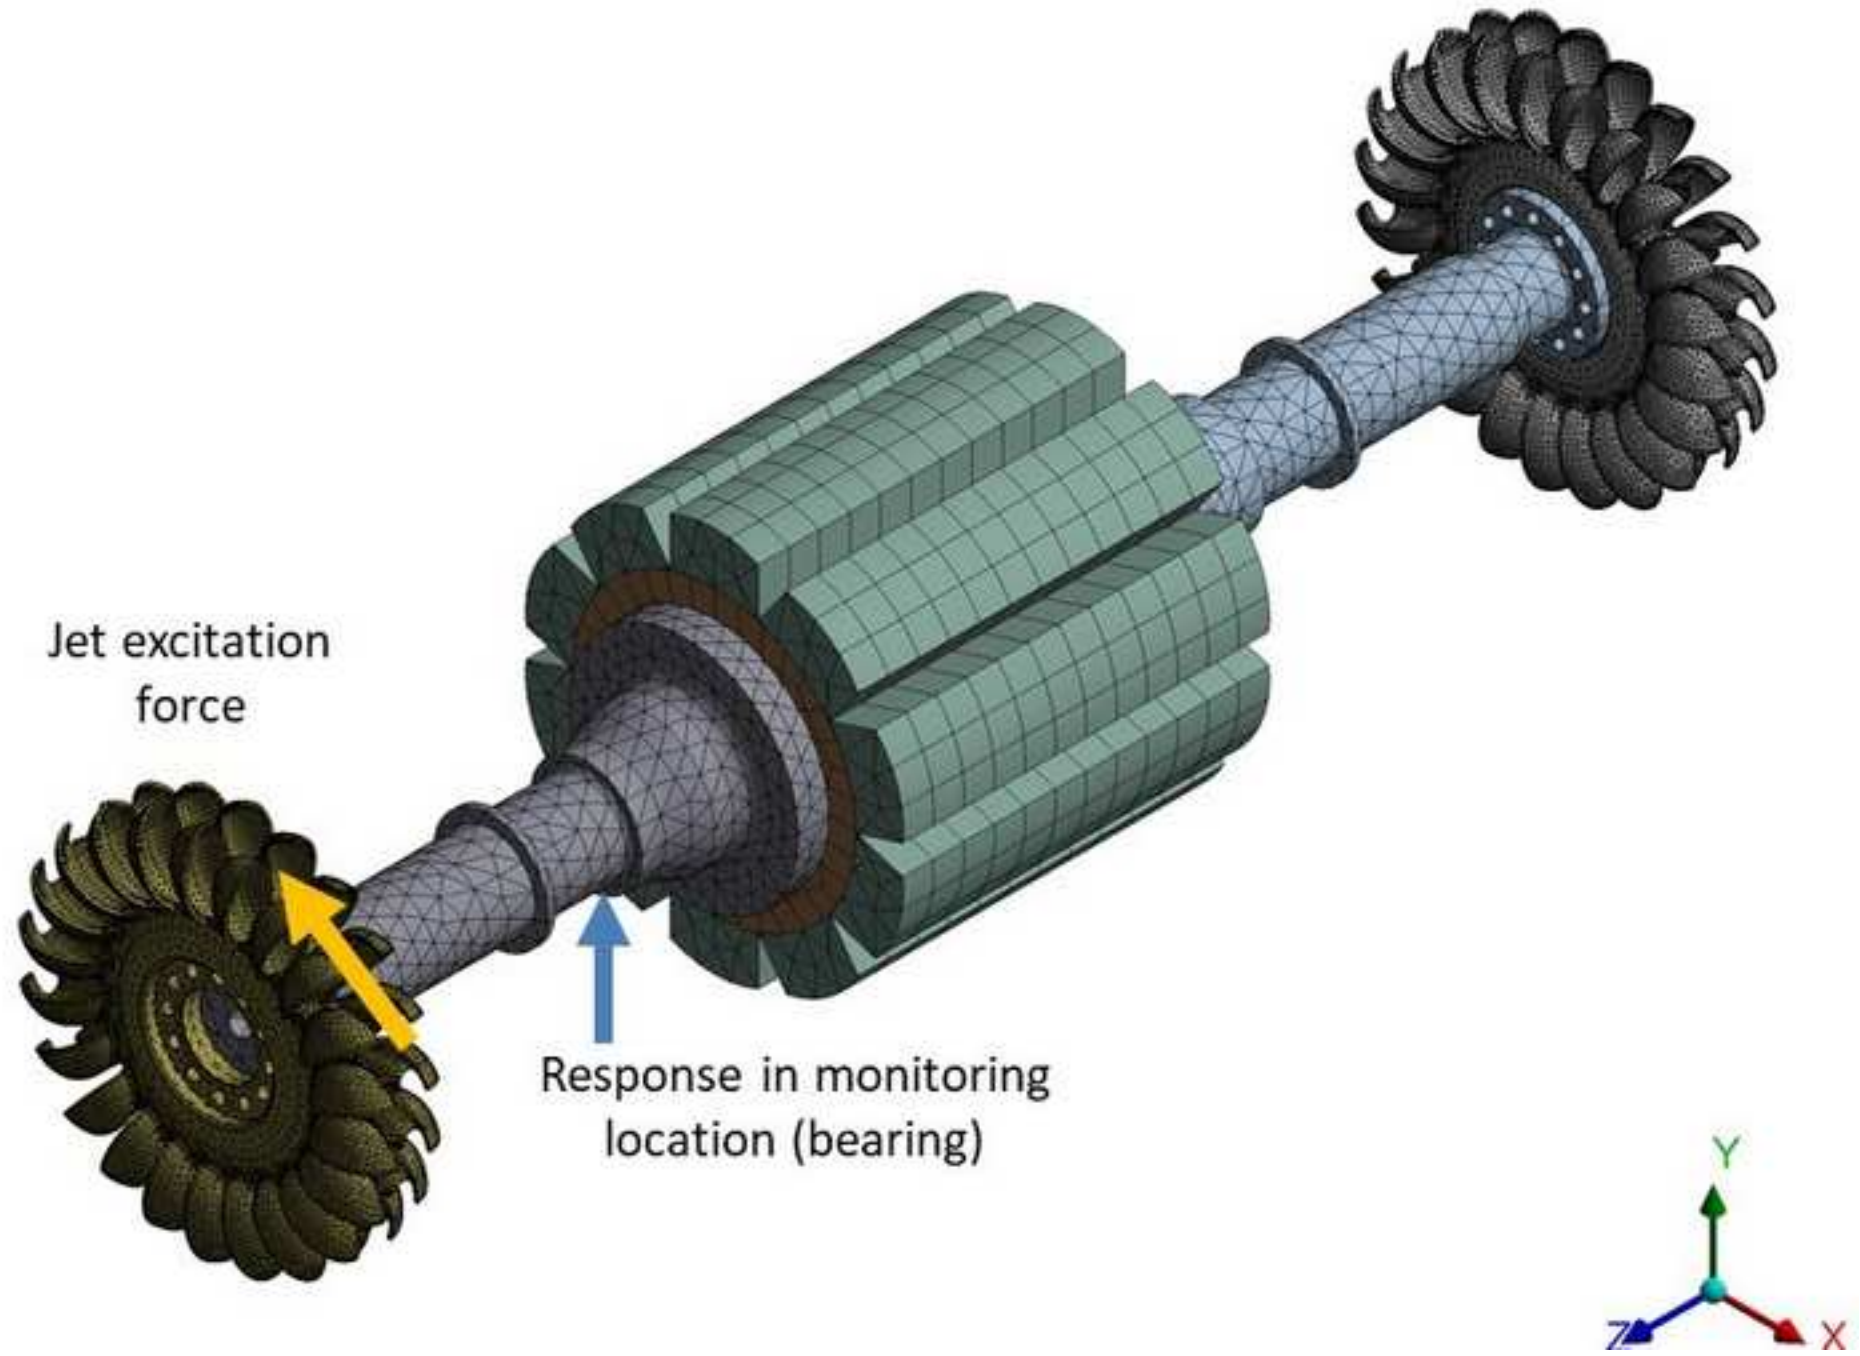
Figure8

Figure 8. Physics-based model of the whole machine

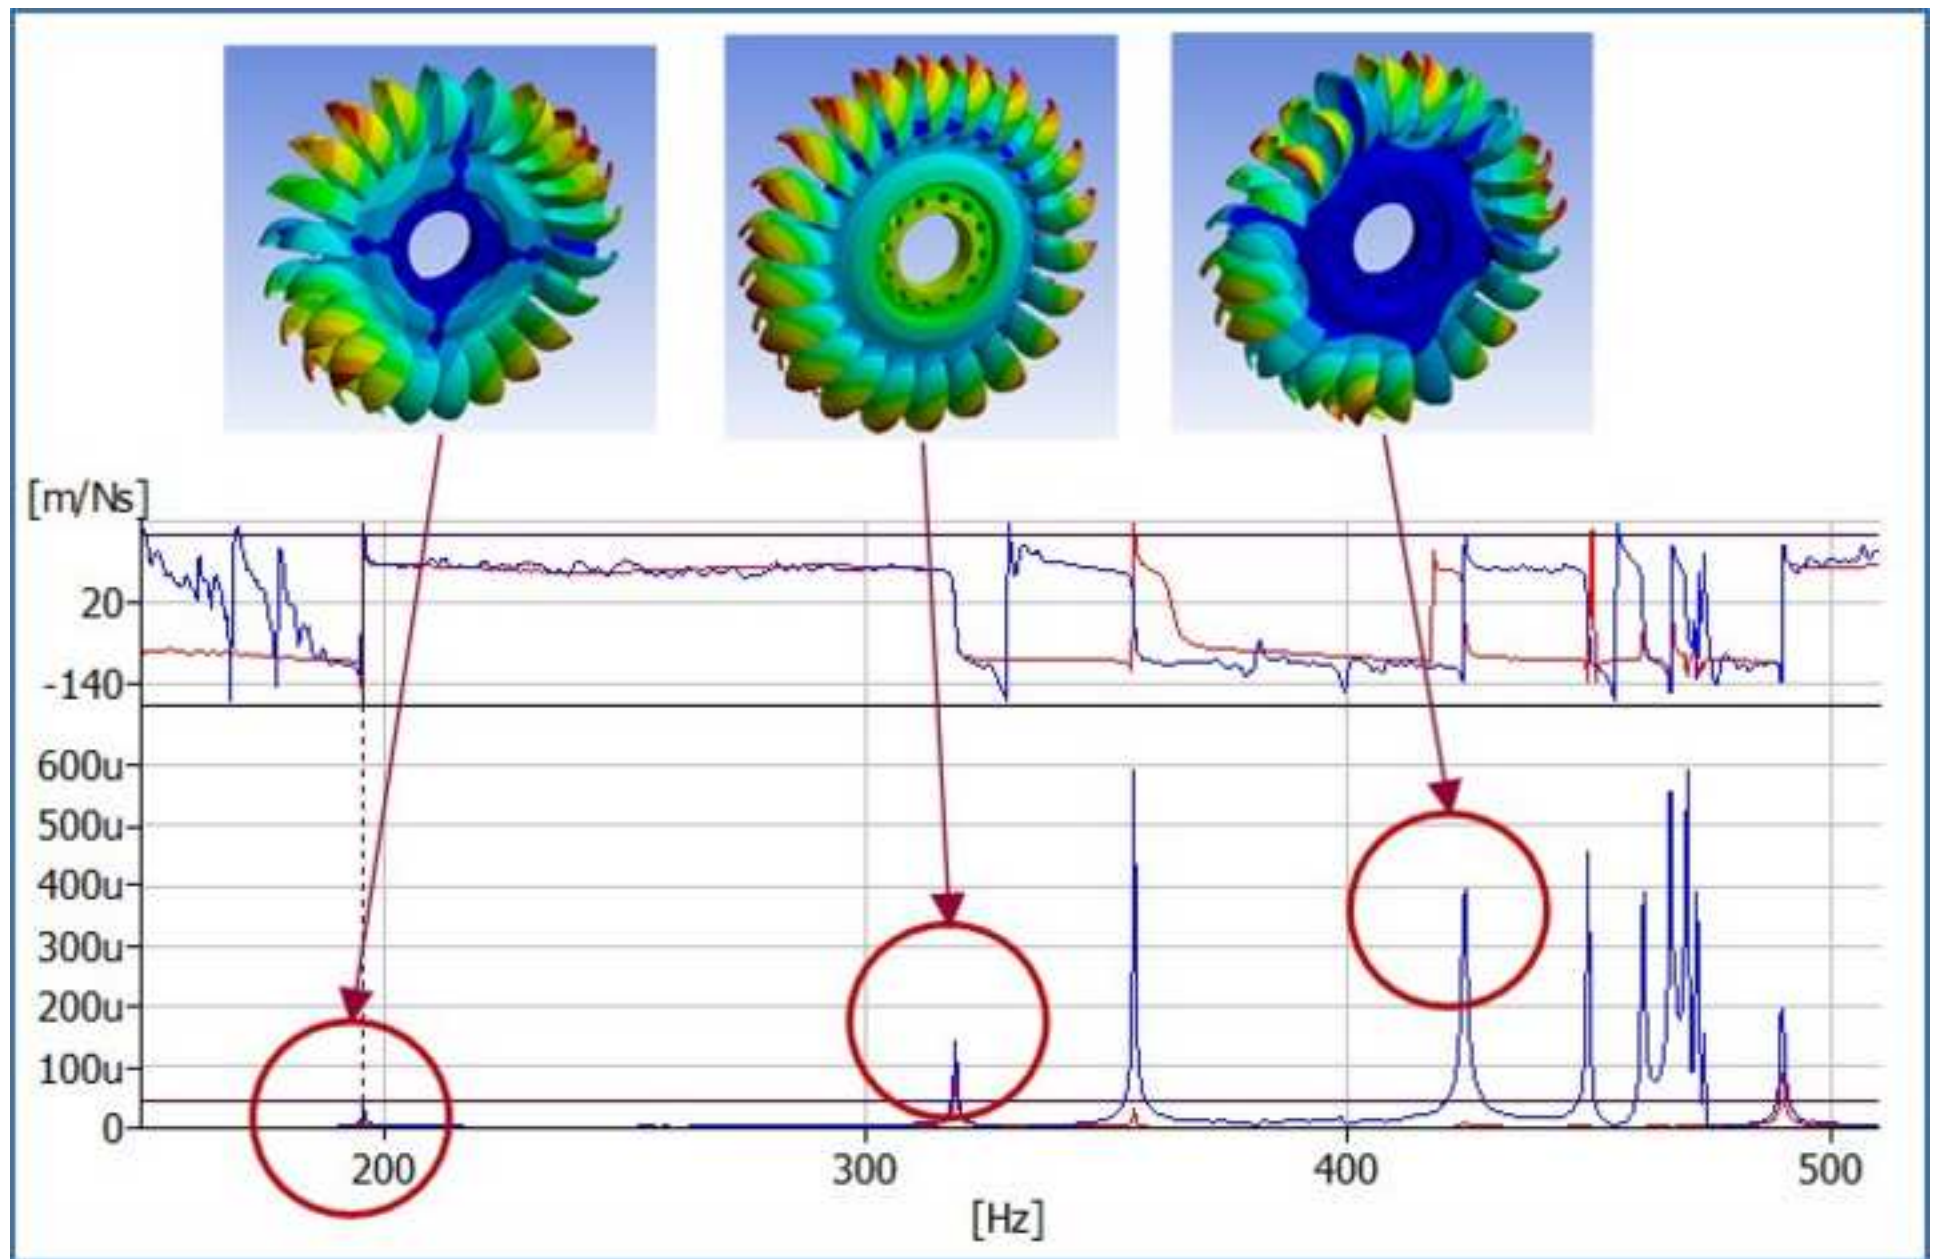
Figure9

Figure 9. Identification of modes and comparison between experimental results and the numerical simulation

To check the validity of the numerical model, the natural frequencies and mode-shapes were calculated and then compared to those of the real machine. To determine the actual modal behavior of the machine an Experimental Modal Analysis (EMA) was done. Natural frequencies were obtained by doing impacts on the runner and on the shaft with an instrumented hammer and measuring the response with accelerometers. The equipment used for the acquisition of signals was a Bruel&Kjaer LAN-XI Pulse system and the accelerometers were Kistler with a sensitivity of (+/- 0,5%). The combination of the hammer signal (input) with the accelerometers signals (output) results in the Frequency Response Function (FRF), which defines the ratio between the vibration levels and the force value. In Figure 9, the comparison between simulation and experimental results can be observed. Runner and rotor modes were then identified and the model was calibrated. The results were compared with the theoretical results obtained from the model.

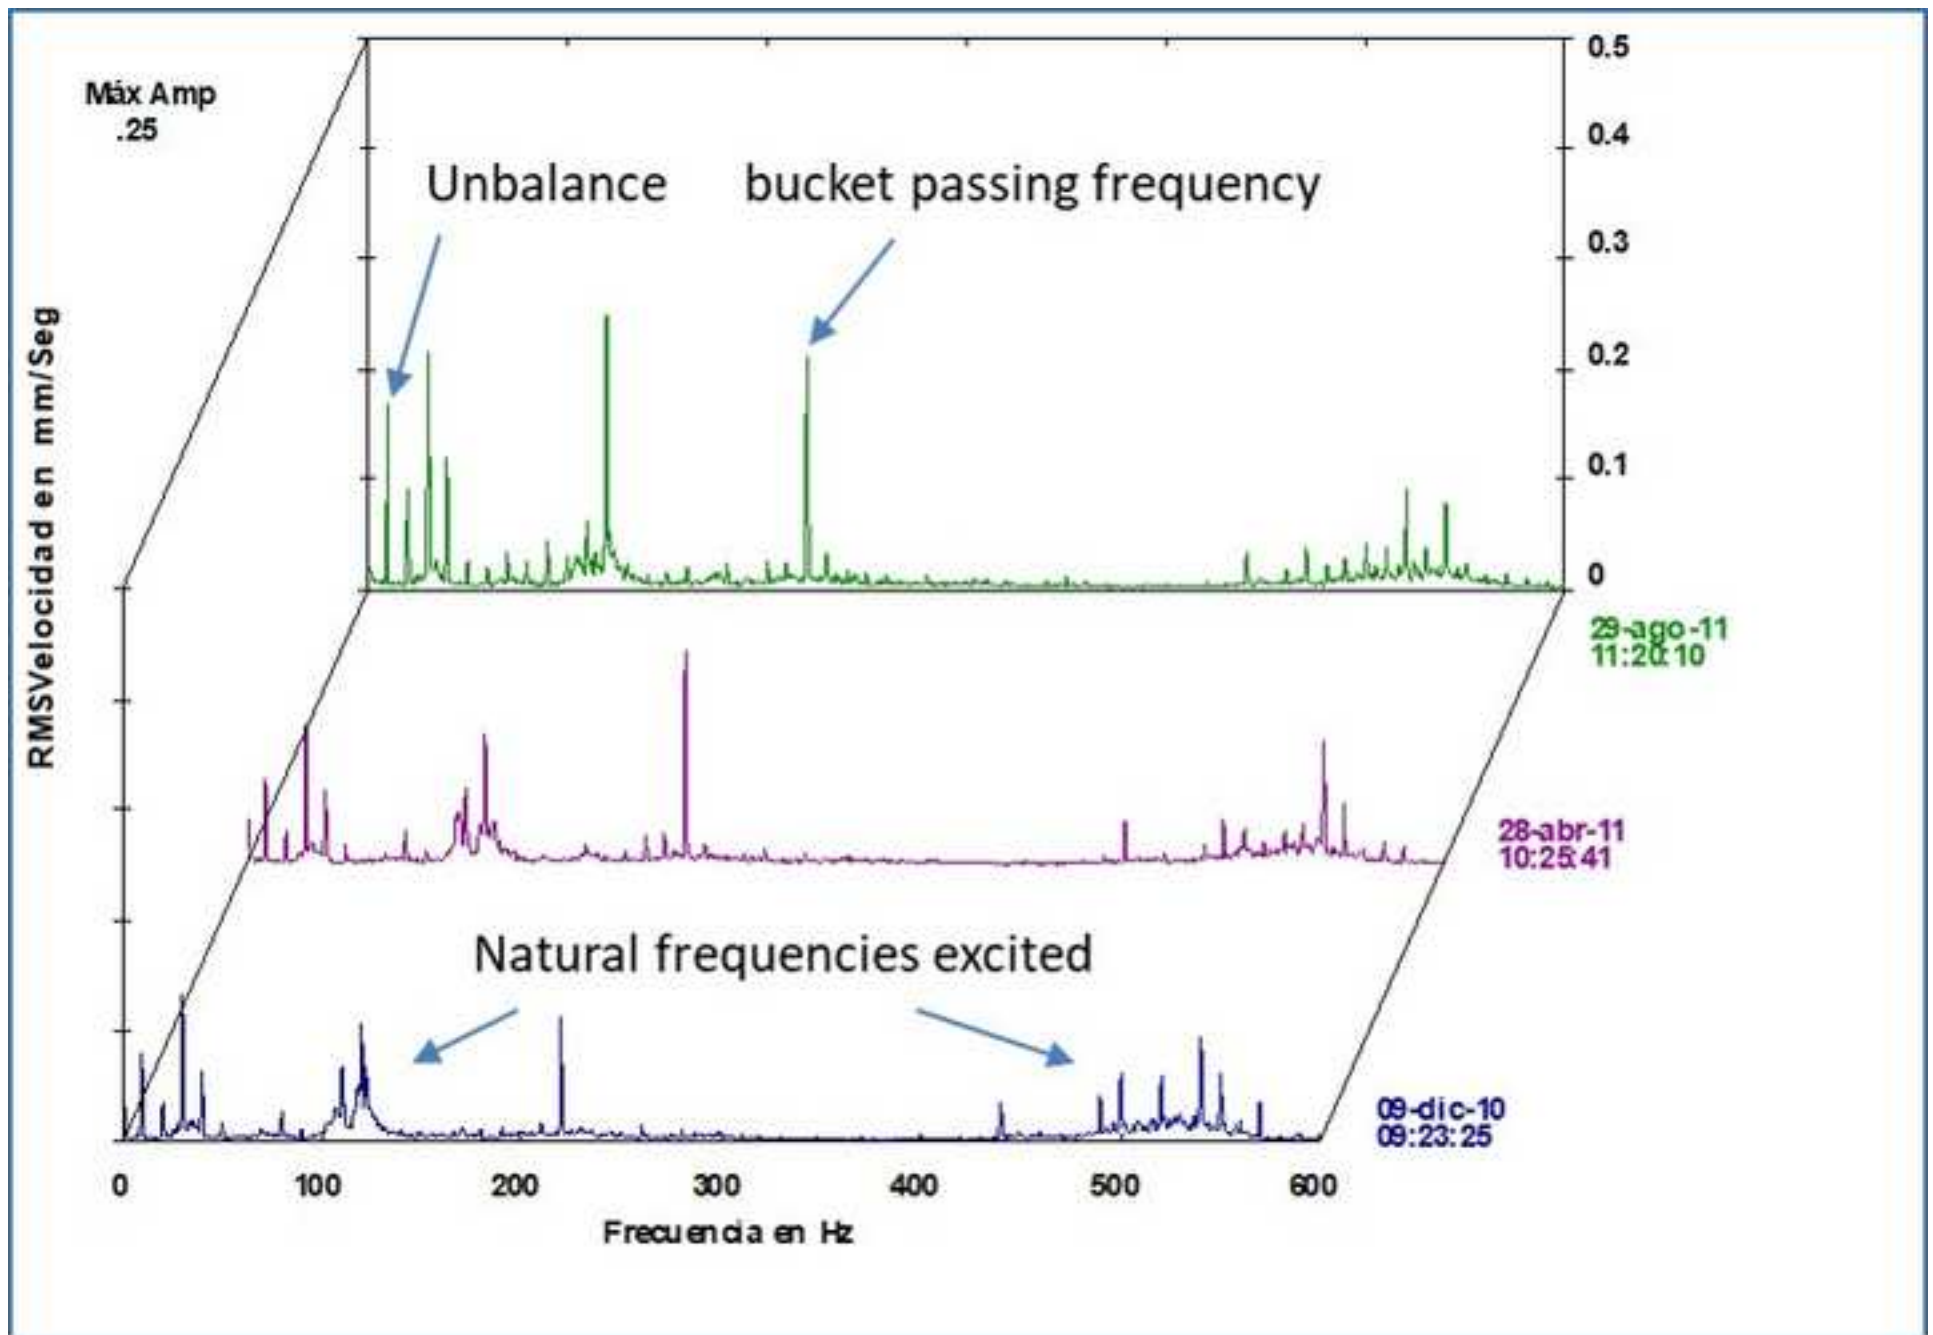
Figure11
[Click here to download high resolution image](#)

Figure 11. Vibrations measured during monitoring

In Figure 11, the vibration signatures of the Pelton obtained during vibration monitoring of the simulated turbine can be observed. The vibrations represented were measured in the radial turbine bearing on different dates. During the inspection of the unit, a few small cracks were found, as well as jet misalignment. In the measured spectra, synchronous vibrations generated by unbalance and the bucket passing frequencies can be identified. It can also be noticed that some natural frequencies of the system were excited.

The symptoms detected in the field data (Figure 11) come from the excitation of some natural frequencies at low regions and at a higher frequency span (500-600Hz). The model indicates that the former are rotor natural frequencies and the latter correspond to axial frequencies of the runner, which means the operation of the turbine is not as expected. To see the influence of jet misalignment on the runner vibrations, the response of the buckets, when the jet is aligned and misaligned, was computed (Figure 13). When the jet is aligned with the runner (machine in good condition), the force that is applied to the buckets is tangential and, consequently, the response of the buckets is in the same direction (tangential modes). In case of jet misalignment, rotor and axial bucket modes are also excited (which can be seen in the spectra), thus changing the stress distribution.

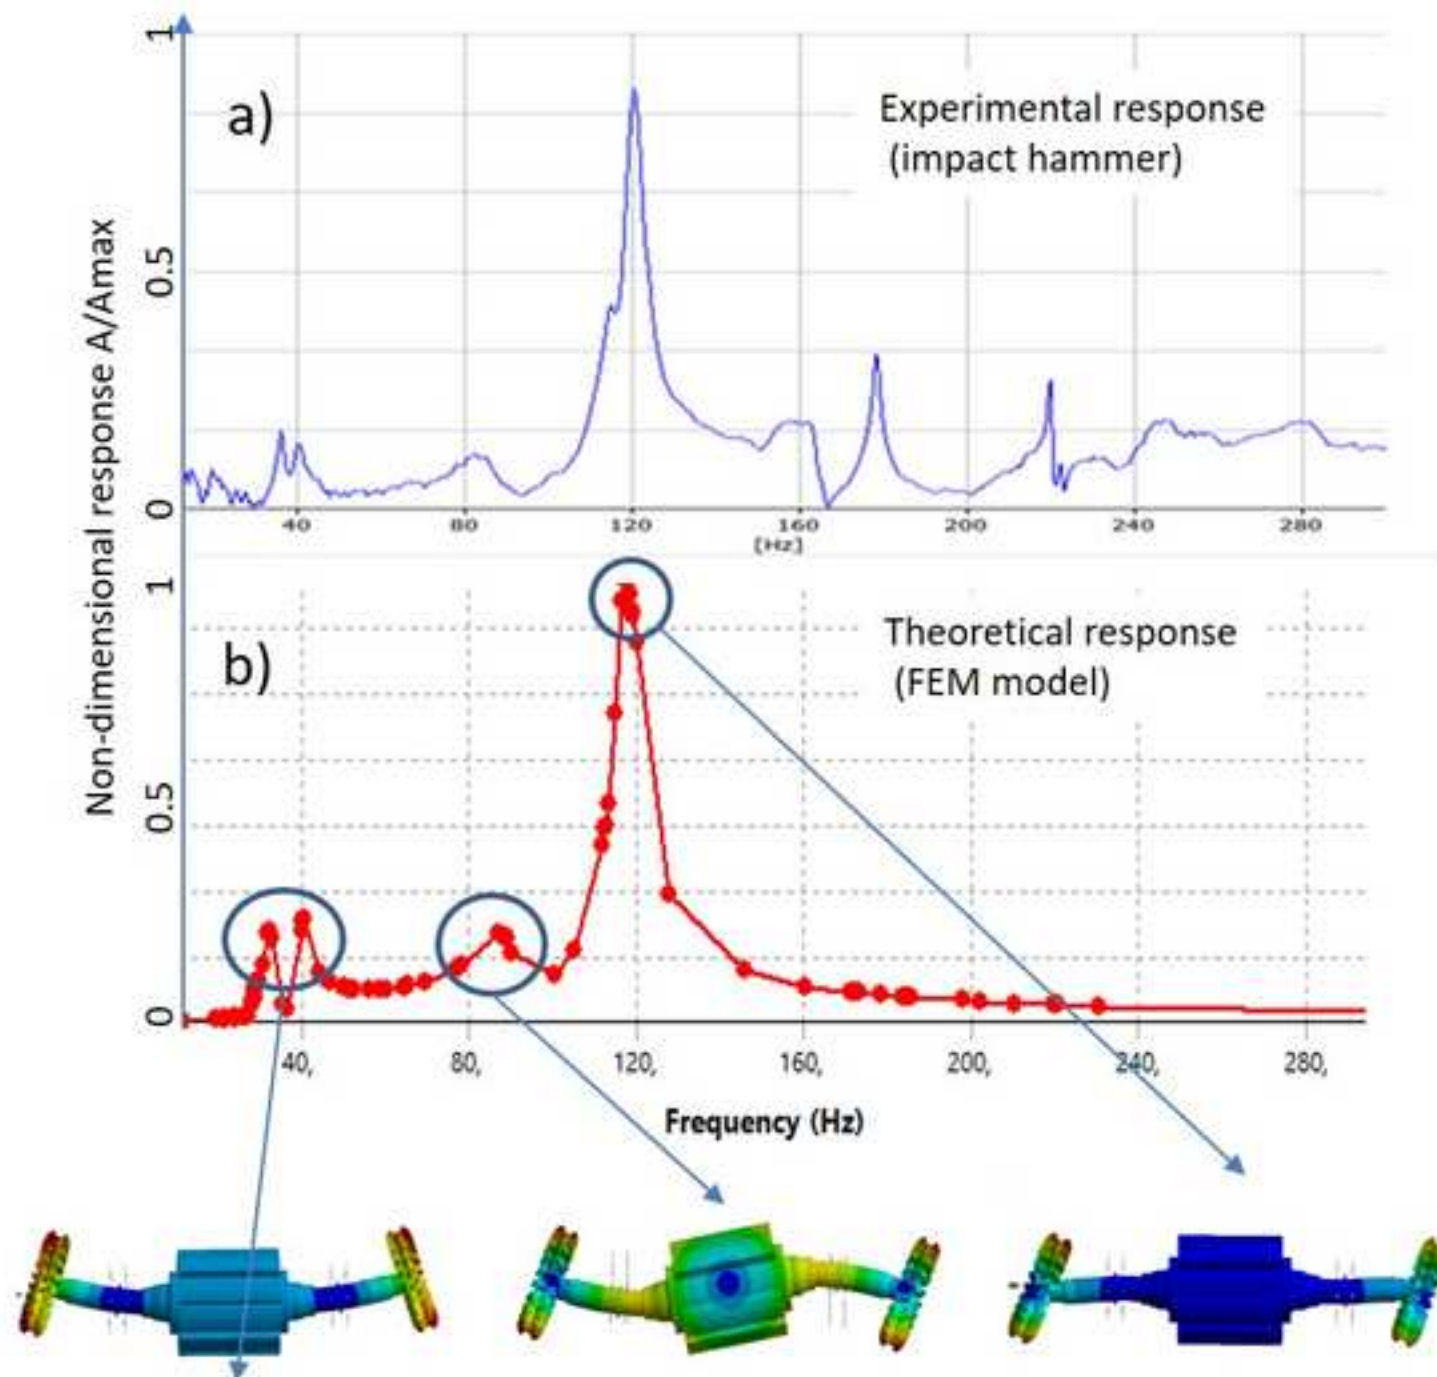
Figure12

Figure 12. Response in the radial bearing to the axial forces generated by the jet misalignment.

The next step consisted in reproducing the vibration behavior of this machine numerically, thus determining the effect of the jet misalignment. The results were compared with monitoring data to see how well the symptoms obtained in the field can be reproduced using the model. The axial force, produced by the jet misalignment, was applied to the numerical model (See Figure 8) and the response in the radial turbine bearing (monitoring position) calculated. In Figure 12, the response of the jet force on the monitoring position (radial bearing) has been represented for a frequency sweep between 0Hz and 300Hz. It can be seen that the maximum response produced by the misaligned jet in the bearing is at frequencies of 40Hz and 120Hz. These are natural frequencies of the rotor whose mode-shapes are represented in the picture.

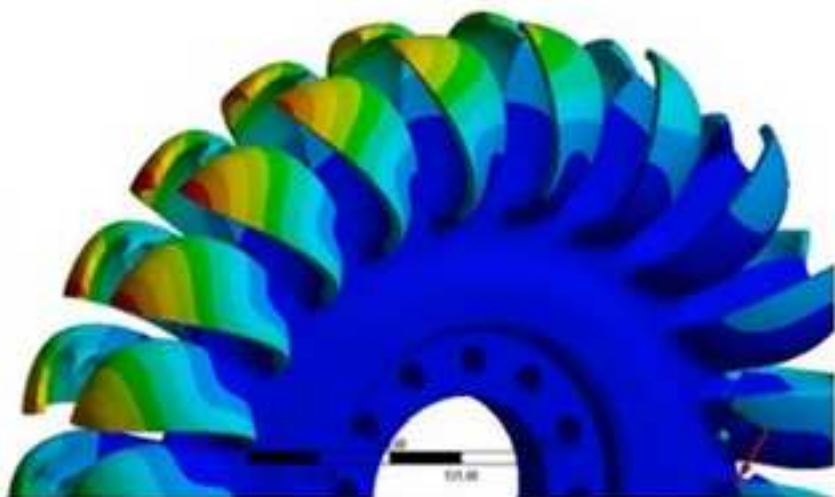
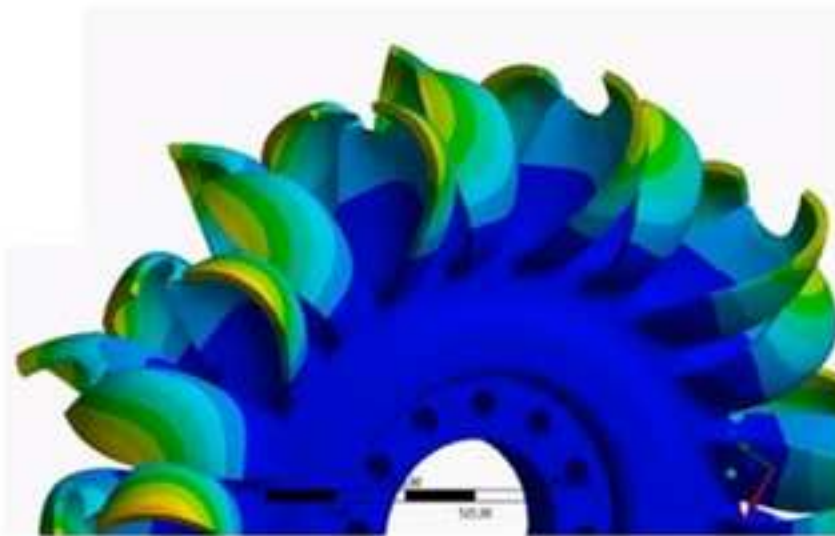
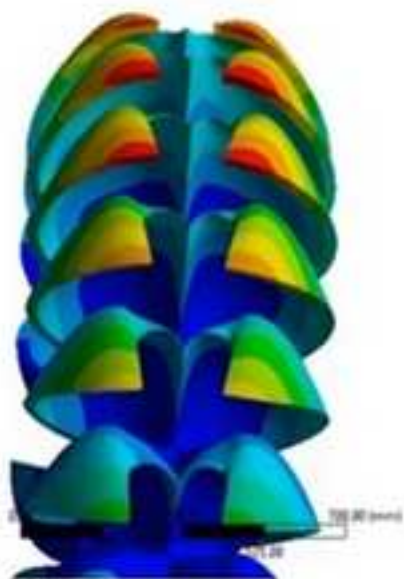
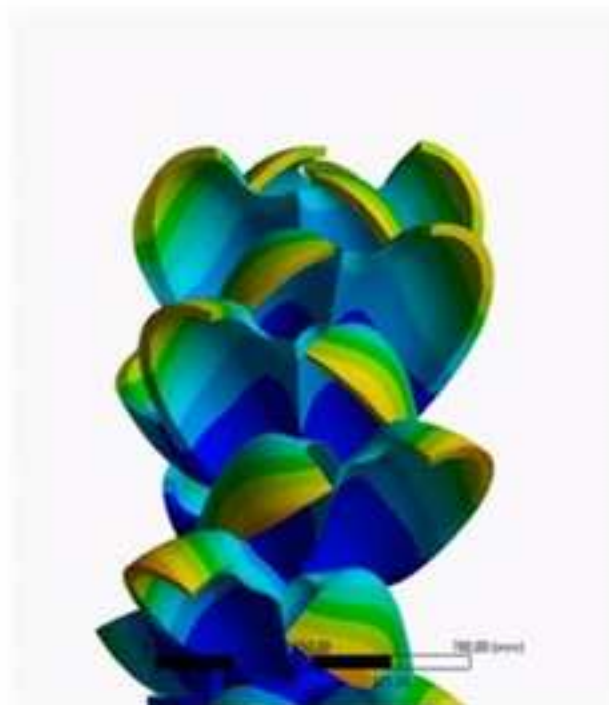
Figure13
[Click here to download high resolution image](#)

Figure 13. Deformation of the buckets a) With a centered jet b) With a misaligned jet

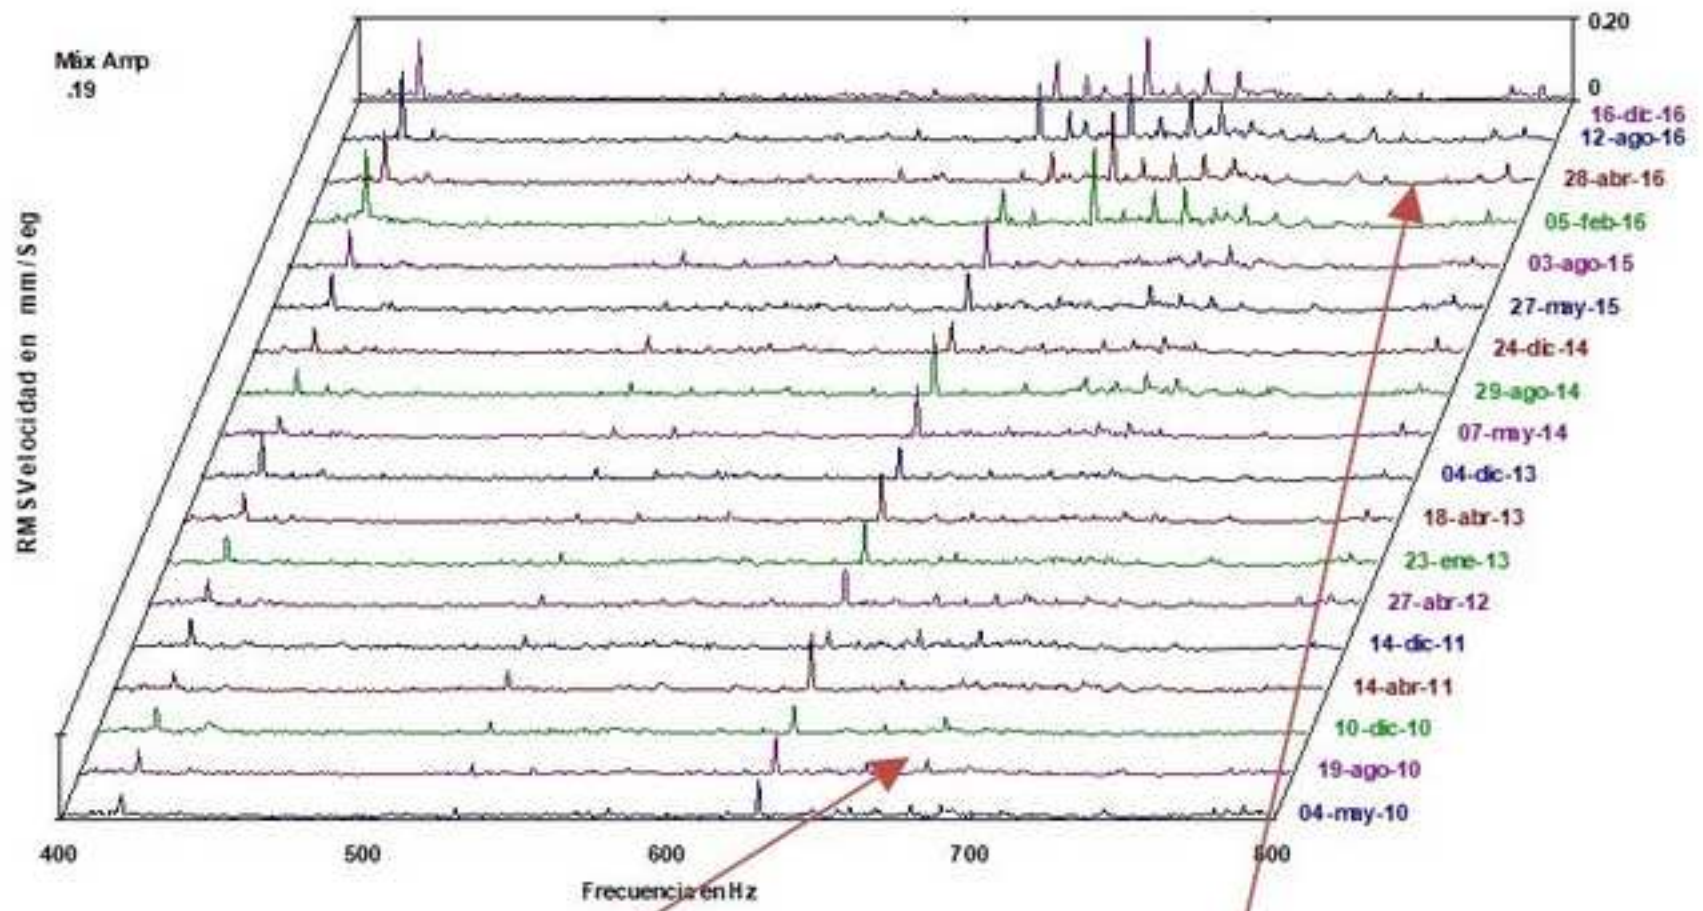
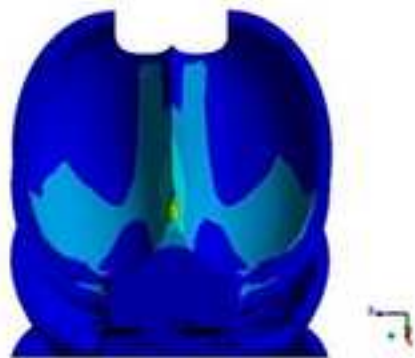
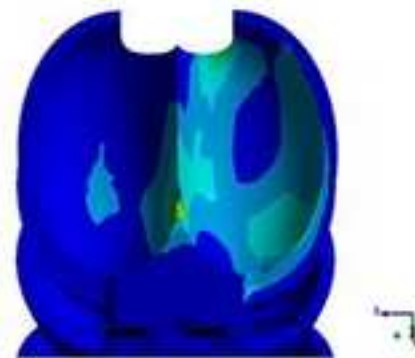
Figure14

Figure 14. Evolution of the vibration signatures in a Pelton turbine. The stress distribution for the runner excited without and with jet misalignment has been represented

Another case of incipient damage generated by jet misalignment in a Pelton turbine is shown in Figure 14. In August 2015 there was a change in the vibration signatures and the excitation of runner axial natural frequencies could also be detected.
