# AIRCRAFT ACCIDENT REPORT

Pan Alaska Airways, Ltd.

Cessna 310C, N1812H

Missing Between

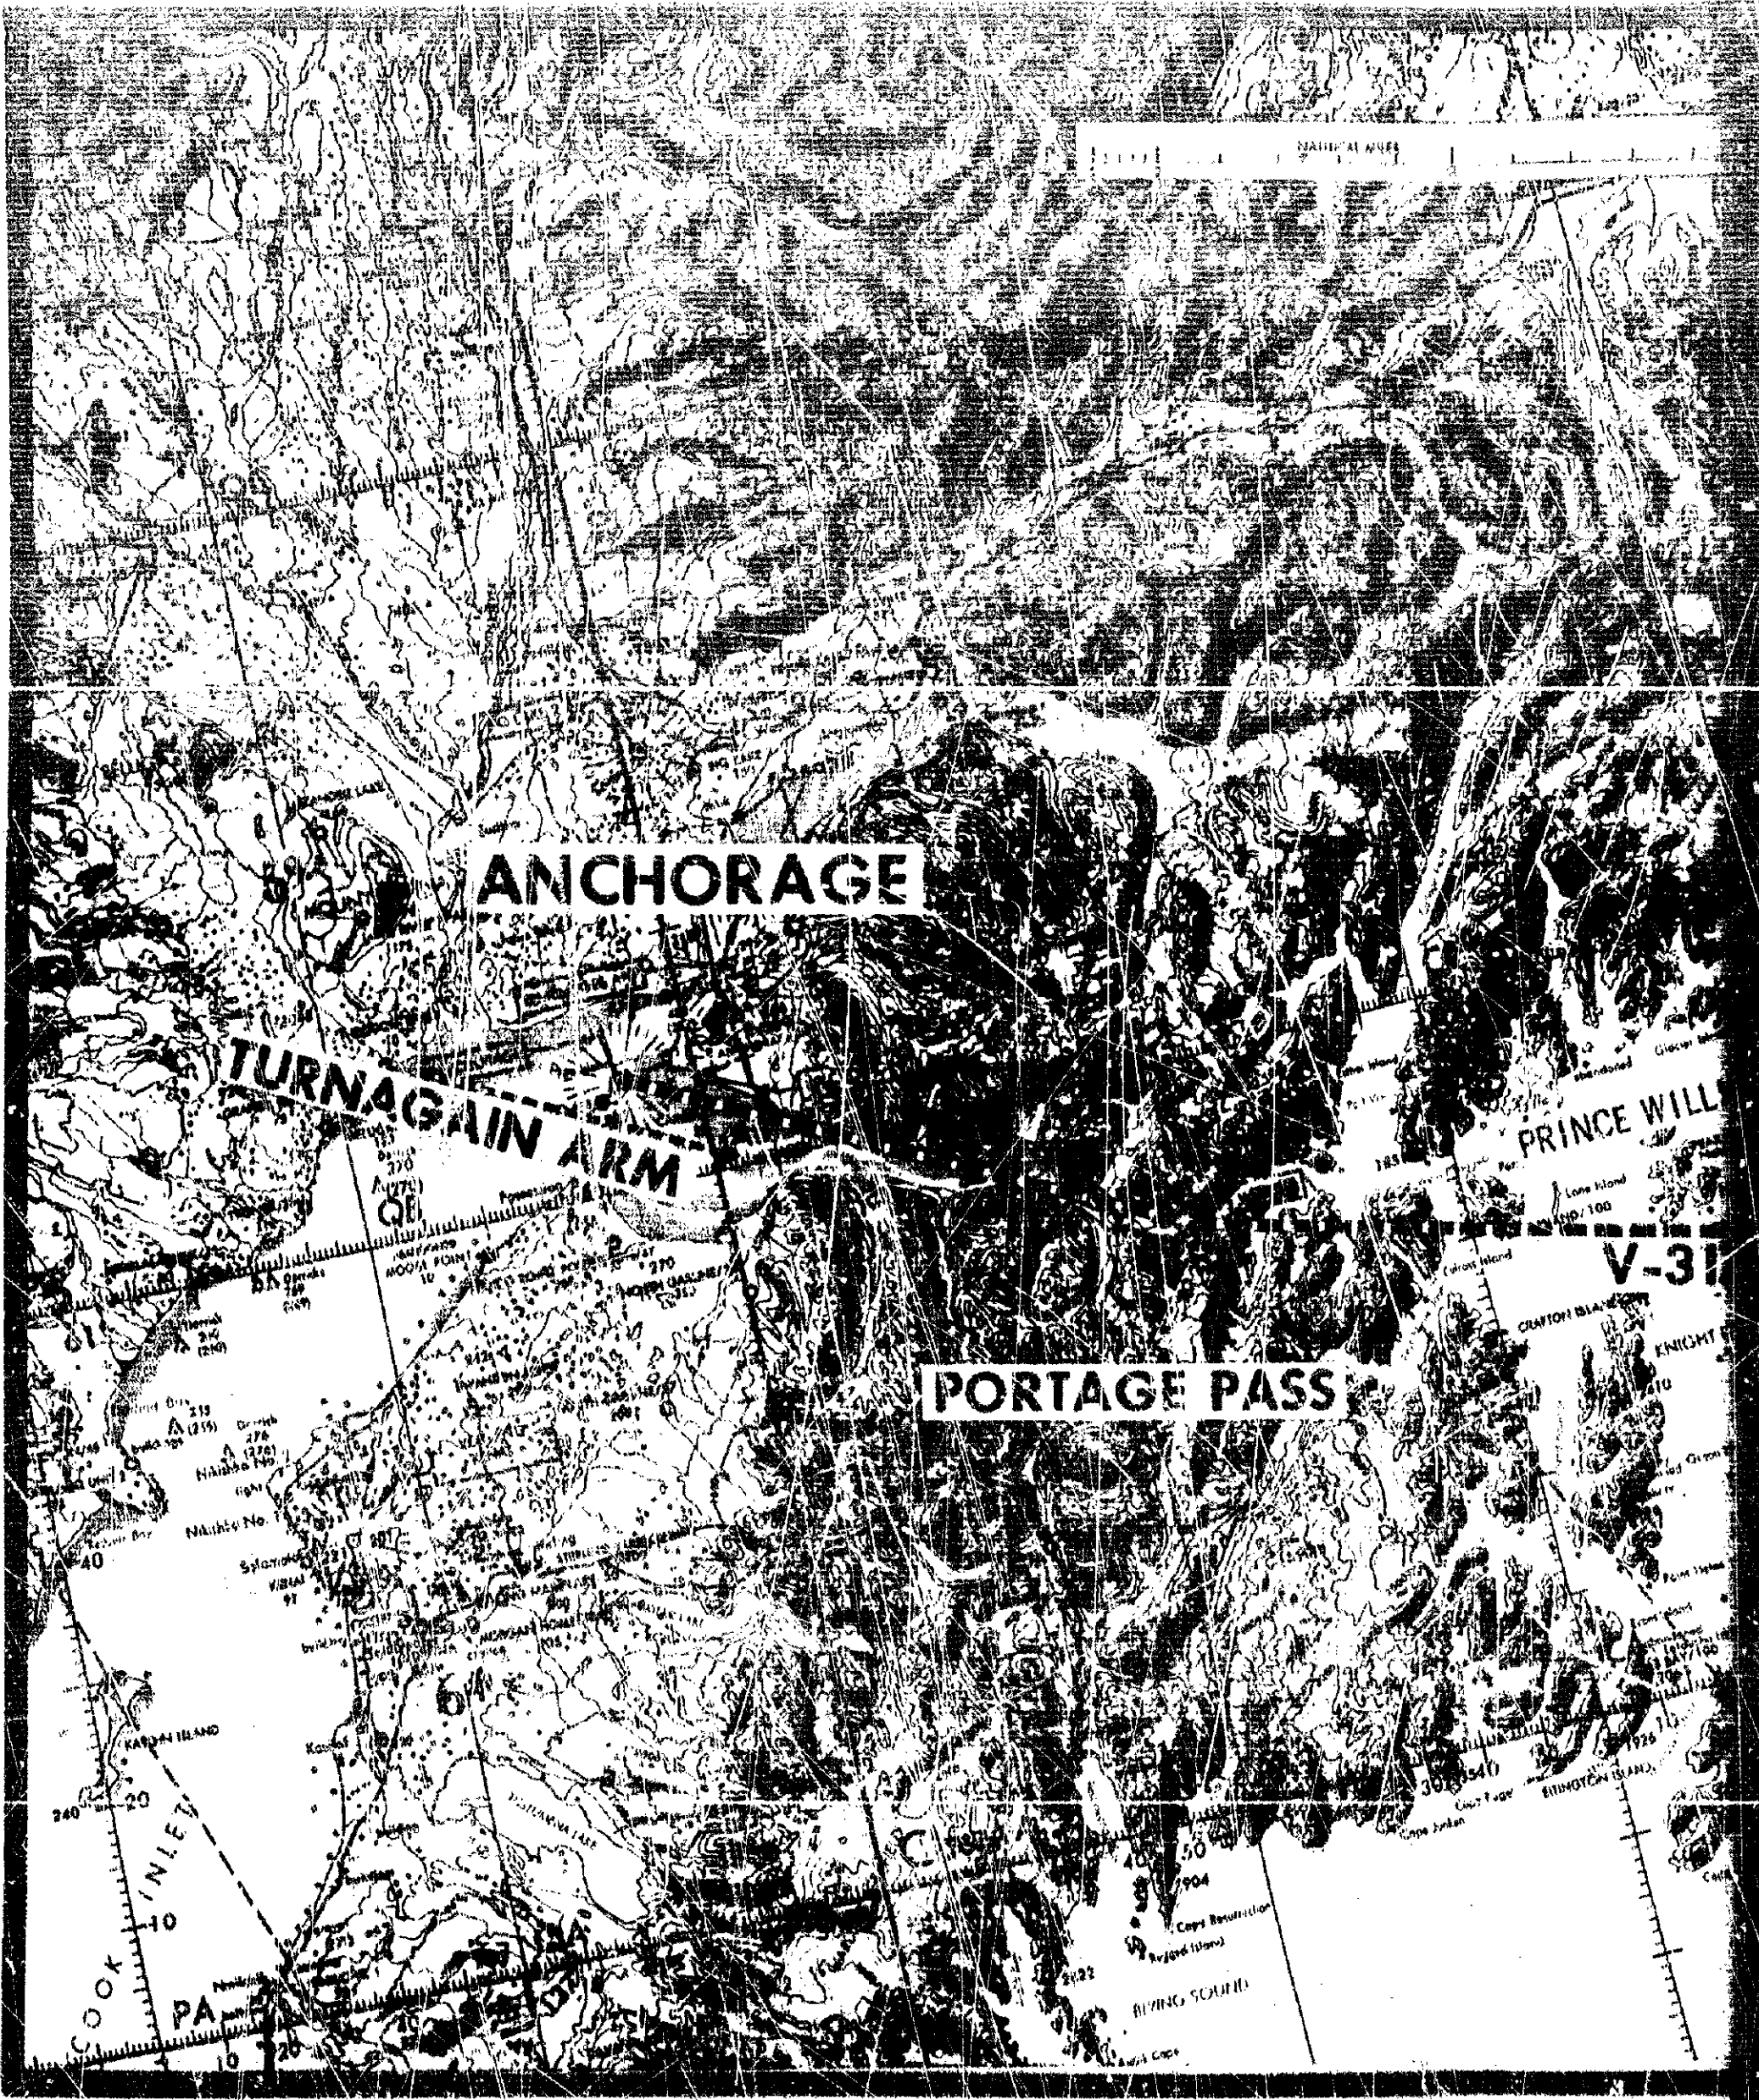
**ATTACHMENT I**

**CESSNA 310C**  
**MISSING BETWEEN ANCHORAGE AND CORDOVA**  
October 10, 1972
