NATIONAL TRANSPORTATION SAFETY BOARD

AIRCRAFT ACCIDENT REPORT

**GRAND CANYON AIRLINES, INC.,
AND HELITECH, INC.,
MIDAIR COLLISION OVER
GRAND CANYON NATIONAL PARK
JUNE 18, 1986**

NTSB/AAR-87/03

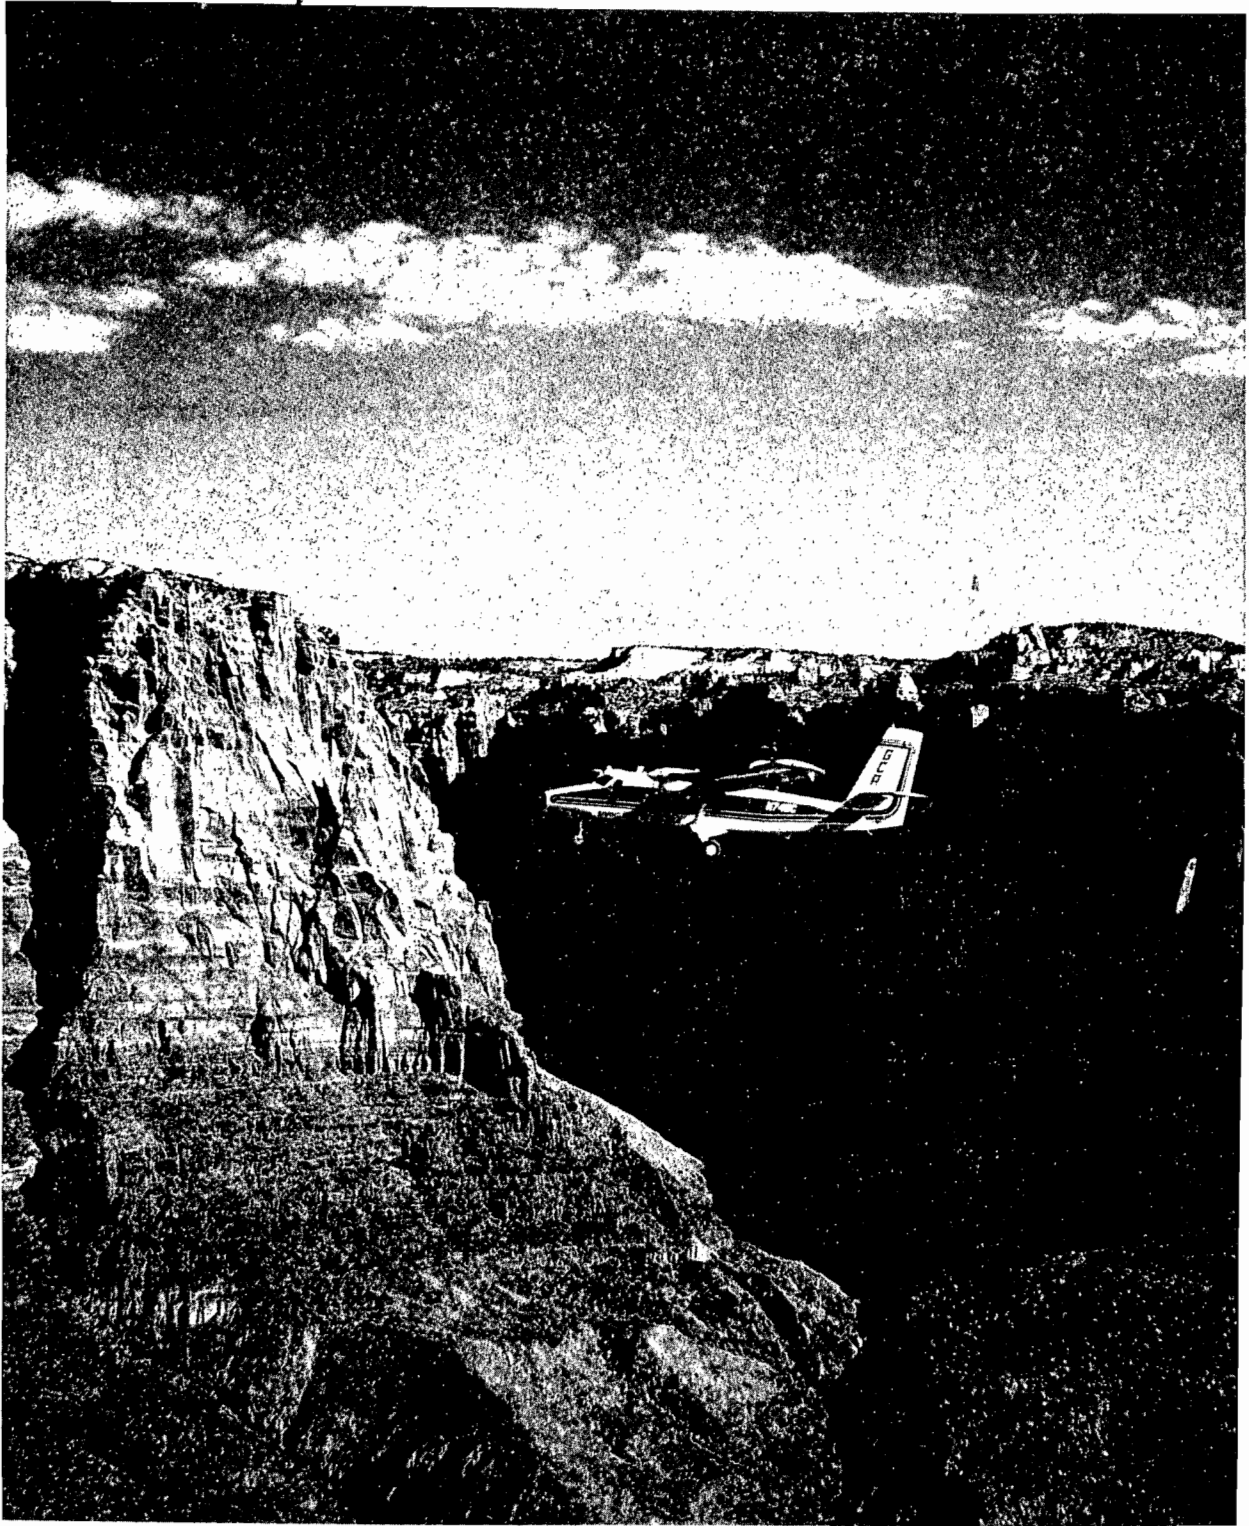
Figure 1.—Grand Canyon Airlines DHC-6.

The DHC-6-300, Twin Otter, United States Registry N76GC, was operated by Grand Canyon Airlines and was configured for a flightcrew of 2 and 19 passengers. (See appendix C.) The airplane was modified in March 1982 with larger than standard windows in the passenger compartment under Federal Aviation Administration (FAA) approved Supplemental Type Certificate (STC) No. SA1814NM. The airplane was equipped with two Pratt and Whitney of Canada PT6A-27 powerplants, each with a three-blade, Hartzell, constant-speed propeller. The airplane was painted with an overall beige paint scheme with horizontal dark brown, gold, and blue stripes. (See figures 1 and 2.) The stripes were about the same width for the length of the fuselage. The brown was 24 inches wide, the gold was 6 inches wide, and the blue was 3 inches wide. The stripes tapered gradually along the rear fuselage and swept upward along the rudder and then forward near the top of the vertical stabilizer.

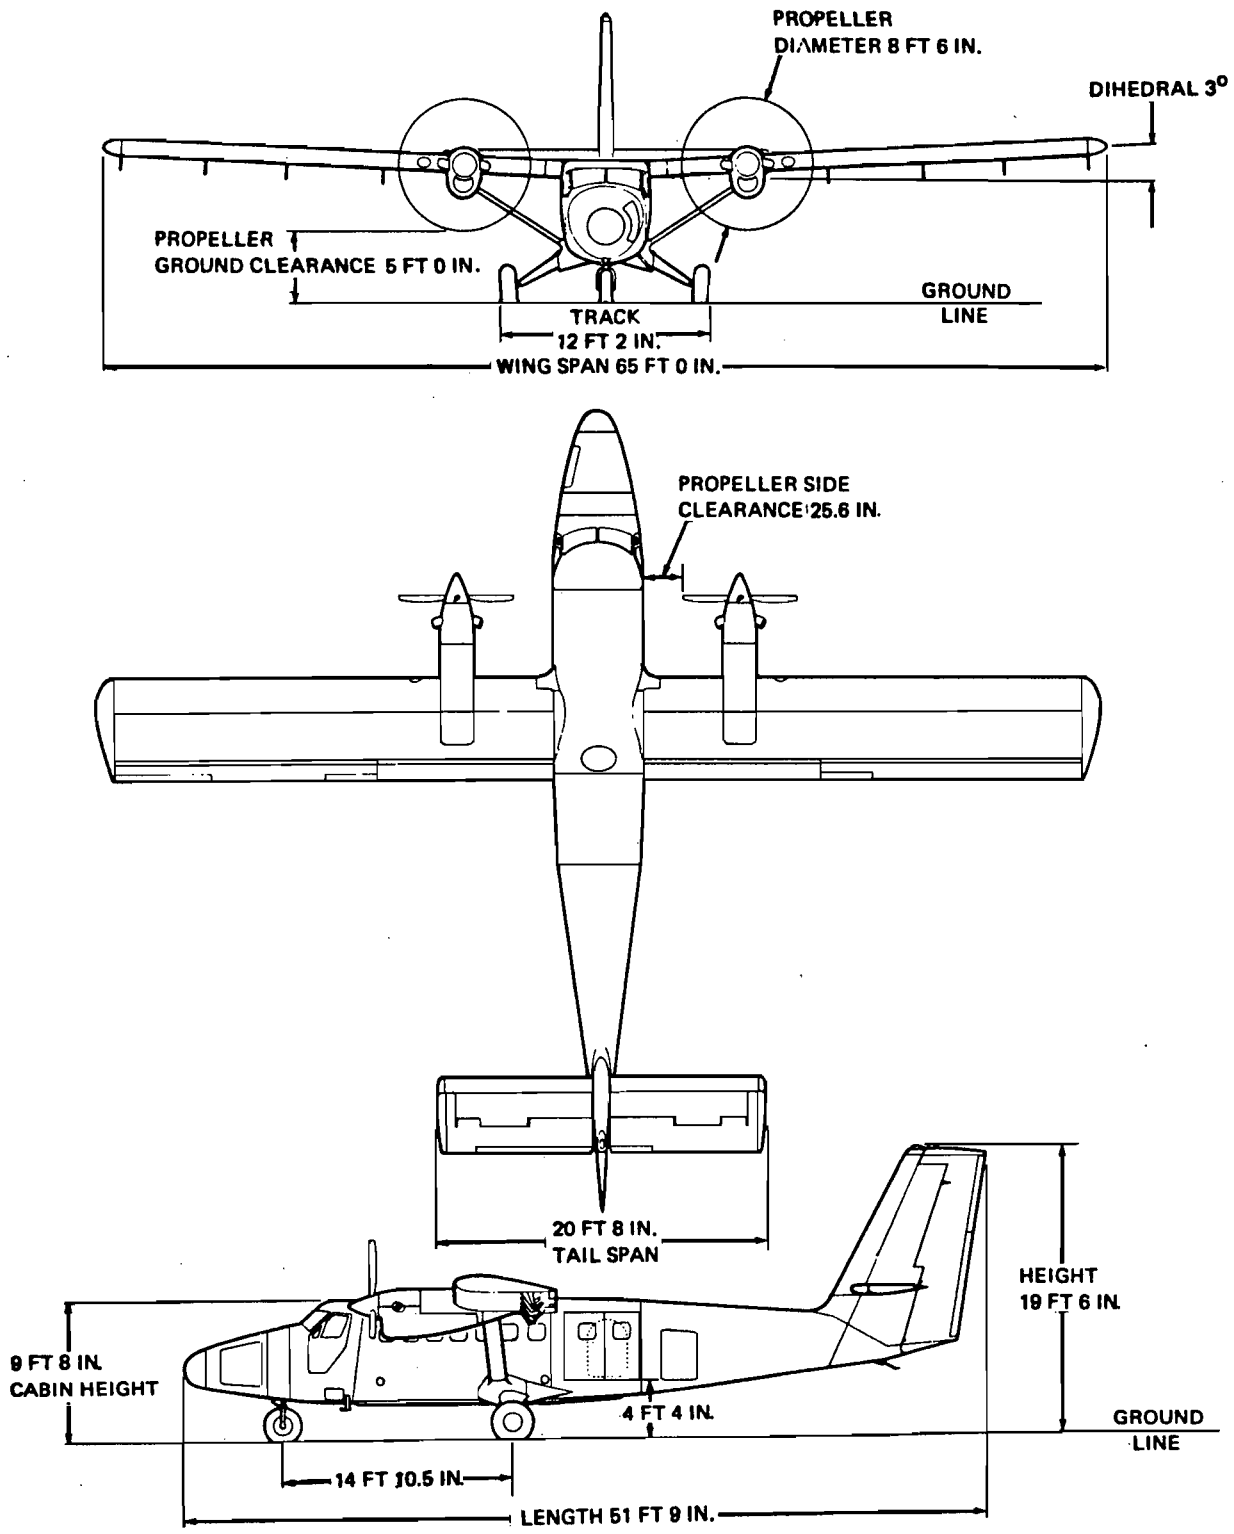
Aircraft Dimensions

Figure 2.--Aircraft dimensions -- the DHC-6-300.

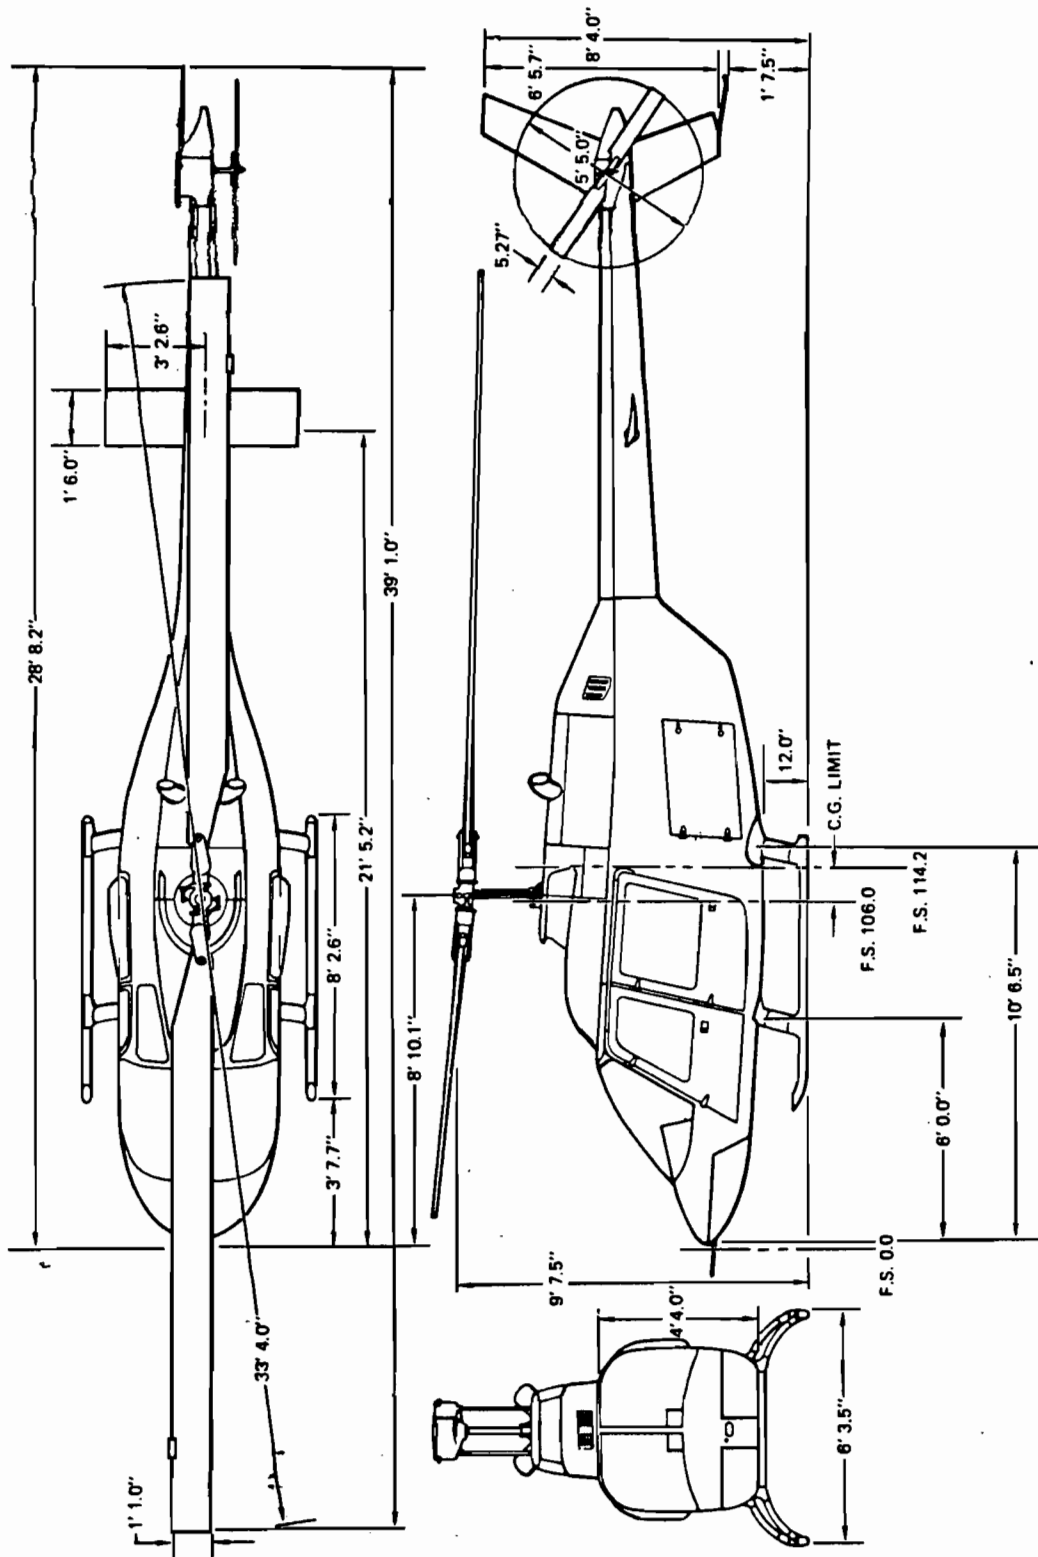
Figure 3. Aircraft dimensions—the Bell 206B.

The Bell 206B III, Jet Ranger, United States Registry N6TC, was a single-engine, utility-type helicopter. It was configured for a pilot and one passenger in the front seats and three passengers in a rear bench-type seat. It was equipped with an Allison 250-C20B powerplant, a two-blade main rotor and a two-blade tail rotor. (See figure 3.) The aircraft was painted white and yellow with yellow the predominant color of the passenger cabin. The main rotor color was gray and the tail rotor was mostly red.
