Advanced European Infrastructures for Detectors at Accelerators

Journal Publication

Module production of the one-arm AFP 3D pixel tracker

Grinstein, S. (Barcelona, IFAE) et al

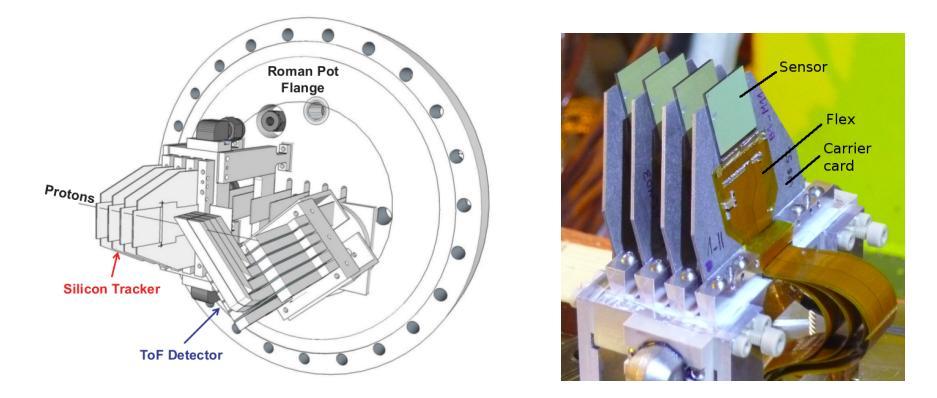
Figure 1. Design of the AFP detector including tracking and time of flight systems (left). The diffractive protons arrive from the left. The tracker modules mounted in the support frame (right). In this picture the slim edge side is facing up.

As already mentioned, the one-arm AFP system consists of two tracking stations placed in Roman Pots at 205 m and 217 m from the IP, that approach the beam horizontally. Each station is composed of four pixel modules arranged such that the short pixel direction of the sensor is horizontal to the LHC floor. Each module includes a 3D sensor interconnected to a single FE-I4B front-end chip, glued to a support holder and wire-bonded to a flexible printed circuit (referred to as flex). The modules are placed with a pitch of 9 mm and tilted by 14° with respect to the beam direction, to enhance hit reconstruction efficiency and horizontal position resolution (see figure 1).

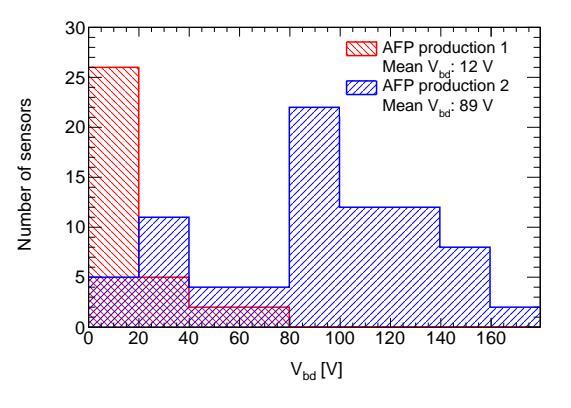
Figure 2. Break down voltage of 3D sensors from the first and second AFP productions.

Due to the low yield of the first AFP sensor production, CNM launched a second run (7945) after improving the fabrication process. The edges of the wafers were protected during the DRIE and the process parameters were optimized to reduce damage to the column sidewall. To refine the sensor selection process, the second production included a temporary metal layer that connected all the pixels. In combination with the pad of the 3D guard ring, the metal layer allowed an accurate determination of the I-V curve. The layer was removed before dicing by chemical etching. The second production finished in March 2016, with a distinctly improved yield: only 2 of the 12 wafers were lost during fabrication, while 68 of the 80 remaining sensors were of green quality. Table 1 summarizes the yields of the two AFP production runs while figure 2 compares the break down voltages.
