**MOBILE CT-SYSTEM FOR IN-SITU INSPECTION IN THE LHC AT CERN**

C. Sauerwein, V. Haemmerle, I. Tiseanu  
RayScan Technologies GmbH, Meersburg, Germany

L.R. Williams, F. Caspers, J.M. Dalin, J.P. Tock  
CERN, Geneva, Switzerland

Presented at the 1st International Particle Accelerator Conference (IPAC'10)  
23-28 May 2010, Kyoto, Japan

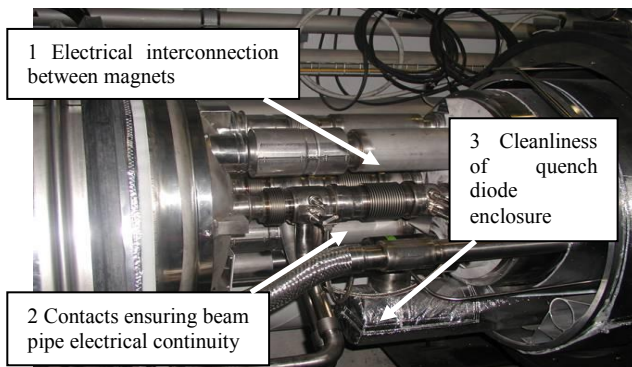
Figure 1: An open interconnect zone between superconducting magnets and the 3 areas of interest requiring periodic non-invasive inspection.

Within the interconnect zones between the main ring superconducting magnets, three areas of interest have been identified as requiring non-invasive inspection to ensure operational reliability (Figure 1).

Any debris that, despite the precautions taken, may remain inside the magnet from the manufacturing processes will tend to be displaced during initial cooling to a diode end box (see Figure 1). On rare occasions this accumulated debris, sometimes metallic, has reduced the insulation resistance of the diodes to ground. The X-ray tomograph will allow pictures of the contents of the diode box in particular where debris is known to accumulate, to be obtained non-invasively.

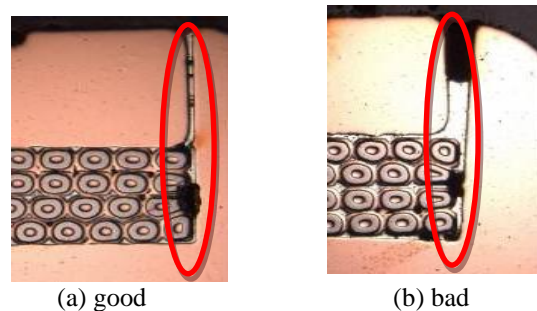
Figure 2: Macrographic Cross Section of Samples of a Cable Junction Box.

Although tight controls have systematically regulated the soldering process, the absence, or insufficiency, of tin/silver alloy in the junction was nowhere reliably detected. The images in Fig 2 show macrographic cross sections of (a) a cable junction box containing adequate alloy and (b) a junction box either severely deformed or containing inadequate alloy, where gaps between the junction box components have not been completely filled by capillary action.

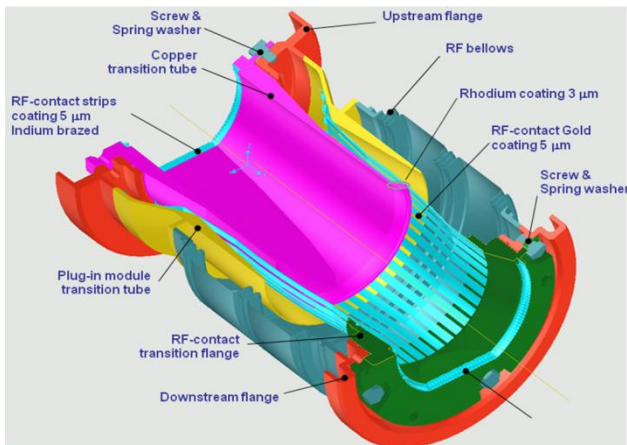
Figure 3: The PIM with its gold-coated RF contact fingers.

It is of vital importance that the electrical continuity of the beam pipes in which the particle beams circulate, is maintained across all the interconnect zones as electrical discontinuities lead eventually to instabilities in the circulating charged particle beams. During interconnection two elements called Plug-in Modules (PIM) (Figure 3) are inserted, one in each beam tube. To bridge from one magnet to the next and ensure the beam-pipe electrical continuity, these PIM are furnished with a complete ring of gold-coated RF contact fingers.

The PIM, has been designed to accommodate thermal contractions of the order of 50 mm, due to refrigeration from room temperature to 1.9K and occasionally, expansions due to warming from 1.9K to room temperature of the LHC main ring magnets.

The PIM lengthens during magnet cooling, and the elastic contact fingers are loaded as they slide under tension. During warm-up the reverse occurs, the PIM shortens and the sliding contact fingers are then loaded in compression leading to a potential buckling failure mode. If a partial warm-up of part of the accelerator is required then the X-ray tomograph may be used in the interconnect zones to obtain non-invasive pictures of the warmed PIMs to verify their integrity.

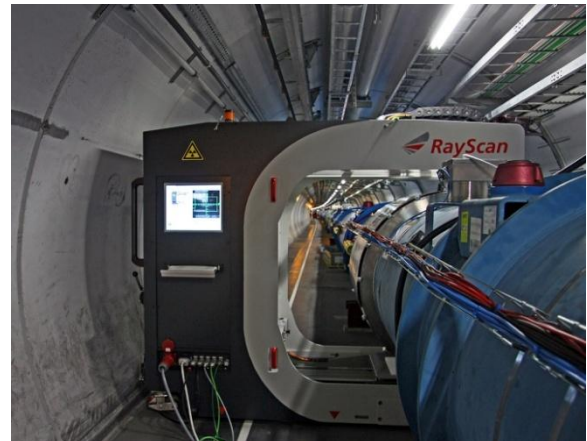
Figure 4: The RayScan Mobile X-ray Tomograph in operation at the LHC.

Ordered by CERN, RayScan Technologies GmbH has designed a mobile X-Ray Computed Tomography (CT) System (the RayScan Mobile) to carry out the inspection tasks described above within the tight space constraints imposed by the LHC tunnel. The RayScan Mobile is shown in Figure 4 in its operational position at an interconnect zone between two main-ring magnets of the LHC.

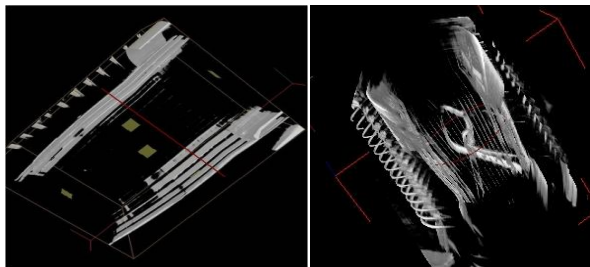
Figure 5: Plug-in module, sectional 3D display good (left) and damaged (right).

The position and shape of all the gold-coated RF contact fingers inside the plug-in module was determined as shown in Figure 5.

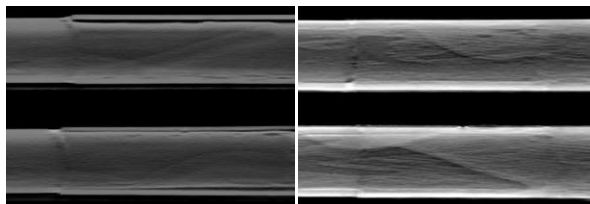
Figure 6: Left: 2D layer coplanar with copper surface of cable junction. Right: 2D layer coplanar with superconducting cables.

Some of the results of the 3D inspection of the 6 electrical interconnections between magnets are shown in Figure 6.

The left image in Figure 6 is a 2D layer from the reconstructed 3D volume that is coplanar with the top surface of the upper copper profile of the cable junction

box is shown. A minor defect in the soldering process has generated local unfilled longitudinal gaps between the cable junction box components. The right image in Figure 6 also shows a 2D layer from the reconstructed 3D volume that is situated a few millimetres lower, at the interface between two superconducting cables. We see therefore the twist-pitch of the super-conducting cable and some minor imperfections in the horizontal solder filling between these cables.
