The Compact Muon Solenoid Experiment

CMS Note

Performance Testing of the CMS Cathode Strip Chambers

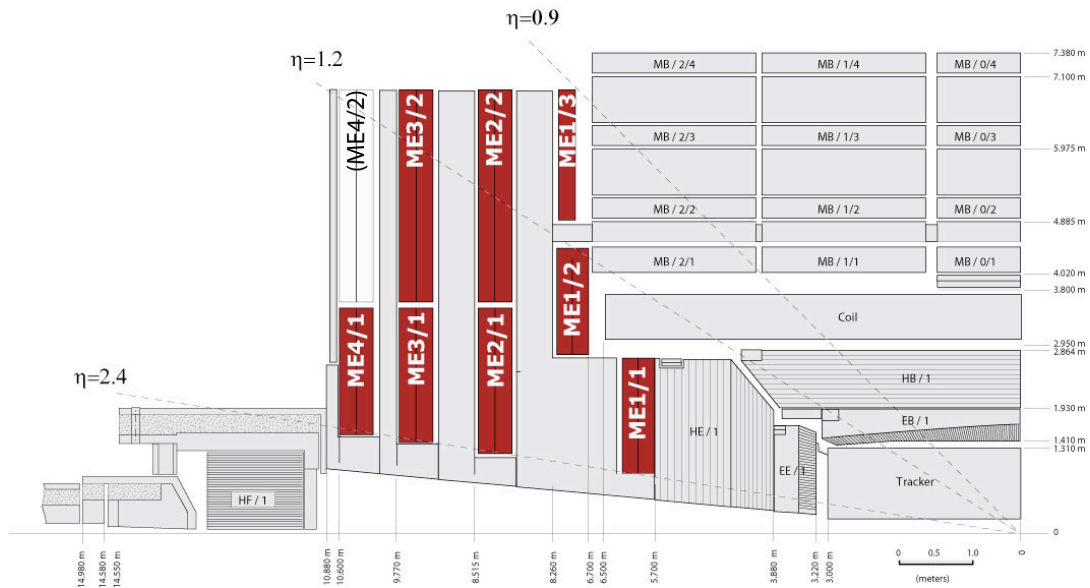
Fig. 1. Cross-sectional view of the one quadrant of the CMS detector.

The descoped version of the EMU detector consists of 468 six-layer CSCs currently installed on the endcap disks (the original design consisted of 540 chambers). They are arranged in 4 stations of concentric rings in both endcaps (Fig. 1). Seven different types of CSCs are used in the system, designated as ME1/1, ME1/2, ME1/3, ME2/1, ME3/1, M4/1, and ME234/2, where the first number stands for a station and the second for a ring within a station. All chambers except ME1/1 are of a similar design—they differ only by size. The special design of ME1/1 is dictated by the strong, non-uniform magnetic field and the high level of radiation expected at their location.

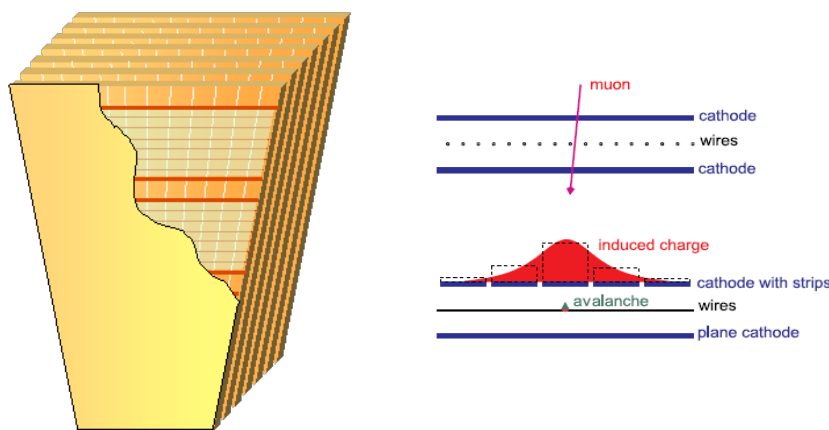
Fig. 2. CSC cross-section and principle of operation.

Each CSC is built from commercially made copper-clad honeycomb panels cut into a trapezoidal shape [2]. A stack of 7 panels, separated by 9.5-mm-wide FR-4 (“Flame Retardant 4” circuit board material) bars glued on the edges of every other panel, creates 6 independent gas gaps (planes) each between 2 copper cathode surfaces (Fig. 2). The stack is secured with bolts through the panels around the chamber perimeter. Gas tightness is provided by assembling the chamber with o-rings around bolts and room-temperature vulcanizing (RTV) silicone sealant that is applied to the perimeter of the contact area of the spacer bars and the panels. Operation gas flows in a zigzag path from the first plane to the last one through holes made in the panels.

One of the 2 cathodes in each plane is divided into strips milled radially along the longer dimension, with the width of each strip increasing along the radius. To achieve improved spatial resolution from a 6-layer chamber, strips in adjacent planes are staggered by $\frac{1}{2}$ of a strip width. The ME1/2, ME2/1, ME3/1, ME4/1, and

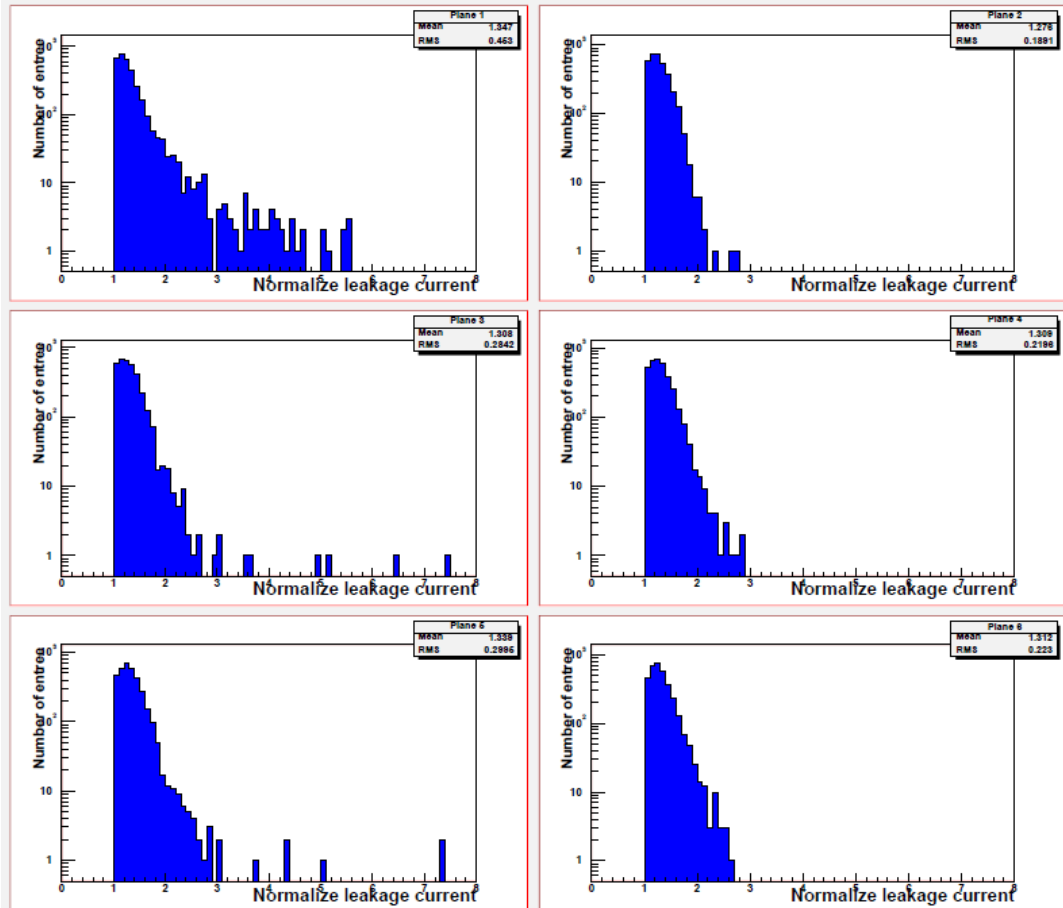
Fig. 3. Leakage current variation in the planes of the ME234/2 CSCs. The results were normalized to the smallest current in a plane.

The next step in the CSC quality control test sequence was a long term HV test. The chambers were flushed with working gas mixture and held for 1 month under 3 sequential HV values corresponding to the beginning, middle point, and end of the efficiency plateau. No noticeable change in measured current, which was usually less than 100 nA, was observed compared to the initial HV tests at the production sites. However, a short-term increase in leak current was observed. We regard this

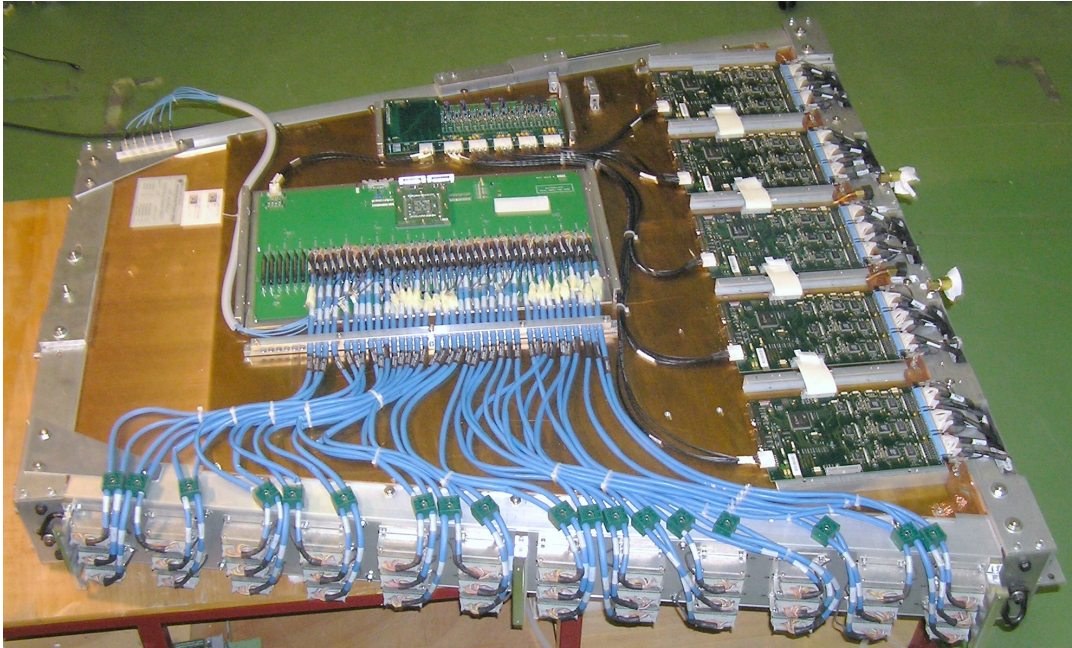
Fig. 4. Assembled ME2/1 chamber showing on-chamber electronics.

The CSC on-chamber electronics consists of anode front-end boards (AFEB), cathode front-end boards (CFEB), and an anode local-charged track trigger board (ALCT) that generates muon trigger primitives for the Level-1 trigger system based on wire hit information (Fig. 4). A low voltage distribution board (LVDB) delivers the voltages necessary for the on-chamber electronics. The CFEBs, ALCT, and LVDB are mounted with good thermal contact on a copper cooling plate, which is attached on the front surface of the chamber. The cooling plate is cooled with a pressurized water system. The CFEBs are mounted as close as possible to the output strip connectors and attached to them with short input cables. The AFEBs are attached to the side of the CSC and connected to the ALCT by cables. The raw data and the trigger information from the CFEBs and the ALCT board are sent by skew-clear cables to a data acquisition motherboard (DMB) and a trigger mother board (TMB), which are located in a peripheral VME crate. Monitoring information about the output voltages and currents of the LVDB is provided by a low voltage mezzanine board (LVMB), which is mounted on the LVDB and sends the data to the DMB.

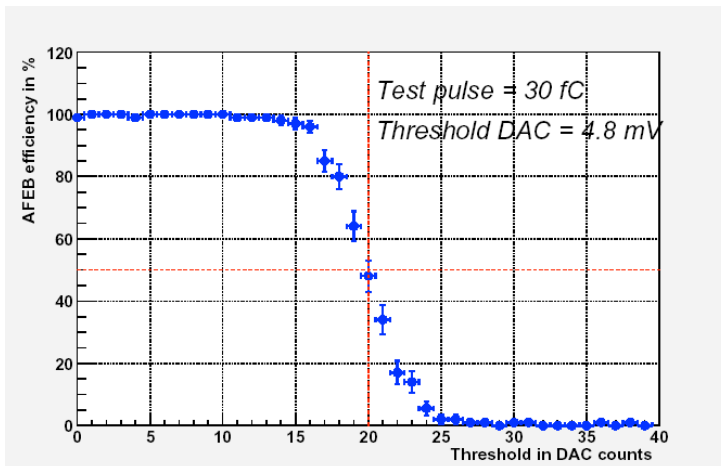
Fig. 5. AFEB channel efficiency for 30 fC test pulse versus applied threshold.

An anode front-end board has one 16-channel ASIC: an amplifier combined with a constant-fraction discriminator that has 30-ns shaping time, 8-mV/fC sensitivity, 1.5-fC noise at 150-pF wire group capacitance, and a tunable threshold nominally set at 20 fC. The AFEBs were checked and certified on a quality control stand [8], where the most critical parameters of individual channels such as the input capacitor value for a test pulse and the gain were carefully measured and stored into the CMS database. Testing of the anode wire electronics started with measuring the thresholds and analog noise of individual channels. Calibrated test pulses of 30 and 50 fC were generated by the ALCT and injected into the inputs of AFEB amplifiers. For each test pulse a scan over the AFEB thresholds was made. An example of AFEB channel efficiency versus applied threshold for the 30 fC test pulse is shown in Fig. 5. The efficiency was fitted by complementary error function (*erfc*). The DAC value with 50% channel efficiency was regarded as the threshold corresponding to the injected charge.

The channel analog noise is defined by the sharpness of the turn-off curve. The nominal thresholds corresponding to 20-fC signals were found by a linear extrapolation of the thresholds found for 30- and 50-fC signals versus DAC values. Since the 16 channels of 1 AFEB use a common threshold, the threshold variation among channels and their offsets and slopes were carefully monitored. Fewer than 10 boards were replaced because of an unacceptable noise level or a threshold offset.

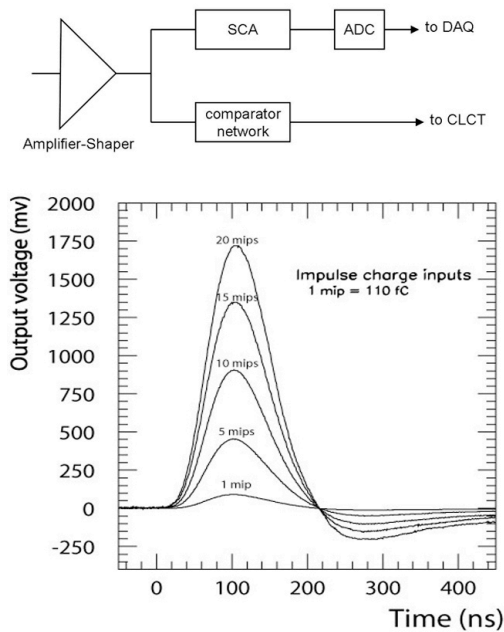
Fig. 6. Diagram of the cathode readout paths and examples of the shape of the Buckeye amplifier signal.

The cathode front-end boards are comprised of an amplifier chip, comparator circuitry for half-strip position resolution, and waveform digitizing circuits (Fig. 6). The “Buckeye” amplifier chip [9] has 100-ns shaping time and 1-mV/fC linear sensitivity up to 1 V. The equivalent noise level at the nominal strip capacitance of 300 pF is typically 1.5–2 fC. The outputs are split into 2 pathways. One goes to the comparator ASIC chip, which identifies the position of muon hit at the trigger level with a half-strip resolution. The other pathway leads to the switched capacitor array (SCA) ASIC chip, a randomly-addressable analog memory chip that samples the signal waveform every 50 ns and stores these analog data for readout. During the

The test of the comparator readout path (Fig. 6) involves measurements of each comparator threshold, noise, and output signal timing. The comparator thresholds and noise levels were found by making a scan over the external threshold at 2 sequential test pulse amplitudes (15 and 40 fC). As in case of the AFEB, the sharpness of the comparator response turn-off curve characterizes the noise value. The DAC value at the 50% efficiency point of the comparator response defines the threshold corresponding to the injected charge. The parameters of a linear fit of the thresholds corresponding to 15 and 40 fC injected charge defined the slopes and offsets of comparator signals, which were also monitored.

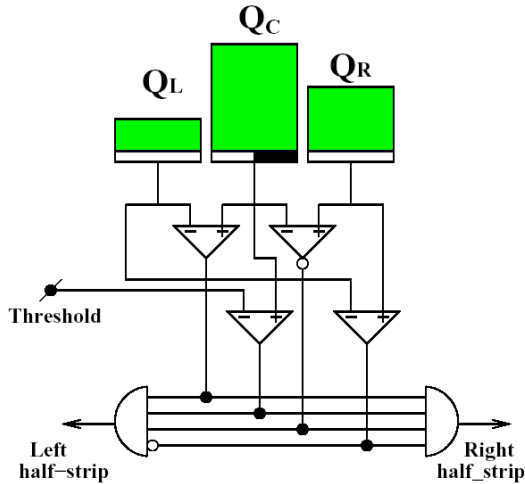
Fig. 7. Scheme of the strip comparator network.

Finally, the right-left comparator logic (Fig. 7) was tested by pulsing 3 adjacent strips at the same time with amplitudes in the ratios 1:3:2 and 2:3:1. The CFEB design does not allow for direct measurement of the performance of the comparators, which carry out an analog comparison of voltages from neighbor strips. This was recovered in the data analysis of a long cosmic ray run.

Finally, the performance of the comparators, which define the particle hit position within half-strip accuracy (Fig. 7), was studied. For each strip, events in which particles crossed a plane in the vicinity of the strip were selected. Then the left and right half strip comparator efficiencies were analyzed as a function of signal amplitude difference between the left-right neighboring strips and between pairs of adjacent strips including the strip under investigation. The accumulated distributions were fitted with the **erf**-function. The parameters of the fit were used for the comparator offset and noise estimations. The limits for the offset and noise were set to 4 ADC counts (4 fC). No CFEBs was rejected because of noise or large offset.

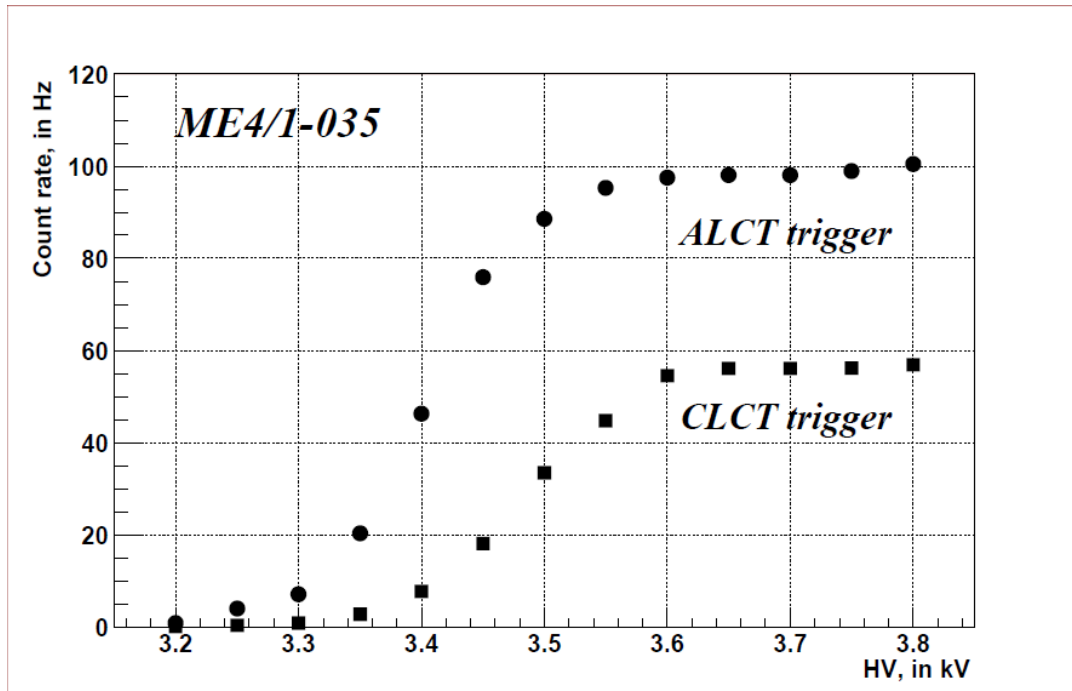
Fig. 8. The cosmic ray particle count rate for one of the ME4/1 chambers based on ALCT and TMB (CLCT) trigger decisions.

The performance validation tests were completed with a set of tests carried out with HV applied to the chamber. The CSC plateau efficiency for charged particle registration was measured based on the ALCT and the TMB trigger requirements for finding a stub with at least 4 hits in the chamber planes in a pattern consistent with a muon track coming from the interaction point. The measurements were taken at nominal AFEB and comparator thresholds of 20 fC. An example of measured count rates versus HV is shown in Fig. 8. The difference between the ALCT and TMB trigger count rates on the plateau is due to the difference in solid angle selection between the ALCT and the TMB trigger patterns. The CSC background noise was measured at HV=3600 V (at 3000 V for ME1/1 CSCs). The triggers were generated by the ALCT based on single wire group hits and by the TMB based on single comparator hits. In parallel with wire group count rates, the probabilities of isolated hits and after-pulsing were also monitored. In general, the CSC background noise level depended on the chamber size and environment where the measurements were taken. The typical noise level varied between 1 kHz for ME1/1 to 3.5 kHz for ME234/2 chambers. If extra noise was detected, the HV value on the sector in question was raised up to 3.8 kV and the sector was kept under this voltage for 24 h. If the noise level remained at its original value, then negative HV was applied to the sector and slowly raised to 3.3 kV. A limit on the training current was set to 50 μ A. Usually, after training for 30 min at 3.3 kV the count rate dropped to an acceptable level.

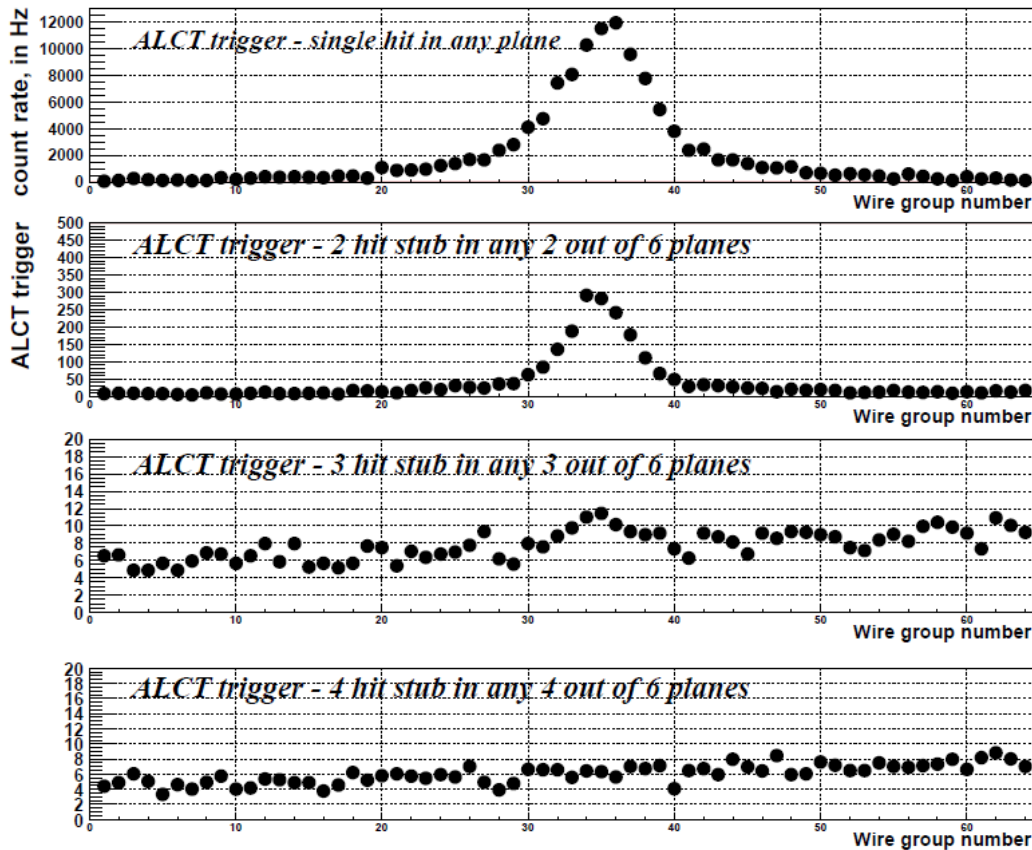
Fig. 9. “Key” wire group occupancies for different ALCT trigger conditions in the presence of the Co^{60} radioactive source.

The capability of the ALCT to make trigger decisions in normal and high hit-rate environments was checked using cosmic-ray particles and a non-collimated 20- μ Ci Co^{60} gamma source. Different trigger conditions (1 hit in any plane of the CSC, 2 simultaneous hits in any 2 planes of the CSC that satisfied muon track “roads” through the 6 layers, etc., and finally tracks with 6 hits) were checked. The trigger signals were required to arrive at the ALCT within a time interval of 75 ns. Histograms of “key” wire group (a wire group in the 3rd plane from the interaction point most likely crossed by a trigger particle) occupancies in the presence of the radioactive source for 4 different trigger requirements are shown in Fig. 9. The count rates of the first 2 trigger settings were mainly caused by secondary electrons from gammas from the radioactive source, whereas cosmic ray particles were responsible for ALCT triggers with 3 or more simultaneous hits.

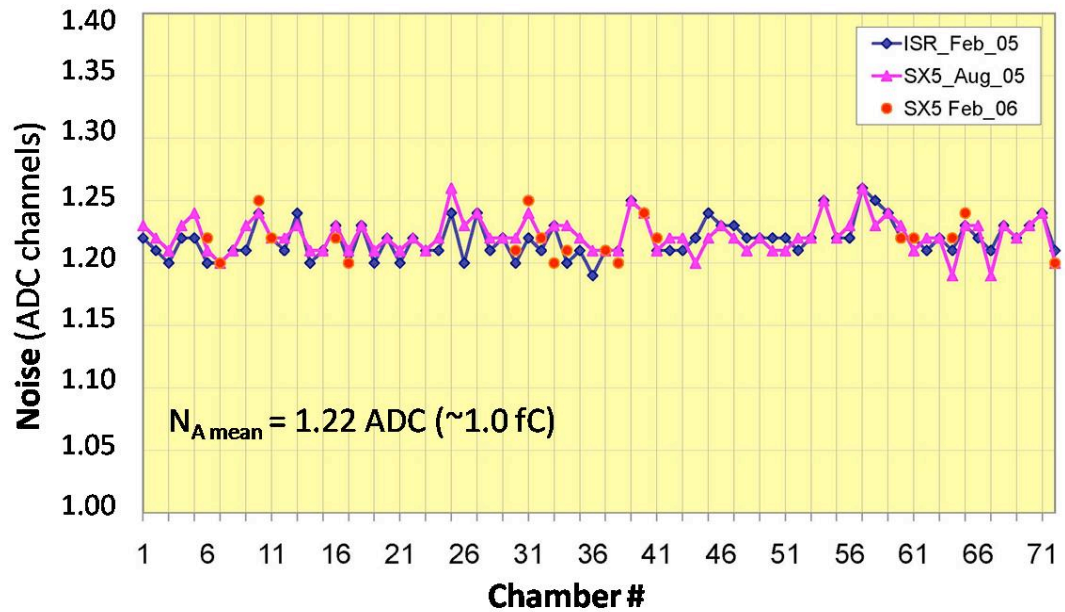
Fig. 10. Average AFEB analog noise of ME1/1 CSCs measured at the ISR FAST site at CERN (diamonds), after chamber installation on the disks (triangles), and 6 months later (circles).

Measurements of the average AFEB analog noise of the ME1/1 chambers (Fig. 10) were taken at the ISR FAST site at CERN, then after the chambers were installed on the steel disks, and then 6 months later. Figure 11 compares the AFEB noise levels for 6 types of CSCs measured at 3 different locations: at the FAST sites, at the ISR at CERN, and mounted on the steel disks. The AFEB noise level has not changed for any type of CSCs since the electronics was installed and it remains within the specification range of 1.2 fC. Figure 12 shows the difference in AFEB thresholds of all CSCs (except ME1/1) measured in the storage area at CERN, and after CSCs installation on disks is shown. No noticeable drift of the AFEB thresholds was observed.

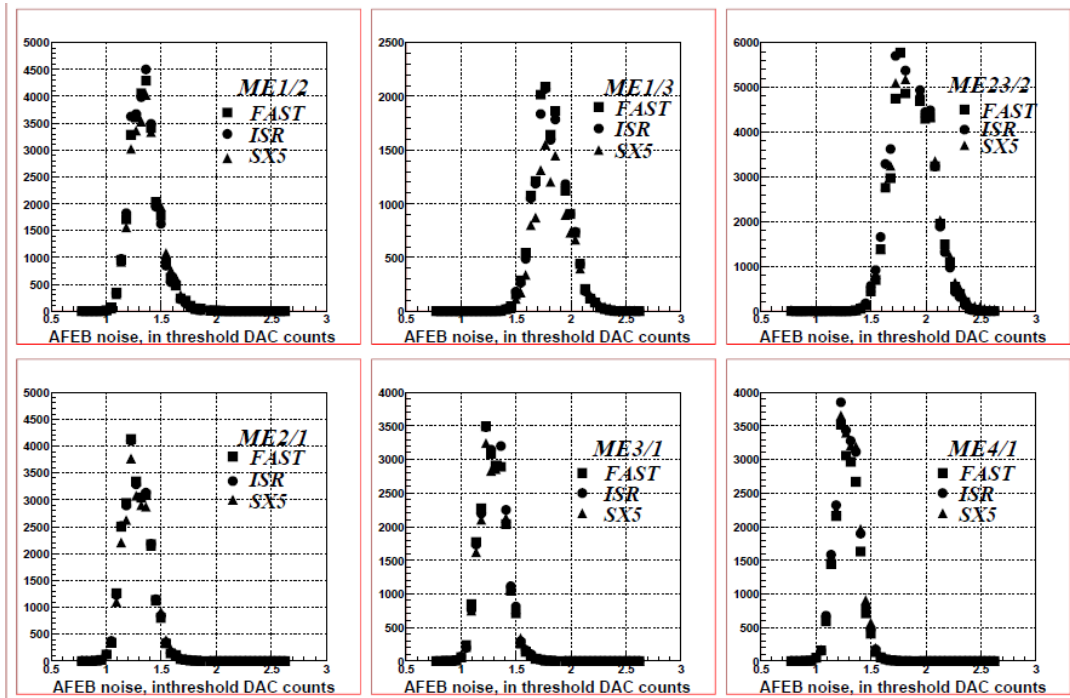
Fig. 11. Distributions of AFEB analog noise for all CSCs (except ME1/1) measured at 3 different locations: at the FAST sites, at the ISR at CERN, and in the CMS detector assembly building (SX5).

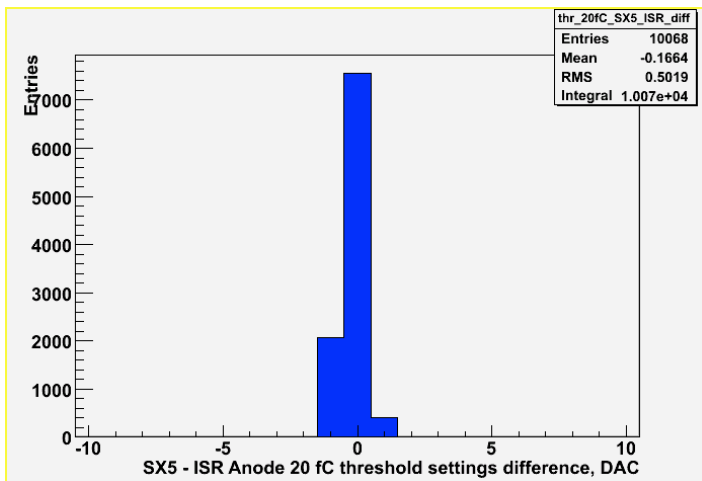
Fig. 12. The difference between AFEB thresholds of all CSCs (except ME1/1) measured at the ISR at CERN and during CSC commissioning in the detector assembly building.

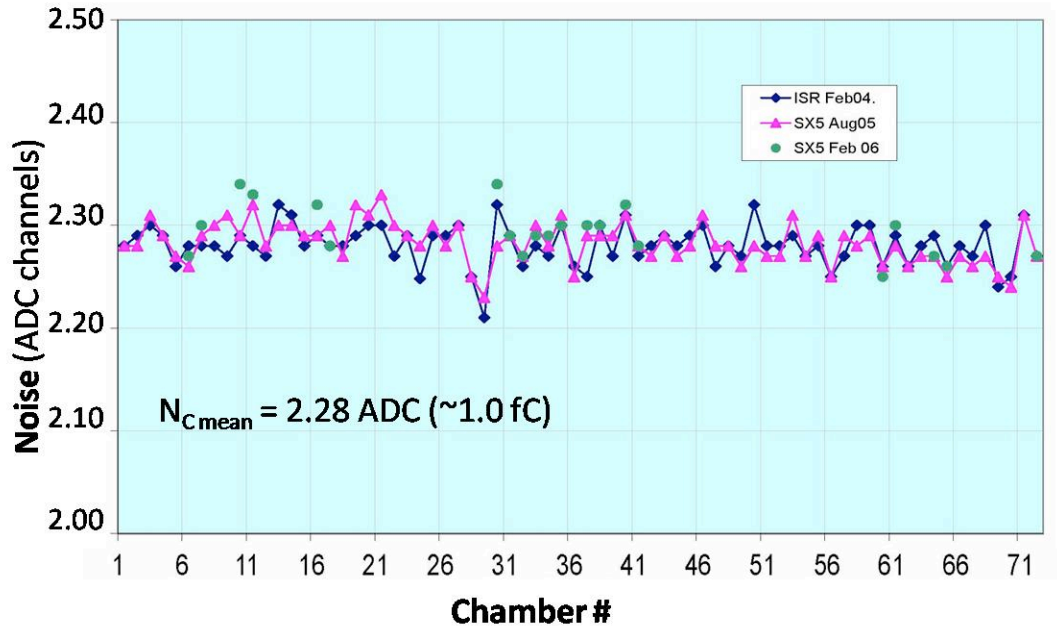
Fig. 13. Average RMS of SCA pedestals for ME1/1 chambers measured at the ISR at CERN, then after chambers installation on the CMS steel disks, and then 6 months later.

The strip connectivity, SCA noise, and comparator thresholds were checked for the cathode readout pathway. In Fig. 13, the average rms values of SCA pedestals are shown for ME1/1 as they were measured at the ISR at CERN, on the steel disks during CSC commissioning and 6 months later. In Table 1, the rms of SCA pedestals, the comparator thresholds and noise measured at 3 stages of quality control are shown for the 6 types of CSCs. The noise level of the SCA readout was within specifications (~ 1.5 fC). No drift of comparator thresholds has been seen since the electronics was put on the chambers. Only 0.6% of CFEBs were replaced during the CSC commissioning and subsequent CSC maintenance. These have been mainly due to the failure of individual channels or on-board ASIC chips.

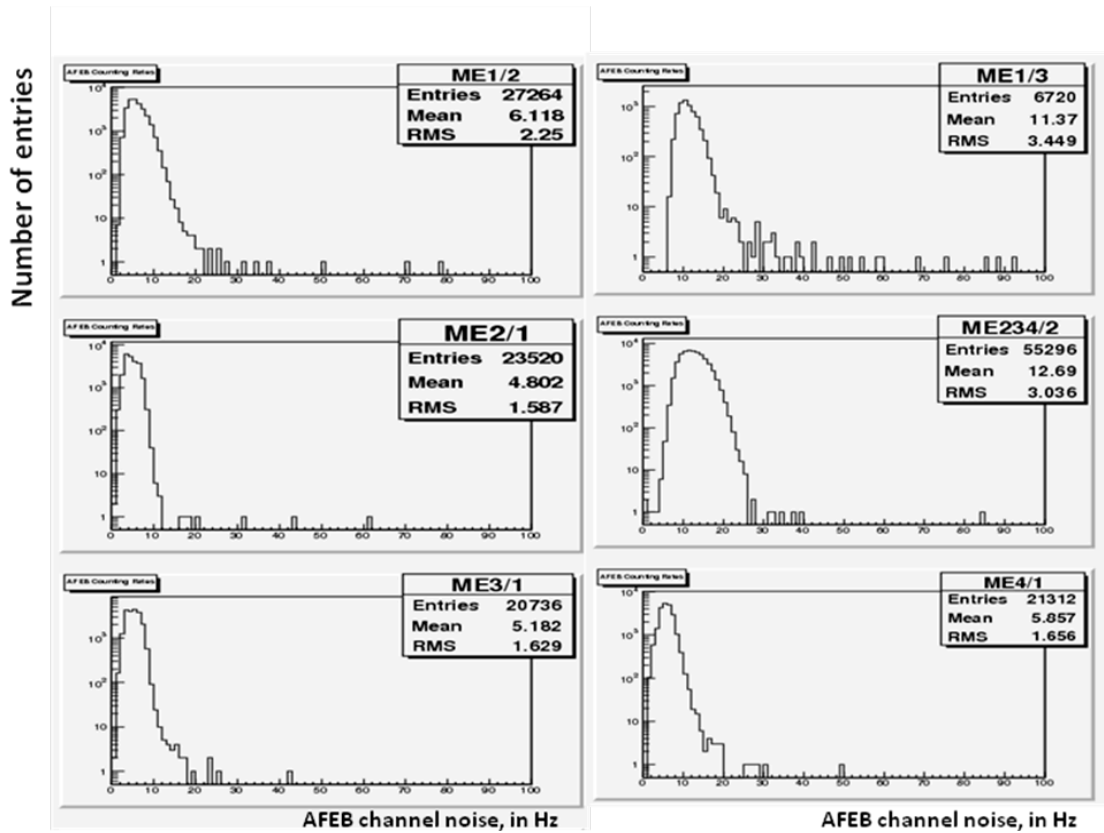
Fig. 14. Wire group count rates at nominal HV for different types of CSCs.

However, in the case of 2 chambers the training failed to suppress the local extra noise and the CSCs were replaced. The final distributions of wire group hit rates for 6 types of CSCs are shown in Fig. 14. The rates are mostly defined by terrestrial radioactivity and cosmic-ray background. The distributions have very small tails and there are only a few wire groups in the system with a noise level of a few tenths of Hz.

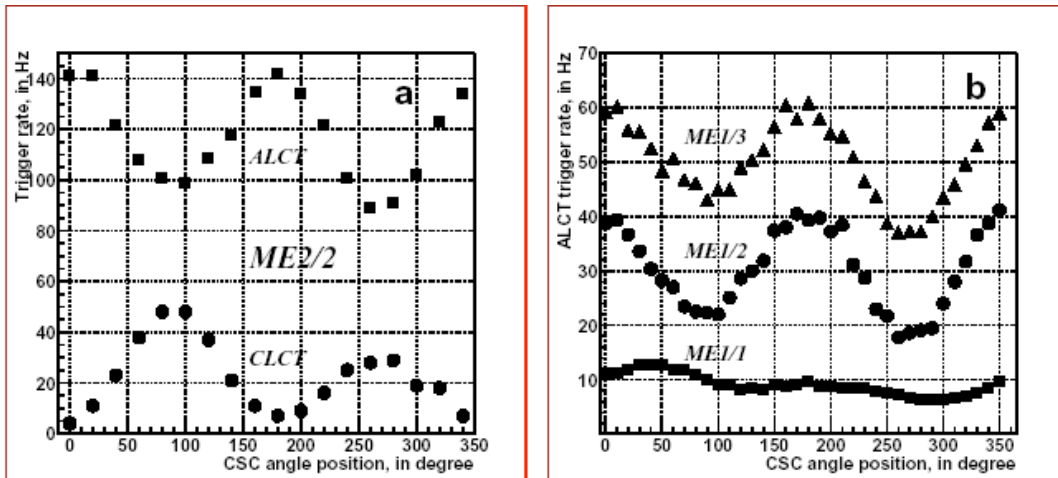
Fig. 15. CSC cosmic-muon trigger rates as a function of chamber angle position on the disks. a) ALCT and CLCT trigger rates for ME2/2; b) ALCT trigger rates for CSCs belonging to the first muon station.

In Fig. 15, CSC cosmic muon trigger rates are shown as a function of the chamber angle position on a steel disk. The muon trigger rates of the CSCs were mainly defined by the sizes of the chambers and their positions on the disks. The observed sinusoidal-type dependence comes from changing the orientation of solid angles, in which the ALCT and the TMB (CLCT) select the cosmic muons. The 29° tilt of the ME1/1 anode wires relative to the wires of other chambers is also clearly seen.
