# Challenges and Lessons Learned from fabrication, testing and analysis of eight MQXFA Low Beta Quadrupole magnets for HL-LHC

**Abstract**—By the end of October 2022, the US HL-LHC Accelerator Upgrade Project (AUP) had completed fabrication of ten MQXFA magnets and tested eight of them. The MQXFA magnets are the low beta quadrupole magnets to be used in the Q1 and Q3 Inner Triplet elements of the High Luminosity LHC. This AUP effort is shared by BNL, Fermilab, and LBNL, with strand verification tests at NHMFL.

In this paper, we present a summary of: 1) the fabrication and test data of all the MQXFA magnets; 2) the analysis of MQXFA07/A08 test results with characterization of the limiting mechanism; 3) the outcome of the investigation, including the lessons learned during MQXFA07 disassembly; and 4) the finite element analysis correlating observations with test performance.

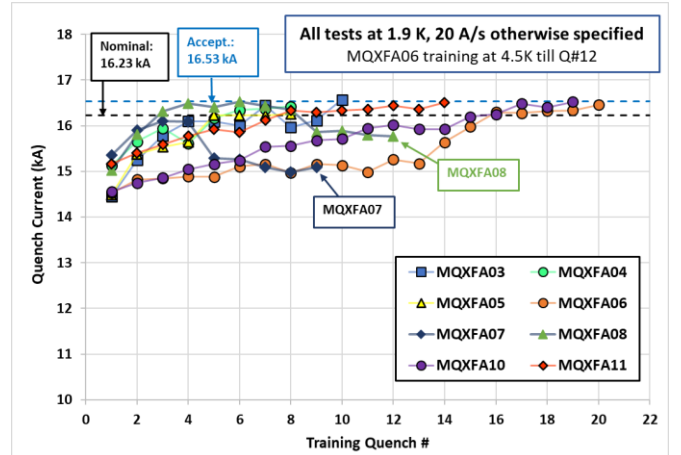
Fig. 1. Quench history of all the MQXFA magnets during vertical tests at BNL (only training quenches are shown). MQXFA06 was trained at 4.5K until quench #12. MQXFA07 and MQXFA08 training can be seen in Figs. 2 - 3.

Eight MQXFA magnets were tested in the vertical test facility. Fig. 1 shows the training part of their tests. Six of the eight magnets, MQXFA03-06 and MQXFA10-11, reached and held acceptance current, while MQXFA07 and 08 showed limited performance. MQXFA05 went through an additional endurance test; it initially reached acceptance current after eight quenches and demonstrated good training memory after two thermal cycles. The endurance test included 42 induced quenches at nominal current (16.23 kA) performed over two additional thermal cycles. At the end of the endurance test, the magnet reached nominal current at 4.5K and again achieved acceptance current at 1.9 K.

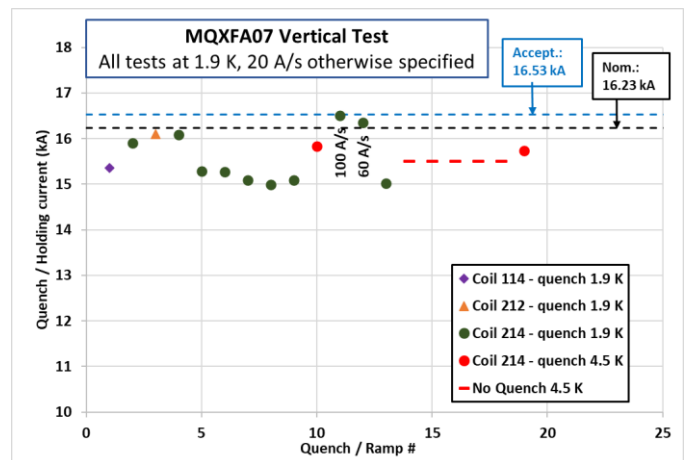
Fig. 2 MQXFA07 quench history plot.

The MQXFA07 quench history plot is shown in Fig 2. MQXFA07 started training at 15.3 kA and reached 16.1 kA after three quenches. Subsequently, during quench #5, it showed a detraining of 800 A. The following quenches at 1.9 K and with a 20 A/s ramp rate eventually settled at a quench current in the range 15–15.1 kA, showing a drop of about 1 kA with respect to the quench current reached in quenches #3 and #4.

All limiting quenches started in a single coil (Coil 214 in quadrant 3), in the same voltage-tap segment (A3-A4), and

about 21 ms before the quench detection trigger. The quench antenna array showed that all limiting quenches in coil 214 at 1.9 K and 20 A/s took place in the same longitudinal position along the coil, at around 2050 mm from the magnet's center. This location corresponds to the beginning of the lead end of the coil. Fig. 2 shows reverse temperature dependence with the quench current at 4.5 K about 800 A higher than at 1.9 K at the standard 20 A/s ramp rate, and reverse ramp-rate dependence with quench currents 1486 A and 1332 A higher at 100 and 60 A/s, respectively, than the last quench at 20 A/s.

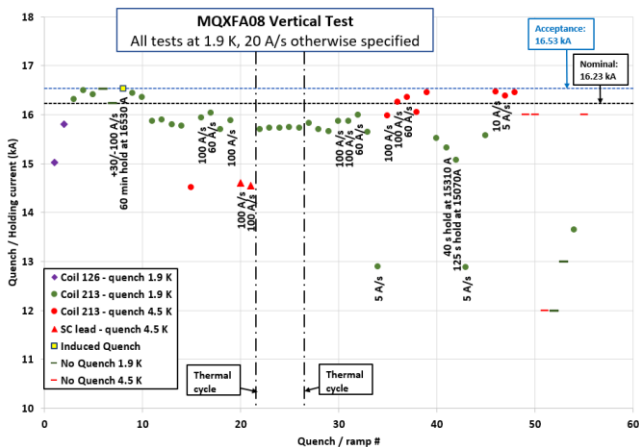
Fig. 3. MQXFA08 quench history plot.

The MQXFA08 quench history plot is shown in Fig 3. The magnet started training at 15 kA and reached acceptance current (16.53 kA) after five quenches. During the hold at 16.53 kA, a power supply shutoff triggered the quench detection, inducing a quench in the magnet. Subsequently, the magnet exhibited detraining, with the quench current settling at around 15.7 kA after three quenches. All limiting quenches occurred in coil 213 in quadrant 3. While the intermediate voltage taps were not available initially, when they were reconnected after the second thermal cycle, they revealed that the limiting quenches were occurring in the same voltage-tap segment as in MQXFA07 (A3-A4) when ramping at the typical 20 A/s at 1.9 K. These quenches started about 16 ms before the quench detection trigger, and the quench antenna data showed that they all occurred in the lead end at about 2100 mm from the magnet's center. Although initially the quenches at 4.5 K were occurring at a lower current (14.5 kA), it was found that the splice between the magnet's negative lead and the test facility had resistance equal to 42 n $\Omega$ . Once the splice was repaired, during the third test cycle, MQXFA08 showed reverse temperature dependence with quench currents in the range of 16-16.4 kA at 4.5 K. At 1.9 K the magnet showed reverse ramp-rate dependence, with the highest quench current achieved at 60 A/s being 400 A higher than that at 20 A/s, and over 3 kA higher than the current reached at 5 A/s. At 4.5 K there was no clear trend in the quench currents in the rate range investigated during the test (5-100 A/s).

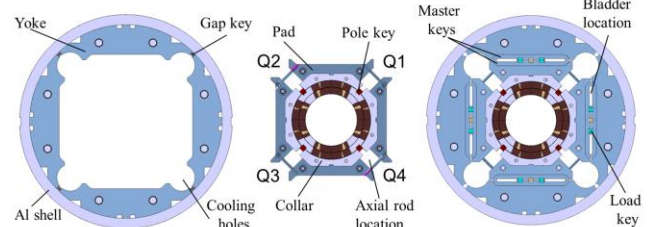
Fig. 4 Magnet cross-section (right), coil-pack sub-assembly (center), shell-yoke sub-assembly (left). Q1 to Q4 are coil quadrants as seen from the magnet's lead end.

After the test at BNL and the shipment to LBNL, both the MQXFA07 (A07) and MQXFA08 (A08) magnets were inspected, unloaded and disassembled. Several measurements were taken before, during, and after the unloading, with the goal of looking for any possible anomaly. The first surprising observation that emerged after removing the coil-pack sub-assembly from the shell-yoke sub-assembly (Fig. 4) was related to the coil-pack horizontal dimensions. As can be seen in Fig. 5, the A07 coil-pack exhibited a trapezoidal shape in the post (“p”) test data (red markers) with the top (T) horizontal dimension being larger than the bottom (B).

This shape was also present during the first assembly procedure (the one preceding the test), as shown by the blue markers. Surprisingly, the difference between the top and bottom dimensions of the coil-pack was not corrected by the loading operation. In other words, the asymmetry remained despite the fact that after the bladder operation the coil-pack is locked by identical loading keys inside the square cavity of the shell-yoke sub-assembly.

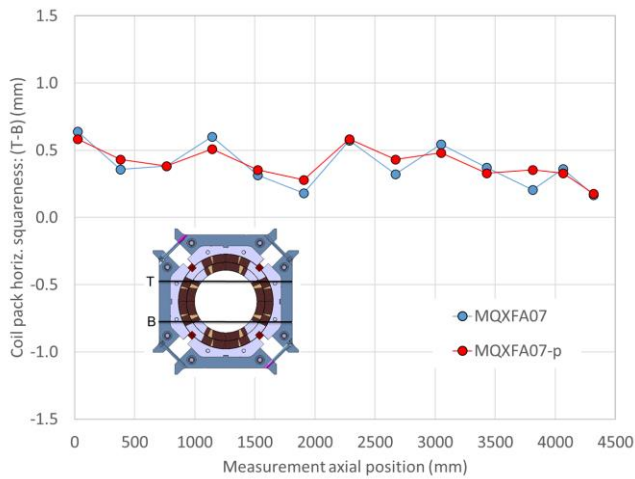
Fig. 5. Measurement of MQXFA07 coil-pack horizontal squareness before the test (A07) and after the test (A07-p). The horizontal squareness is the difference between the top (T) and the bottom (B) dimensions.

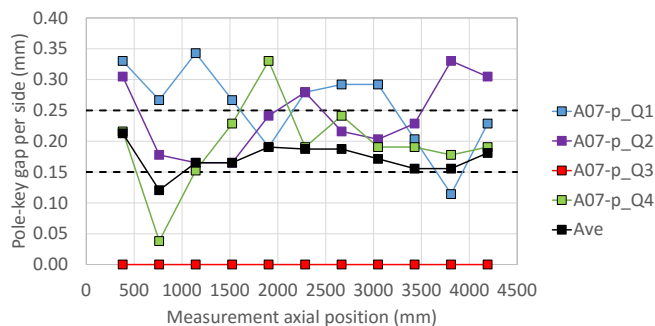
Fig. 6. Pole key gap measurements in each quadrant as a function of the axial position after the test (A07p). The dashed lines indicate the spec values of the average among the four quadrants on each longitudinal location.

Consistently with the trapezoidal shape of the coil pack, a non-uniformity in the distribution of the pole-key gaps was observed after the vertical test. The pole-key gaps are small gaps between each pole key and the collars. Fig. 6 shows measurements of these gaps in each quadrant as a function of the axial position in MQXFA07 after the test. The specifications for the pole gaps used during the assembly of A07 and A08, indicated by the dashed lines, stated that the average pole-key gap (per key side) among the four coils on each longitudinal location shall be  $+0.200 \pm 0.050$  mm. It can be seen that the average among the four quadrants was on spec, but a significant variation among quadrants was present. In particular, in quadrant 3 (Q3) a null gap was observed after the test. A similar very low pole-key gap was observed both before and after the test in A08 as well, again indicating that the pre-load operation did not correct this asymmetry.

In order to prevent this issue from occurring, the pole-key gaps were increased from 0.4 to 0.8 mm at each gap [25]. In addition, a specification was set for the minimum pole-key gap (0.6 mm) in each coil at each location [25]. MQXFA assembly procedures were changed to meet the tighter specifications [26].

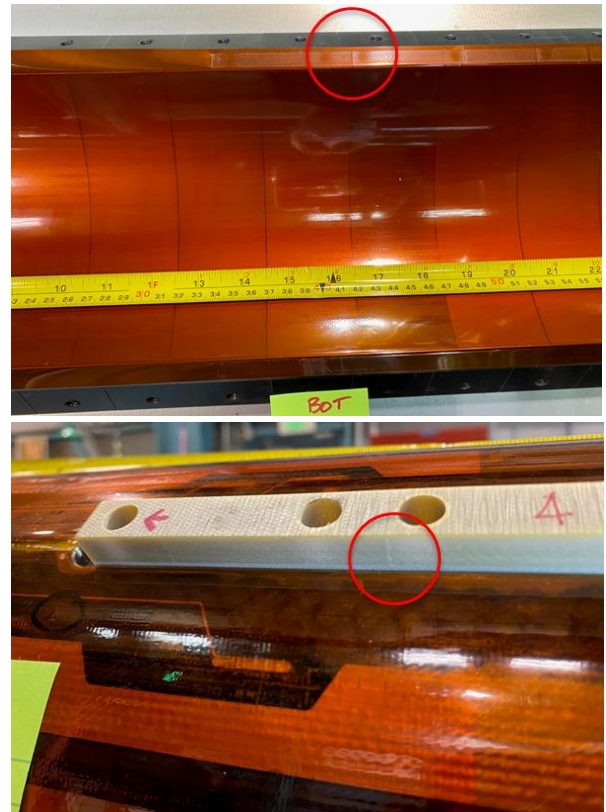
Fig. 7. Red circles: high pressure “imprints” of collar lamination on the polyimide insulation between the collars and pole keys (top) and on the pole keys of Q3 (bottom).

After the coil pack disassembly, coils, ground isolation layers, and pole keys were inspected. In Q3, deep imprints in the polyimide insulation between the collars and pole keys, indicating collar lamination lines and pole key G11 grain, were observed (Fig. 7, top). In addition, the G11 pole keys in Q3 also showed high pressure imprints of collar lamination gaps (Fig. 7, bottom). These imprints, all indicative of higher pressure, were not seen in the other quadrants.

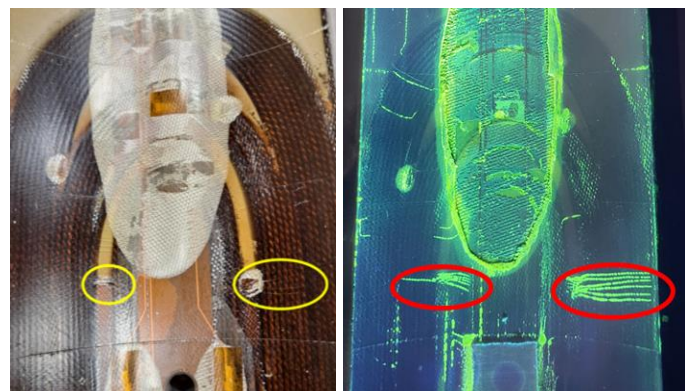
Fig. 8. Left: detail of coil 214 lead end. The yellow circles show bubble/delamination at each transition between wedge and end-spacer. Right: results of the dye penetrant test showing in the red circles cracks starting at the interface between wedges and end-spacers.

The visual inspection of coil 214 (the A07 limiting coil) found large bubbles (delamination of the insulation on the coil’s inner surface) in both ends on the inner layer at the coil tips. These bubbles are typical in MQXF coils after testing. However, a closer look at both ends showed that there is a small bubble/delamination at each transition between wedge and end-spacer (see yellow circles in Fig. 8, left). In addition, a dye-penetrant test performed at CERN [22] to check for bonding among coil components showed horizontal cracks starting from the wedge to the end-spacer transitions (see red circles in Fig. 8, right).

If now we look at the contact area between the wedge and the end-spacer in the coil's inner layer (indicated by the yellow circles of Fig. 8, left), we see that, if we assume that all of the coil's surfaces are bonded, a tension develops in Q3 during excitation, as shown in Fig. 10, right. More precisely, when Lorentz forces are applied, the average tension between wedge and end-spacer is about 30 MPa in quadrant 3, while it remains close to zero in the other quadrants.

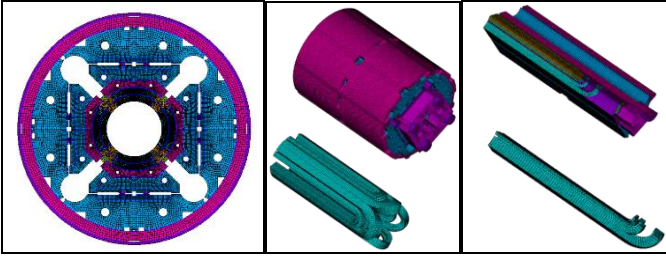
Fig. 9. Left: 360-degree, full cross-section 2D finite element model. Center: 360-degree, full cross-section 3D model. Right: octant 3D model.

The effect on coil stress of closed pole-key gaps in Q3 was studied using three different finite element (FE) models: a 360-degree, full cross-section 2D model (see Fig. 9, left), a 360-degree, full cross-section 3D model (see Fig. 9, center), and an octant 3D model (see Fig. 9, right). Both 3D simulations reproduce an MQXF short model (MQXFS, with a 1.2 m magnetic length) to reduce the simulation time and increase the mesh density. The results in the end region were found to be consistent with those from the full-length model.

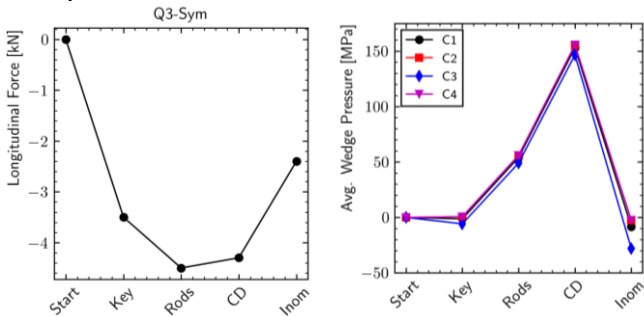
Fig. 10. Left: Difference between the force provided by the axial rods to the Q3 coil with respect to the case with an open pole-key gap. Right: average contact pressure (negative in tension) between wedge and end-spacer in the bonded case in the four quadrants.

In addition to the azimuthal stress in the straight section, the 3D model allows an investigation of the behavior of the four quadrants in the end region in the A07-A08 scenarios. If we focus on the axial pre-load system, the 3D model predicts that the axial force delivered by the end plate to the coil in Q3 is smaller as compared to the other quadrants (Fig. 10, left, shows the difference). This phenomenon can be explained as follows: the lower azimuthal pre-load in Q3 results in a smaller elongation caused by the Poisson effect, and in lower friction between the coil and the structure. Therefore, when compressed by the end plate, the Q3 coil contracts axially more than the other coils, which are better constrained axially by the higher frictional contact with the support structure. As a result, the coil Q3, being axially less rigid than the other three coils, receives less axial force from the end plate.

In summary, a 30 MPa tension between wedge and end-spacer is observed in Q3 due to the lower azimuthal and axial pre-load caused by the closed pole-key gaps. This tension may cause cracking of the fiberglass-loaded epoxy between the wedge and the end-spacer, or separation between the epoxy and a metallic surface.

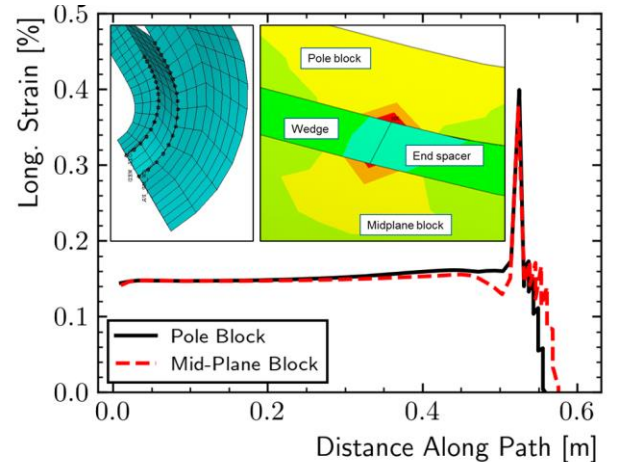
Fig. 11. Longitudinal strain if there is no bonding between wedge and end-spacer in the coil's inner layer lead end with asymmetric azimuthal preload. A short model was used for this analysis and the paths go from the magnet's center to its end.

The impact of a possible separation between the wedge and the end-spacer on the coil strain was studied using an octant model, which allows a more refined mesh as compared to the 360-degree model. Assuming that there is no bonding between wedge and end-spacer (i.e. epoxy that has been cracked or separated from metal), a small gap opens and induces a local axial strain spike in the coil, which can exceed 0.4% (see Fig. 11). This strain level is considered sufficient to introduce

permanent degradation due to filament failure in  $\text{Nb}_3\text{Sn}$  strands [23]. The strain increase is larger in the pole block as compared to the mid-plane block.

In order to assess strand integrity along the whole wedge to end-spacer transition, it was decided to perform longitudinal cuts on the two cables facing the wedge to end-spacer transition on both sides (see Fig. 12, center top). The longitudinal cuts were to be performed along the cable side facing the transition (yellow lines). The results of the metallurgical inspection are presented in Fig. 12 in the left and right pictures where every red marker indicates a crack in an  $\text{Nb}_3\text{Sn}$  filament (sub-element). The cracks are predominantly localized in the cable of the pole-block side, whereas no or fewer cracks were found in the cable included in the midplane block. This is consistent with the simulation results (see Fig. 11), which show a

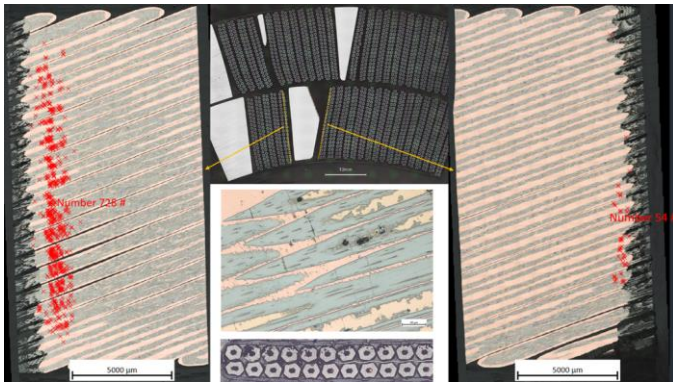
Fig. 12. Metallurgical inspection of cables adjacent to the wedge-spacer transition in the lead end non-layer-jump side of coil 214. Each red marker shows a cracked  $\text{Nb}_3\text{Sn}$  filament (sub-element), as shown in the central and bottom pictures. Figure from [24].

larger strain increase on the pole-block side. The central and bottom images show a detailed image of some cracks and the resulting collapsed filaments. In order to assess whether there is damage also on the second layer of strands (i.e., on the cable side opposite to the wedge-spacer transition), the same metallurgical analysis was performed on the second layer of strands, and not a single cracked filament was found on that cable sample.

A more focused investigation on the position of the cracks with respect to the wedge-spacer transition indicated that filament cracks are clearly clustered around the transition between the wedge and the epoxy resin (filled with S-2 glass). This is consistent with the observation in [24] that “the ceramic coating of the end-spacer provides good cohesion with the resin” and that the bonding between the copper wedge and the resin is not as strong.
