# The High Voltage Feedthroughs for the ATLAS Liquid Argon Calorimeters

**ABSTRACT:** The purpose, design specifications, construction techniques, and testing methods are described for the high voltage feedthrough ports and filters of the ATLAS Liquid Argon calorimeters. These feedthroughs carry about 5000 high voltage wires from a room-temperature environment (300 K) through the cryostat walls to the calorimeters cells (89 K) while maintaining the electrical and cryogenic integrity of the system. The feedthrough wiring and filters operate at a maximum high voltage of 2.5 kV without danger of degradation by corona discharges or radiation at the Large Hadron Collider.

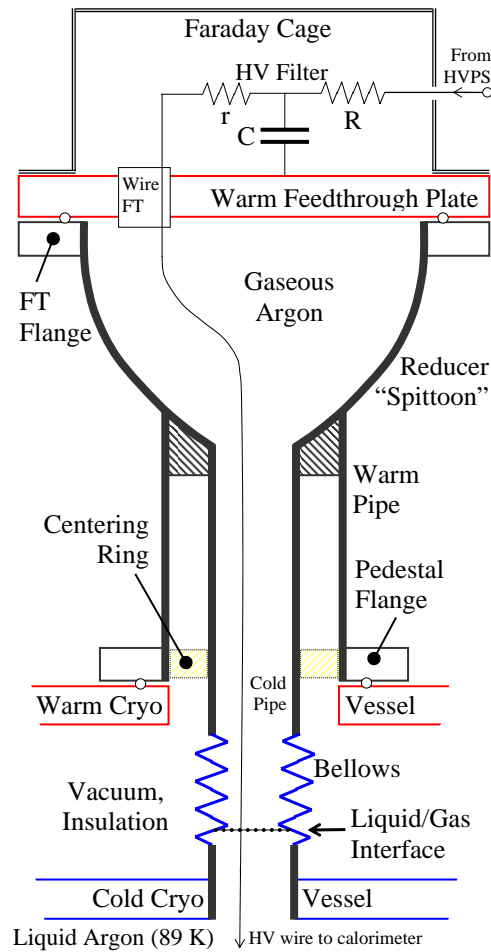
**Figure 1.** Conceptual drawing of the ATLAS LAr high voltage feedthrough (HVFT) port and the HV filters. The HVFT ports are located near the top of the LAr cryostats. Not to scale.

The conceptual design of a HVFT port is shown in Fig. 1. The HV lines lead from the various calorimeter patch panels and come up through the surface of the LAr into a small pipe (73 mm inner diameter). A stainless steel bellows in this cold pipe accommodates the differential motion of the cold and warm walls during cooldown and serves as the dominant thermal resistance in the cold pipe. At approximately 0.9 m above the liquid, the cold pipe is welded to the warm pipe of the HVFT which is bolted to the outer cryostat vessel so that, above this point, the FT wall is at room temperature. Above this point, the HV wires fan out to four HV Wire FTs (WFTs) mounted in a strong FT Plate, from where each wire is connected to its own RC filter to reduce electronic noise entering the cryostat. The HV filter section is also severely limited by the available space. A total of 840 HV channels is accommodated in each HVFT port. Two HVFT ports serve the barrel cryostat, one per end, and two ports serve each of the two end-cap cryostats. This makes for a total of six HVFT ports with 5040 HV channels, including about 10% spare channels.

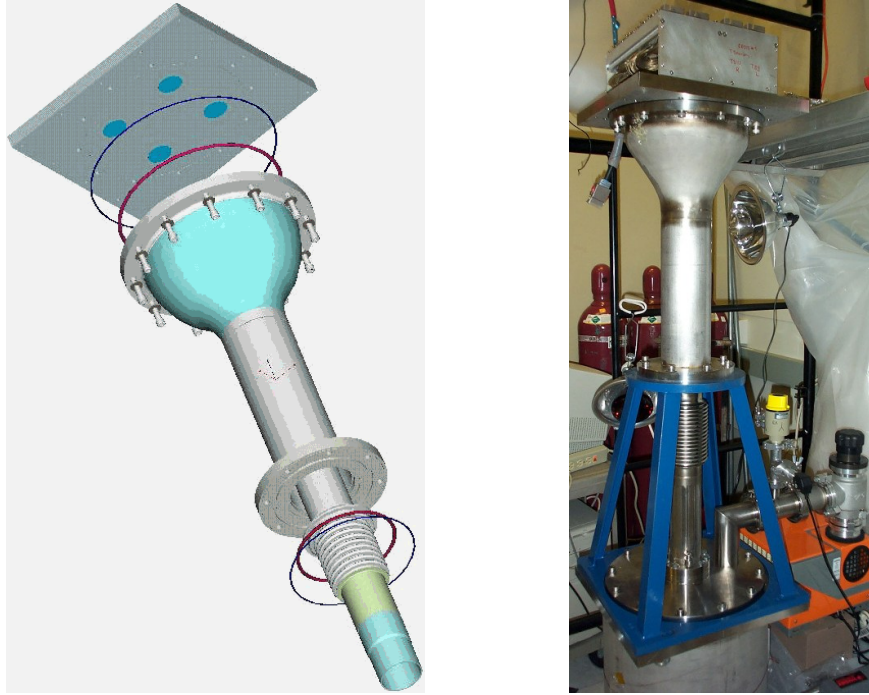
**Figure 2.** Mechanical design of a HV feedthrough port (left). The four holes on the FT plate accommodate the four wire feedthroughs of 210 wires each. Also shown are the O-rings and RF gaskets. The leak testing at Stony Brook of a completed HVFT port mounted on a test vessel which contains the HV wire bundle (right).

The mechanical design and technical specifications of one HVFT port are respectively shown in Fig. 2 and Table 1. A single port consists of several mechanical parts that are welded or bolted together and meet stringent cryogenic code requirements.

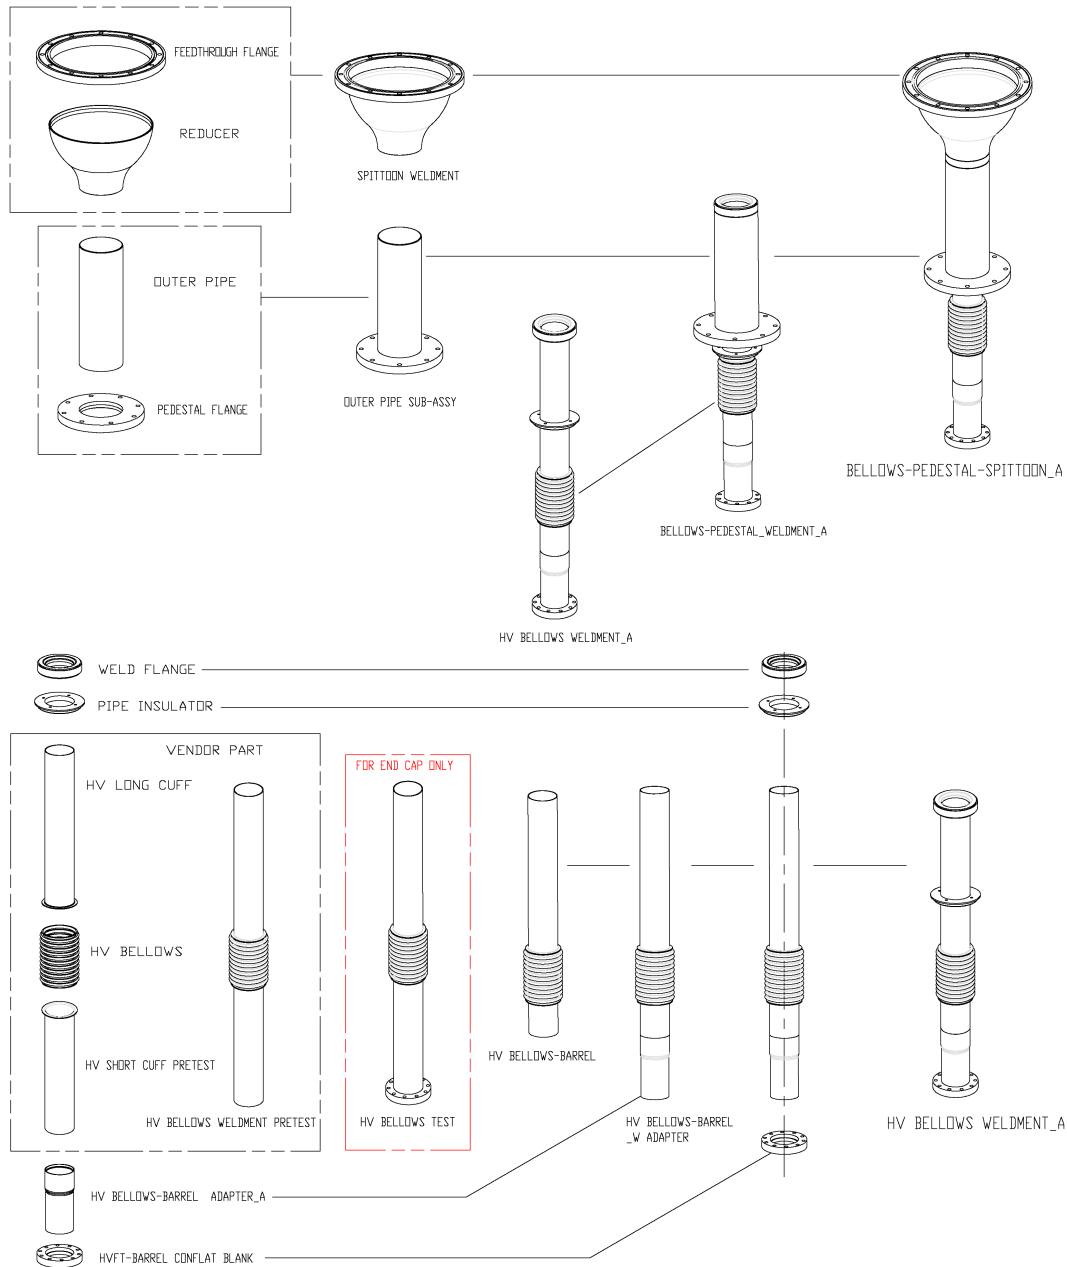
**Figure 3.** Assembly tree of a HVFT port: cold pipe and bellows (below). Assembly of the warm parts: pedestal, outer pipe, reducer; and the final port assembly (above).

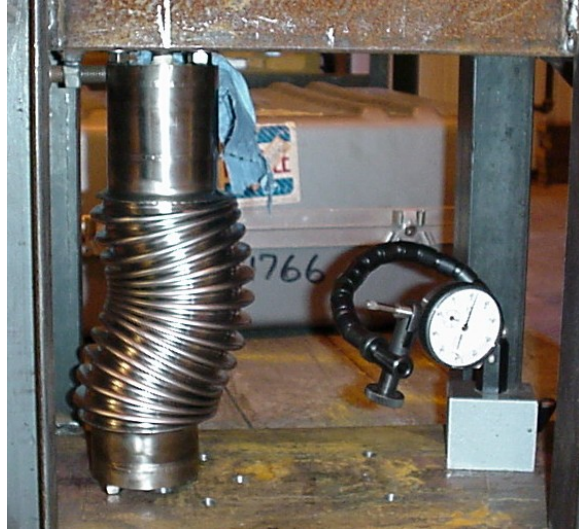
**Figure 4.** “Squirm” test of a bellows unit. Squirm occurred at 190 psi (13 atm).

Given the highly sensitive role they have in the HVFT mechanics, the bellows were tested separately at BNL to test the “squirm”-limit (sideways bulging instability that could destroy the bellows), see Fig. 4. The critical pressure for squirm,  $P_{cr}$ , was found as  $P_{cr} > 4 \times P_{op}$ , where  $P_{op}$  is the nominal operating pressure of 2.8 bar.

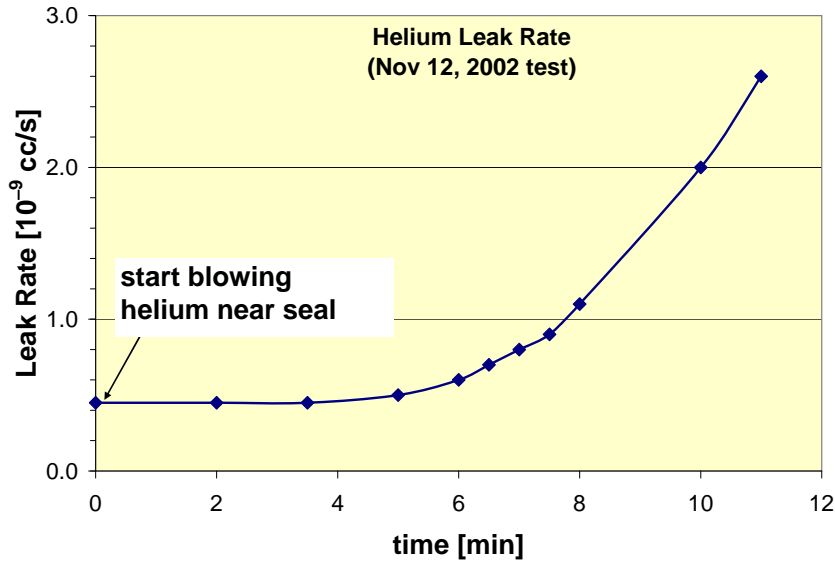
**Figure 5.** Helium leak rate in a HVFT port (results of second test).

effect observed in the earlier test, helium was finally injected at high flow rate in a bag enveloping all seals. A steady increase was observed, as in the first test, starting after 4-5 minutes, see Fig. 5.

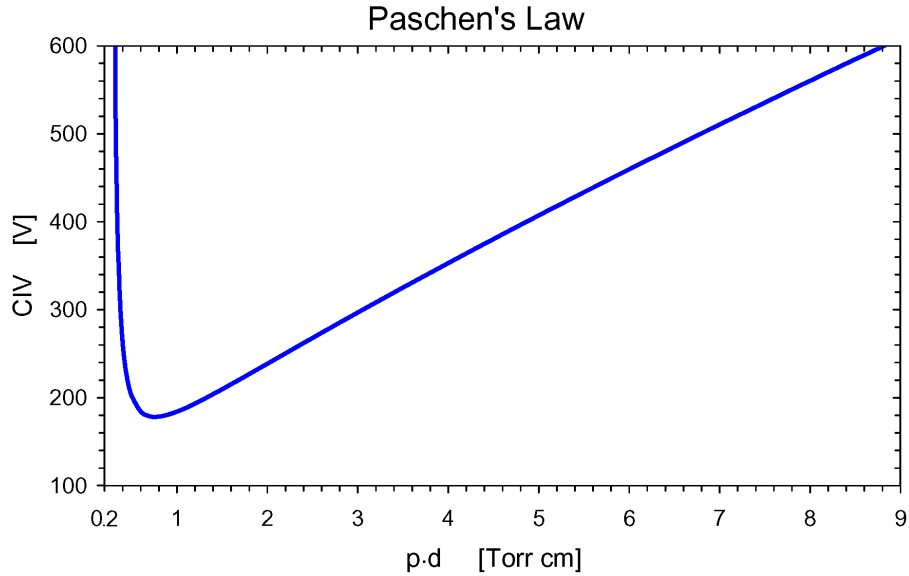
**Figure 6.** Paschen's curve for Ar/Cu.

Corona is the repetitive charging and discharging of electrical conductors at high voltage through a gas or air. In the case that one electrode is an insulated HV wire, the corona current and the UV photons created in the electrical avalanche in the gas may slowly damage the insulation and cause catastrophic breakdown. Several good references exist on corona in wiring systems [4, 5]. Corona has the insidious property that it searches out the weakest part of the insulation and eventually drills a hole in it. The voltage is highest in the gas where the insulation is thinnest around a wire, so that is where the corona will occur. Beginning approximately 100 years ago, extensive studies have been done on the conditions necessary to cause a spark in a gas. It was found experimentally that the sparking voltage is a function of pressure times distance and followed Paschen's Law, see Fig. 6. This curve shows that there is a minimum voltage for corona ignition at any separation of the electrodes. For argon gas and air this voltage is respectively about 270 V and 330 V [6] and is sensitive to both temperature and humidity.

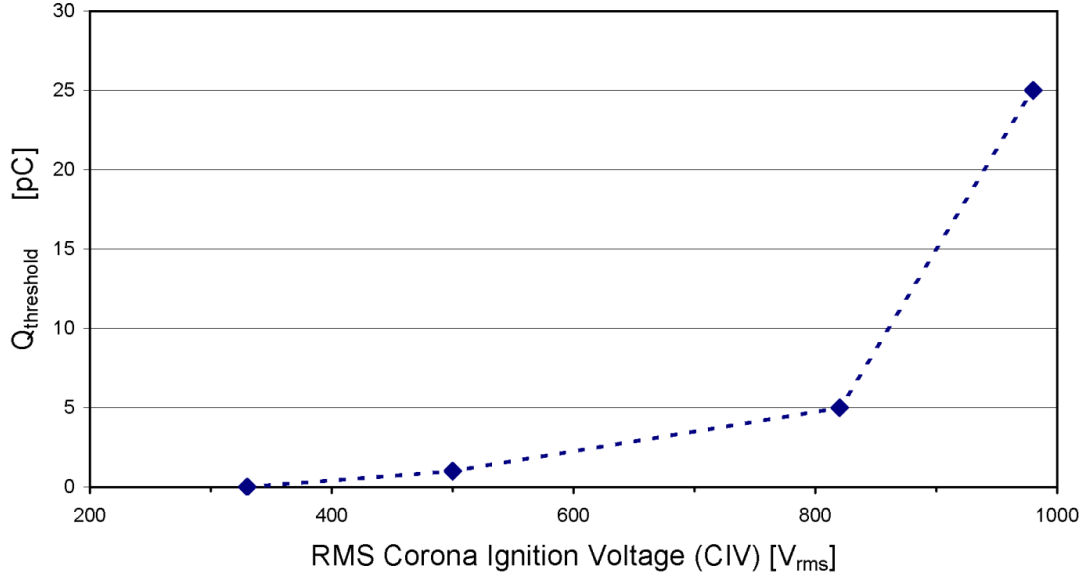
**Figure 7.** Corona charge threshold ( $Q_{threshold}$ ) versus Corona Ignition Voltage (CIV) measured with the HABIA wire wound on a grounded Al cylinder.

used 12 m of ATLAS production wire wound on an aluminum mandrel in air. Thus, this test was sensitive to both internal and external corona. Fig. 7 shows the CIV as a function of the charge threshold in pC (pC) for a single corona pulse. This curve is consistent with the Paschen minimum of 330 V DC or 233 V RMS for very small single-pulse charges in air (the bubbles in the wire contain air that could not be removed in the extrusion process.) The curve reaches 1 pC at 500 V and increases very rapidly after 800 V. The capacitor industry's standard threshold is 25 pC for the single pulse charge threshold. Corona charge pulses smaller than this value are not considered dangerous because they are observed not to damage capacitors.

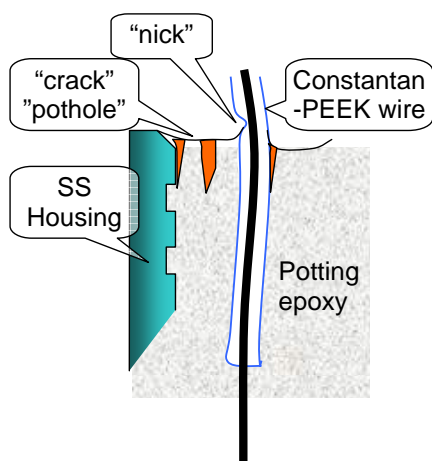
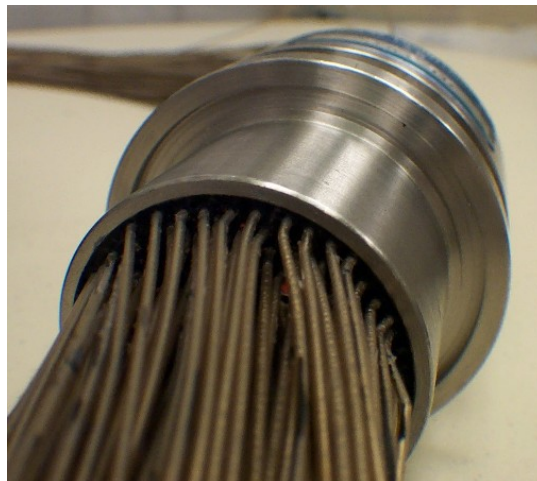
**Figure 8.** An illustration of Wire Feedthrough faults (left). Right: wires exiting a WFT on the cold side, showing the high-density 216-wire HV bundle.

immersed in water at ground potential. We applied 4.8 kV to each wire loop, one at a time, while keeping all others at ground. This test discovered shorts to adjacent wires or housing and breaks in the wire insulation of the wires on the warm and cold sides. On average, two shorted (i.e. current  $> 10$  nA) wire loops per WFT were found this way. These loops were cut and the faulty wires were identified and labeled on both cold and warm side of the WFT. During bundling, the faulty wires were removed.

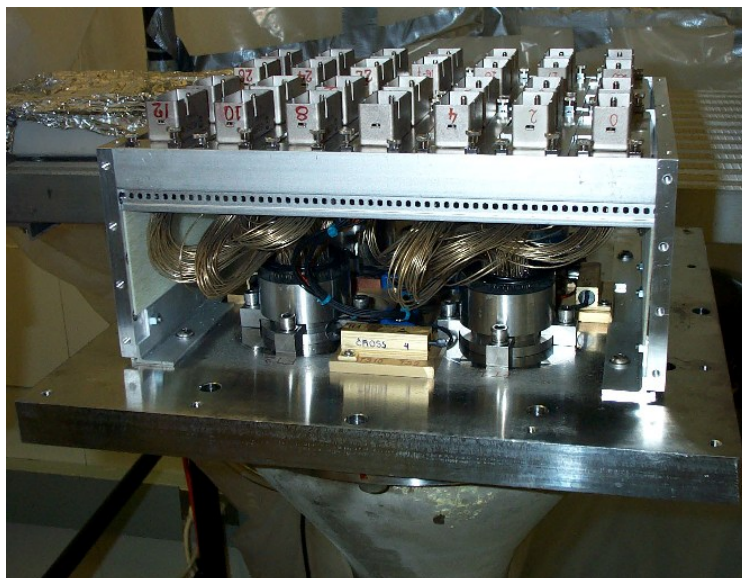
**Figure 9.** View of a FT plate with WFTs, bolted on the HVFT reducer flange. In the foreground one of four heater resistors is seen. The HV backplane with four rows of seven REDEL multi-contact HV connectors is mounted over the FT plate.

The wire bundles were carefully guided through the appropriate FT plate holes and the WFTs were bolted in place. The HV Backplane is mounted on the FT plate. The warm REDEL HV connectors are mounted on the 56-HP-wide (1 HP = 5.08 mm) backplane, constructed using EURO-standard hardware, as shown in Fig.9. Before leaving the clean room, to prepare the wires for shipment to CERN, the bundles on the cold side were wrapped with protective plastic cling wrap to form a single HV bundle. This bundle was threaded through a PEEK spacer ring (that centers the bundle in the throat of the metal reducer of the HVFT port), looped and attached to a cage supported by the FT plate, and the whole was bagged in plastic for mechanical and dirt protection.

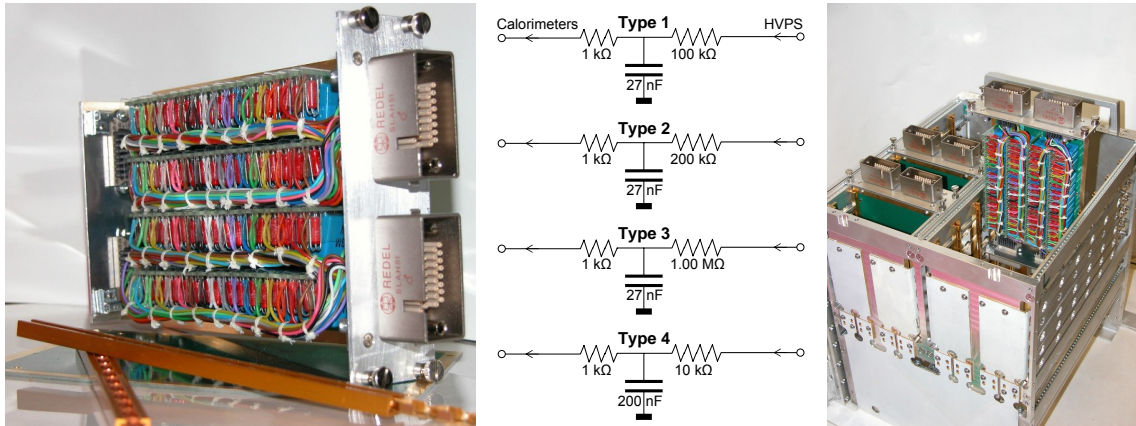
**Figure 10.** Left: a filter module showing the four daughter boards with 16 rCR filter circuits each. The grounding cover is removed, and two Ground-R-Guides card guides are shown in the foreground. Middle: arrangement and component values of the four types of HV filters: Type 1 for EM calorimeters, Type 2 for Preshowers and the Hadronic Calorimeters, Type 3 for the Forward calorimeters, and Type 4 for the LAr Purity monitors. Right: HV filter crate with three filter modules mounted on a HV backplane and without the shielding side panels in place. The grounding strips (left side of photograph at the “bottom” of the crate) and the ground planes leading from the strips to the FT plate (right-front side of photograph and at the side of the crate) are clearly visible.

As shown Fig. 10, the filters are mounted in a very tight configuration. The filter circuits are separated from each other by thin sheets of Mylar<sup>14</sup> mounted in slots between neighboring circuits. For the required flexibility, the HV wire used was multi-strand tin-plated copper with polyethylene insulation (the same wire as in the multi-conductor HV cables for ATLAS). Special care was taken in the soldering (avoiding all sharp points) and intensive ultrasonic cleaning was performed to minimize surface conduction. Mother boards, card guides and grounding rims are gold-plated, and RF gaskets are used on grounding connections and around frontpanels in order to provide shielding and a low-inductance ground path for the filters.
