The 4 K outer cryostat for the CUORE experiment: construction and quality control

The external shell of the CUORE cryostat is a large cryogen-free system designed to host the dilution refrigerator and the bolometers of the CUORE experiment in a low radioactivity environment. The three vessels that form the outer shell were produced and delivered to the Gran Sasso underground Laboratories in July 2012. In this paper, we describe the production techniques and the validation tests done at the production site in 2012.

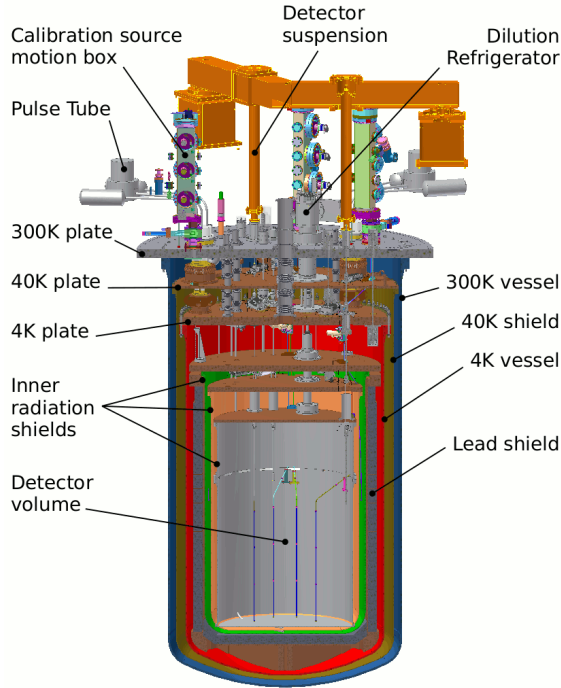
Figure 1: The CUORE cryostat.

The CUORE cryostat consists of six nested vessels and shields. The three outermost ones are included in the outer Cryostat. Two of them (300 K and 4 K) are vacuum tight: the space between the 300 K and 4 K vessels constitutes the Outer Vacuum Chamber (OVC)

of the cryostat and the 300 K vessel operates at room temperature. The volume inside the 4 K vessel represents the Inner Vacuum Chamber (IVC) and in normal running condition this vessel is thermalized to 4 K. Between the 300 K and 4 K vessel there is a thermal radiation shield at 40 K covered with multi-layer aluminized superinsulation. Up to five pulse tubes (PT) mounted on the OVC top plate provide the cooling for the 40 K radiation shield (PT first stages) and the IVC (PT second stages). The IVC encloses the detector and the shielding lead with a volume of about 3 m³.

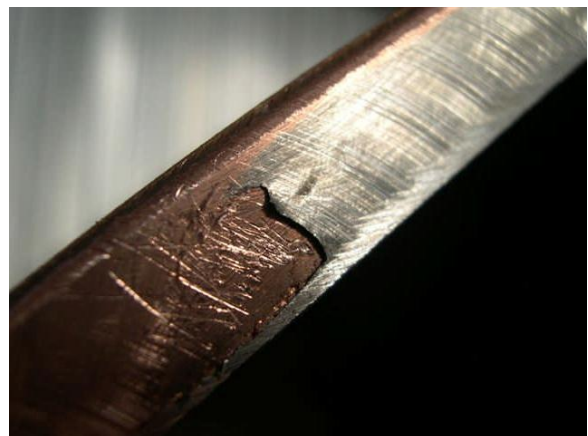
Figure 2: Defective welding at the steel-copper interface of the 300 K vessel.

copper plates which are first calendered and longitudinally welded. The cylinder pairs are then joined together, to the heads, and to the top flanges by three radial weldings. The quality of all welding seams was assessed at Pro-beam by means of dye penetration tests and X-rays. All weldings were also individually tested for helium leaks with a specially designed tool at Simic. Both type of weldings required several iterations to be tuned. In particular, the steel-copper weld turned out to be quite challenging mostly due to an uncompensated deflection of the electron beam in the proximity of the Cu-304L interface that resulted in a significant lack of fusion during the first welding attempt (Fig. 2). The problem was solved using an inclined beam (5° at a distance of 500 mm) and re-tuning the electron accelerating parameters of the Pro-beam machines. In order to achieve a larger margin of safety, the EBW was done joining the copper vessel with a 10 cm high steel ring. The steel flange of the 300 K vessel was joined to the ring later on, using standard Gas Tungsten Arc welding (GTAW). All GTAW weldings were performed using radiopure tungsten electrodes; they were selected by the INFN Radioactivity Laboratory located at University of Milano-Bicocca. Some of the Cu-Cu welds of the 300 K and 4 K vessel showed a significant level of porosity, which required two additional EBW passages. A second EBW passage was applied also to the steel-copper weld. The final quality assessment of the welds and, in particular, X-ray checks excluded lack of fusion. However, shallow and mid-depth porosities were still visible (Fig.3). Direct vacuum and pressure tests (see Sec. 6 below) demonstrated that these porosities do not weaken neither the vacuum tightness nor the structural properties of the vessel.

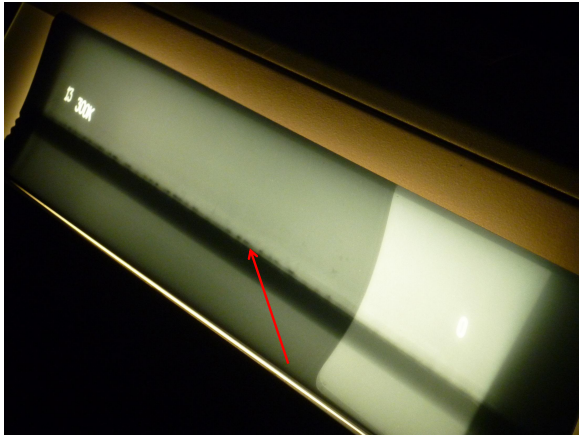
Figure 3: X-ray mark of the steel-copper welding. The gray spots pointed by the arrow are indication of shallow and mid-depth porosities.

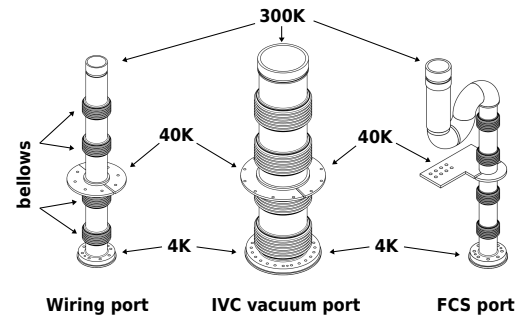
Figure 4: The wiring port, the IVC vacuum pumping port and the Fast Cooling System port.

age. This design allows the system to withstand seismic events with a peak ground acceleration as large as about 0.08g. Finally, several feedthroughs will be employed in CUORE for pumping, fast cooling with cold He and for the electrical leads of the detector (Fig. 4). During the tests at the production site we mounted only a few of them: the vacuum ports for the IVC and OVC, the two ports of the fast cooling and one wiring port. Fig. 5 shows the 300 K and 4 K plates connected by the A-bars with the above-mentioned ports before closing the chambers (see Sec. 5).

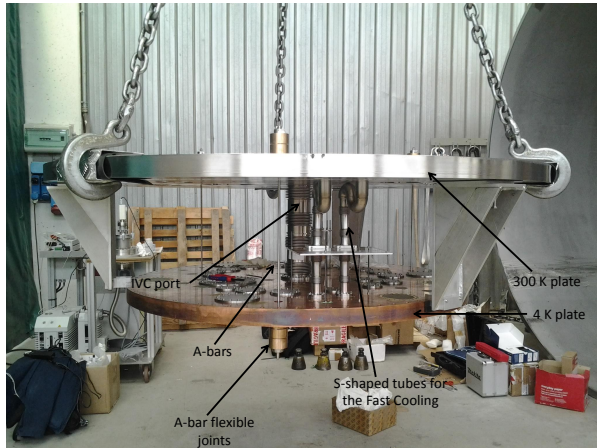
Figure 5: The 300 K and 4 K plates before positioning into the vessels. The plates are connected by the A-bars and the fast cooling tubes, the IVC vacuum tube and (not visible in the photo) the wiring tube are installed.

The test setup was built using the 300 K and 4 K vessels with their plates. The 300 K plate was connected to the 4 K plate using the A-bars, as in the final CUORE setup, while the 40 K vessel and plate were missing. The two plates were first connected together by the A-bars with the selected ports in place, then they were lowered onto the 4 K vessel. The vessel was sealed with the Helicoflex and, later on, the 300 K plate and the 4K plate-vessel assembly were positioned on top of the 300 K

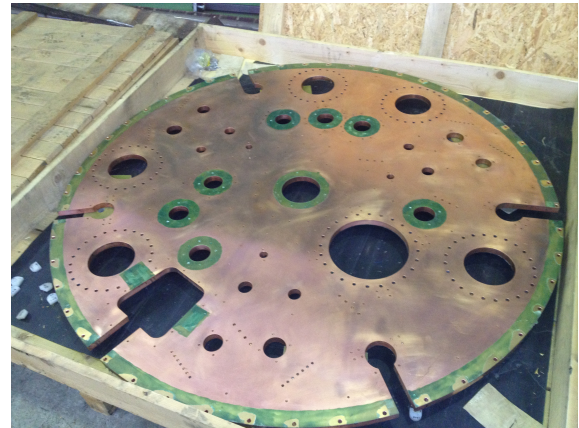
Figure 6: The 40 K plate with gilded flanges protected by a plastic layer.

and several flanges were gold plated in order to improve thermalization (Fig. 6). The copper has been selected for its very low bulk radioactivity, therefore special care has been put into the welding and milling procedures to preserve its purity. However, surface treatment after machining is needed to remove surface contaminations that can compromise radiopurity, vacuum (surface degassing) and thermal (emissivity) properties. In fact, from the radioactivity point of view, the surface cleaning of the cryostat outer shell is not particularly critical in CUORE since none of these parts are directly facing the bolometers. Unlike the innermost CUORE copper pieces [17] in contact to the detector, here the removal of surface contaminants was achieved by standard metal treatment for industrial applications. Still, degreasers, acids and solvents used during the processing of the metals were pre-selected for radiopurity. In particular, we have applied the treatment of the copper successfully employed for CUORICINO [4].

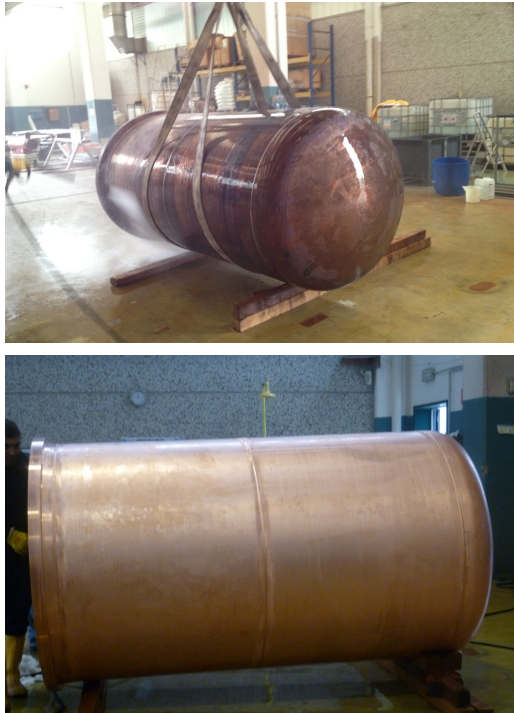
Figure 7: The 4 K vessel at the beginning and at the end of the cleaning procedure.

The surface contamination of the vessels was mainly due to machine oil deposited during calendaring (Fig.7). In most cases, pre-processing was necessary to remove the bulk of the machine oil. Such pre-processing was done with degreaser (10% weight), nitric acid ($\sim 1\%$ weight) in hot ($\sim 40^\circ\text{C}$) unpurified water solution. All gilded parts were protected by a peelable rubber coating (Green Maskant), which was removed before the installation at the production site (see Sec. 5). The 300 K plate, which is made from AISI 304L steel, was cleaned by INFN personnel at the production site. In this case, only the degreasing cycles and the final flushing with Grade 2 water were performed (Fig.8).

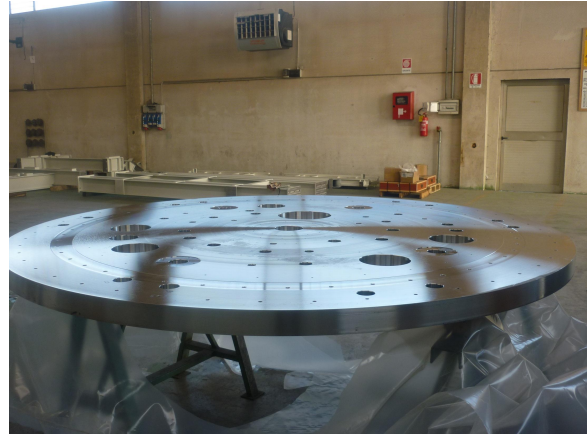
Figure 8: The 300 K plate after cleaning at the production site.

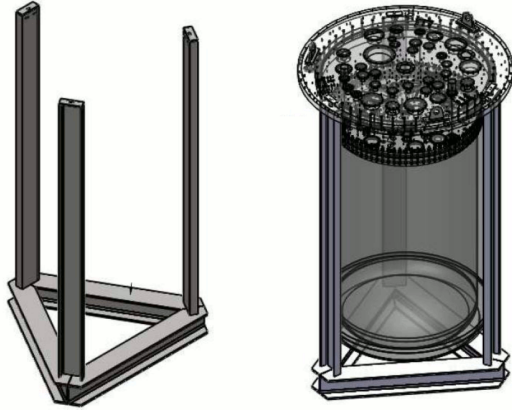
Figure 9: Iron support structure for the vessels at the production site (Courtesy of Simic s.p.a.).

vessel. This setup was held in vertical position by an iron support structure located near the pumps and the cooling system (see Fig. 9). Only a few selected ports (see Sec. 2) were employed during the tests, the 300 K and 4 K opening of the others were sealed with blanks. The use of the ports varied during the tests as described in Secs. 6. Before closing the 4 K chamber, each port was individually tested for helium tightness of all sealings to a level of about 10^{-9} mbar · l/s. High vacuum (down to 10^{-6} mbar at room temperature) was achieved using a 0.017 m³/s rotary pump coupled with a 0.3 m³/s hybrid turbo-molecular pump (ATH300, Adixen). The turbo-molecular pump was mounted just on the top of the IVC or OVC ports, to reduce flow impedance. The rotary pump was located on the ground floor and connected to the turbo through a DN25 flexible line. The cooling system was based on regulated flux of liquid Nitrogen (LN₂) stored in a 3000 l dewar and connected by a flexible line to the input port of the fast cooling system (FCS). A second port was employed as exhaust to keep the IVC at atmospheric pressure during cool-down. The LN₂ flow was regulated by a cryogenic solenoid valve positioned on the output line of the dewar. The cryogenic valve was driven by a set of thermometers located inside the test setup as described in Sec. 6.3.

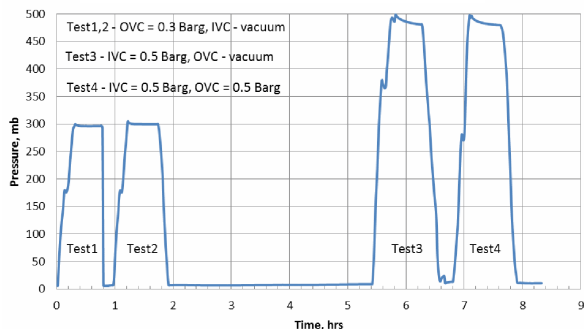
Figure 10: Pressure versus time in the IVC and OVC.

Overpressure was obtained injecting a He (50%) -Ar (50%) gas mixture in the IVC (OVC) port, while pumping the OVC (IVC). For greater safety, the test was performed filling a buffer bottle from a high pressure reservoir. The pressure of the buffer bottle (p_b) was chosen so that the expansion of the gas into the IVC (or OVC) was enough to bring the IVC to the sought-for pressure ($p_{IVC} = p_b V_b / V_{IVC}$, V_b and V_{IVC} being the volume of the buffer bottle and IVC respectively). In this way, there is no risk of accidental overpressure in the vessels even in case of a malfunction of the pressure reducer at the reservoir. During the expansion, the pressure at IVC/OVC was monitored by a digital pressure gauge and recorded by the DAQ system. The overpressure was kept for ~ 30 min in each cycle and every cycle was repeated twice (see Fig. 10).

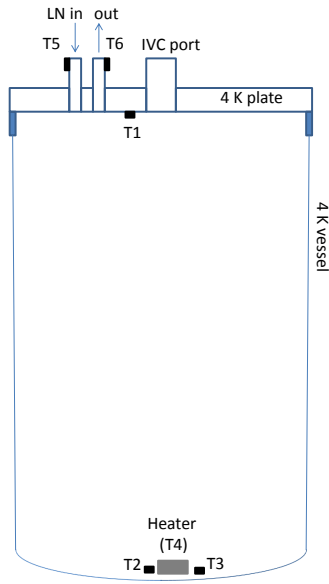
Figure 11: Position of the thermometers T1-T6.

As anticipated in Sec. 5, cooling was achieved circulating LN₂ from the input port of the FCS. The Nitrogen was extracted by the dewar at a pressure of 2 bar at the entrance of the cryovalve. The opening of the cryovalve was driven by four PT100 thermometers (T1, T2, T5, T7 in Fig. 11). T1 and T2 were located at the bottom and top of the 4 K vessel, respectively. T5 and T7 at the end and at the beginning of the line connecting the cryovalve to the FCS port. The cryovalve was opened/closed through a relay by a Lake Shore model 218 Temperature Monitor. The valve was open when the following conditions were fulfilled: $T_2 > 80$ K (no LN₂ accumulating in the bottom of the vessel), $T_1 - T_2 < 30$ K (temperature gradient along the height of the vessel < 30 K), $T_5 - T_7 < 200$ K (a safety condition to test the integrity of the transfer line). In addition, the temperature of the Nitrogen vapor at the exit of the vessel, i.e. at the output port of the FCS, was monitored (T6). A 60 W heater was also installed at the bottom of the vessel to speed up the warming. The regulation system, however, operated smoothly down to the target temperature ($T_1 = 82$ K) and the heater was not used in any phase of the cycle. Finally, T3 and T4 were employed as spare for T2 and as T monitor in the proximity of the heater, respectively.

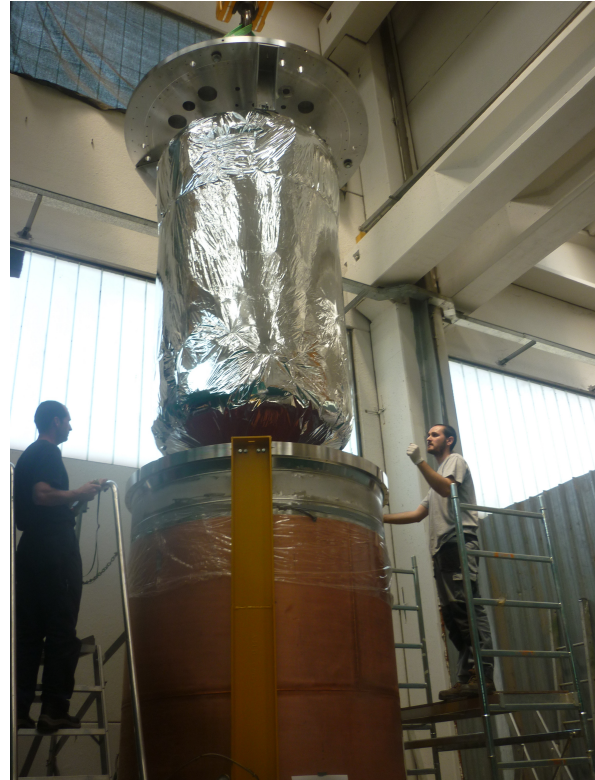
Figure 12: Insertion of the IVC into the 300 K vessel before the cold tests. The 4 K vessel and plate is wrapped with superinsulation.

Before the cold test, the 4 K vessel and plate were wrapped with a 10 layer aluminized superinsulation blanket (Ruag Space GmbH, model COOLCAT II, see Fig. 12). During cooldown, the IVC port was equipped with a rupture disk with burst pressure 0.45 ± 0.05 bar, a drop-off plate (300 mbar) and connected to the pressure gauge used during the tests of Sec. 6.2. Along this line, a pressure switch set at 200 mbar was connected in parallel to the relay driving the cryovalve. Hence, the maximum overpressure causing a stop of the cooling was set to 200 mbar while exhaust through the IVC port was granted at 300 mbar. The OVC port was used to connect the turbo pump to the OVC and record the pressure with a high-vacuum pressure gauge. The wire port was employed for the readout of the thermometers and to drive the heater with a 24V/3A DC current generator.

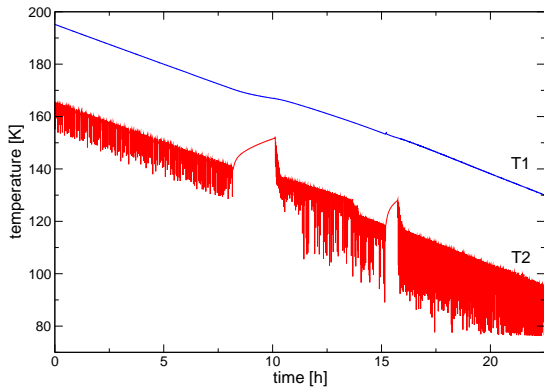
Figure 13: Temperature at T1 (4 K plate) and T2 (bottom of the 4 K vessel) during cooldown. The temperature jumps at T2 occurred after 8 and 15 hours from the beginning were caused by failure of the silicon tube section in the LN₂ transfer line.

Cooldown started with a pressure in the OVC of $p_{OVC} = 3.8 \times 10^{-5}$ and 1.8×10^{-5} mbar in the first and second cycle, respectively. During cooldown it reached a minimum value of $p_{OVC} = 5 \times 10^{-8}$ mbar. The cooldown rate was stable (see Fig. 13) at about

3 K/h and the opening of the cryovalve was driven by the $T1-T2 < 30$ K condition until $T1 \approx 110$ K, i.e. when the temperature at T2 was close to LN_2 temperature. Then, cool-down was mostly driven by the $T1 > 80$ K condition. The temperature reached at the end of the cooling was 82.5 K (84 K) at T1 and 77 K (77 K) at T2 during the first (second) cycle. The LN_2 consumption per cycle was about 1800 l, the total mass to be cooled being 2012 kg. As expected, LN_2 consumption was ~ 2 times larger than for an ideal cooling system that uses only the latent heat of vaporization (900 l [14]). Warm-up was purely passive (no use of heaters) in both cycles. While keeping high vacuum in the OVC ($p_{OVC} = 5 \times 10^{-3}$ mbar with the turbo pump off) the warming rate was about 3 K/h and it reached 4 K/h when p_{OVC} was brought to 1 mbar. In the final phase of the warm-up ($T1 \approx 260$ K), in order to increase the heat exchange and maintain a warming rate of 4 K/h, p_{OVC} was brought to 50 mbar.
