# Testbeam and Laboratory Characterization of CMS 3D Pixel Sensors

**ABSTRACT:** The pixel detector is the innermost tracking device in CMS, reconstructing interaction vertices and charged particle trajectories. The sensors located in the innermost layers of the pixel detector must be upgraded for the ten-fold increase in luminosity expected at the High-Luminosity LHC (HL-LHC). As a possible replacement for planar sensors, 3D silicon technology is under consideration due to its good performance after high radiation fluence. In this paper, we report on pre- and post- irradiation measurements of CMS 3D pixel sensors with different electrode configurations from different vendors. The effects of irradiation on electrical properties, charge collection efficiency, and position resolution are discussed. Measurements of various test structures for monitoring the fabrication process and studying the bulk and surface properties of silicon sensors, such as MOS capacitors, planar and gate-controlled diodes are also presented.

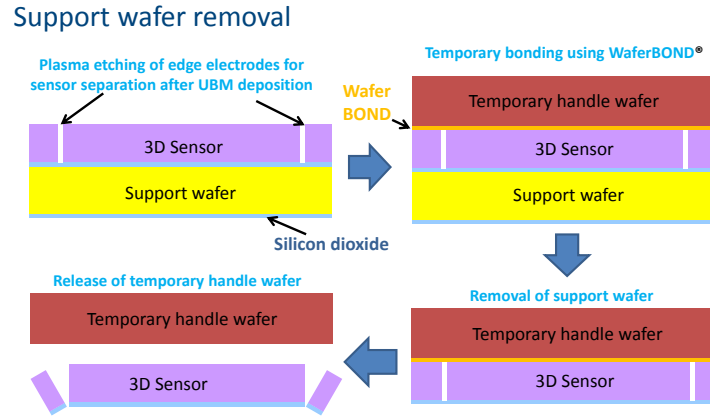
**Figure 3.** Support wafer removal to obtain Active Edge 3D sensors using plasma etching and temporary bonding for supporting the separated sensors.

In order to reduce the costs and improve yield, Fondazione Bruno Kessler (FBK), Trento, Italy [6], and Centro Nacional de Microelectronica (CNM-IMB), Barcelona, Spain [7], have independently developed the so-called 3D Double-side Double-Type Column (3D-DDTC) sensors. These designs offer advantages with respect to the original 3D sensor technology, in terms of: (a) reduced process complexity, (b) allowing columnar electrodes without requiring a support wafer, and (c) allowing the back side fully accessible for module assembly. SINTEF, Norway [8] has developed the capability of producing full 3D detectors by single-sided processing using a support wafer. By plasma etching instead of dicing, and dopant diffusion of an electrode at the edge of the sensor, an active edge can be obtained which reduces the width of the inactive periphery to only a few microns. Figures 1 and 2 show the cross-section and pixel sensor layout of 3D pixel sensors, manufactured at FBK and SINTEF respectively. One of the challenges of SINTEF technology is the removal of 300  $\mu\text{m}$  thick support wafer. SINTEF recently removed the support wafer by DRIE (deep reactive ion etching). Temporary bonding using the new WaferBOND<sup>©</sup> developed by Brewer Science [10] was used to keep the sensors in place once the support wafer was removed. Figure 3 shows the various steps involved in removal of the support wafer from SINTEF 3D wafers.

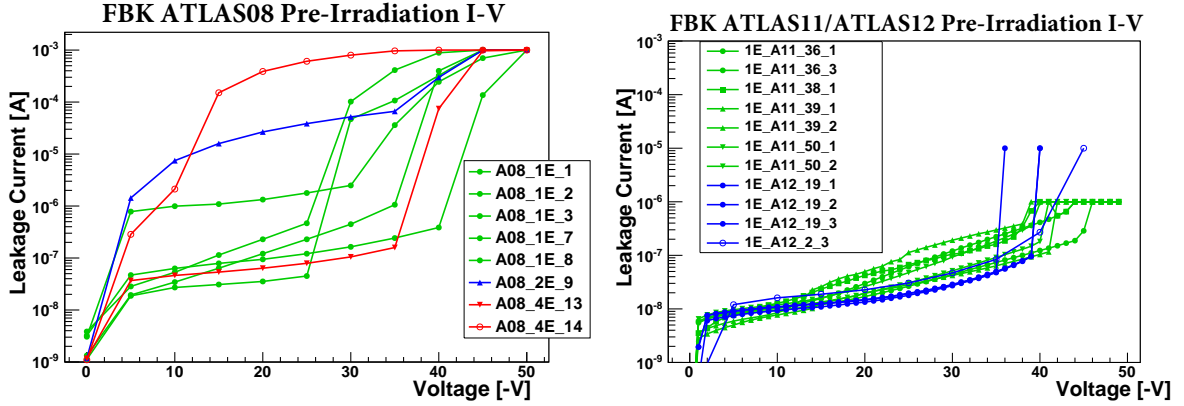
**Figure 4.** I-V measurement of FBK 3D pixel sensors before irradiation at 20°C from ATLAS08 batch (left) and IBL ATLAS11 and ATLAS12 batches (right).

The electrical characterization (I-V and C-V measurements) of FBK and SINTEF 3D pixel sensors was performed in the laboratory at room temperature on-wafer and after dicing. The on-wafer measurements were done using a temporary metal layer which connected all the pixels together, and was later removed as a final processing step. The leakage current,  $I_L$ , was again measured after bump bonding for quality control. The measured  $I_L$  for assembled modules as a function of the bias voltage,  $V_{Bias}$ , for FBK ATLAS08, ATLAS11 and ATLAS12 batch sensors are shown in Figure 4. ATLAS08 sensors have a depletion voltage of  $\sim 5V-10V$ ,  $I_L=10$  nA -  $10 \mu A$ , and a breakdown voltage of 35V-45V. ATLAS08 (Figure 4 (left)) was one of the first batches of 3D sensors produced at FBK with fully passing through columns and had some fabrication problems. The inter-pixel isolation in ATLAS08 sensors was done using a p-spray doping of  $3 \times 10^{12}$   $P/cm^2$ . The p-spray doping caused high electric fields at the junction of the  $n^+$  columns and p-spray on the front side of the sensor. The high electric field combined with mechanical stress due to wafer bowing and other surface effects, such as increased oxide charge density and higher surface mobility caused a high leakage current density ( $1 \mu A/cm^2$ ) and unusually low breakdown voltage in this batch [11, 13]. The p-spray doping was reduced to  $2 \times 10^{12}$   $P/cm^2$  in ATLAS09 and later batches used for the construction of the ATLAS Insertable B layer (IBL) [9]. As clearly shown in Figure 4 (right), the change in the process improved the breakdown voltage in IBL sensors, while maintaining sufficient inter-pixel isolation. FBK ATLAS11 and ATLAS12 1E sensors have better and more uniform  $I_L$  (10-200 nA) and improved breakdown voltage (35V-45V). The  $I_L$  of these 3D sensors meets the required specifications and it is comparable to the current CMS planar sensors (10-100 nA).

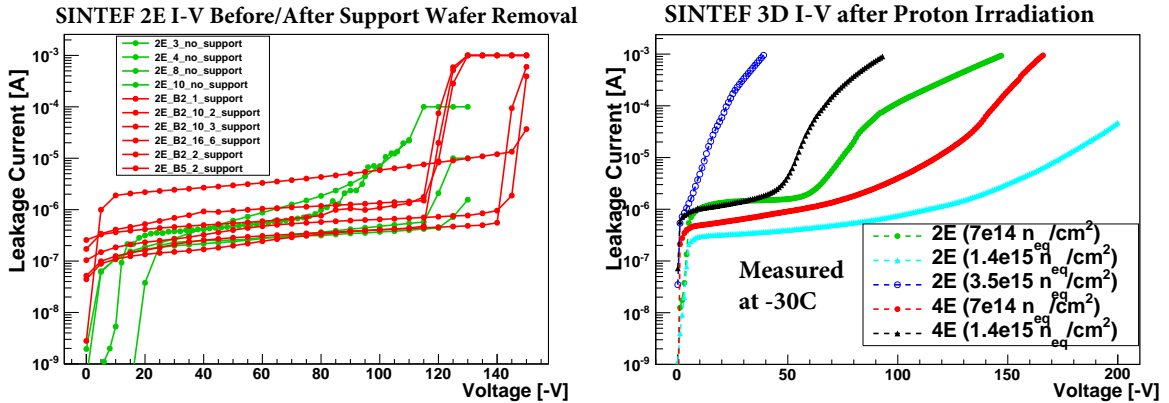
**Figure 5.** I-V measurements of SINTEF 2E sensors before and after support wafer removal (left), Leakage current of SINTEF 3D sensors after  $7 \times 10^{14}$  -  $3.5 \times 10^{15}$   $n_{eq}/cm^2$  proton irradiation (right).

wafer was recently removed in some SINTEF sensors. The I-V was measured for assembled 2E and 4E sensors. The measurements show that  $I_L$  of the 2E sensors (200 nA - 4  $\mu$ A) is better than that of 4E sensors (1  $\mu$ A - 10  $\mu$ A). The sensors get fully depleted at ~10V-20V, the breakdown voltage is 100V-140V for 2E sensors and 90V-110V for 4E sensors. Figure 5 (left) shows the leakage current for different SINTEF 2E sensors, before and after the removal of support wafer. The slight decrease in breakdown voltage after support wafer removal for some sensors is due to fabrication defects introduced on the edges of the sensors after separation from the support wafer. These defects are introduced during DRIE (deep reactive ion etching) and other processing steps during support wafer removal, and the correlation between these defects and the increase in leakage current is still under investigation

Figure 5 (right) shows  $I_L$  for SINTEF 3D sensors after fluences of  $7 \times 10^{14} - 3.5 \times 10^{15} \text{ n}_{\text{eq}}/\text{cm}^2$  measured at  $-30^\circ\text{C}$ .  $I_L$  increases to 500 nA -  $5 \mu\text{A}$  while the breakdown voltage changes to 50V-160V. The I-V distributions show a non-flat slope in many sensors after irradiation, which is due to trap-assisted thermal generation of charge carriers in the band gap region. For the SINTEF 3D sensor which received the dose of  $3.5 \times 10^{15} \text{ n}_{\text{eq}}/\text{cm}^2$ , it was difficult to measure  $I_L$  due to thermal runaway.

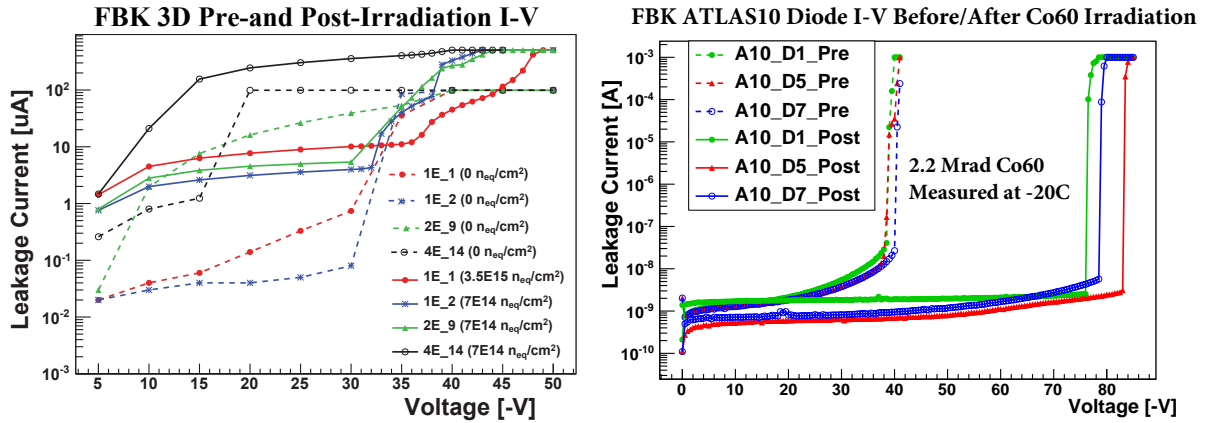
**Figure 6.** I-V measurements of FBK 3D ATLAS08 sensors (left) before/after  $7 \times 10^{14} - 3.5 \times 10^{15} \text{ n}_{\text{eq}}/\text{cm}^2$  proton irradiation, and FBK ATLAS10 1E diodes (right) before/after 2.2 Mrad  $\text{Co}^{60}$  gamma irradiation.

the surface effects due to irradiation using  $\text{Co}^{60}$  gamma irradiation and bulk effects with 800 MeV protons. Figure 6 (left) shows the FBK ATLAS08 sensors measured at  $-20^\circ\text{C}$  after  $7 \times 10^{14} - 3.5 \times 10^{15} \text{ n}_{\text{eq}}/\text{cm}^2$  proton irradiation. The  $I_L$  in FBK ATLAS08 after proton irradiation increases to  $2 \mu\text{A} - 120 \mu\text{A}$ , which is caused by radiation induced defects. The depletion voltage slightly increases to 7V-10V (extracted from CV measurements), while the breakdown voltage slightly improves to 35V-45V. A similar effect was observed in 3D diodes from the same batch (ATLAS08) irradiated with up to 2 Mrad X-rays. This is to be ascribed to the high p-spray implant dose used in ATLAS08 batch, which minimizes the beneficial effect of radiation-induced oxide charge build-up on the breakdown voltage. As already mentioned, in more recent FBK batches [9], the p-spray dose was reduced, resulting in a higher breakdown voltage before irradiation and in a much larger breakdown voltage increase after irradiation (up to 160V) [14].

This improvement can also be appreciated from Figure 6 (right), which shows the change in the I-V in FBK ATLAS10 diodes after 2.2 Mrad  $\text{Co}^{60}$  gamma irradiation. As expected, gamma irradiation mostly creates surface defects and there is no trap assisted bulk carrier generation, so the leakage current does not change significantly after irradiation. The breakdown voltage increases from 40V to 80V after irradiation. Gamma irradiation generates a higher concentration of oxide charges that reduces the effective p-spray doping between the neighbouring pixels. This leads to lower electric fields at the junction of n+ columns and the p-spray region surrounding them and improves the breakdown voltage.

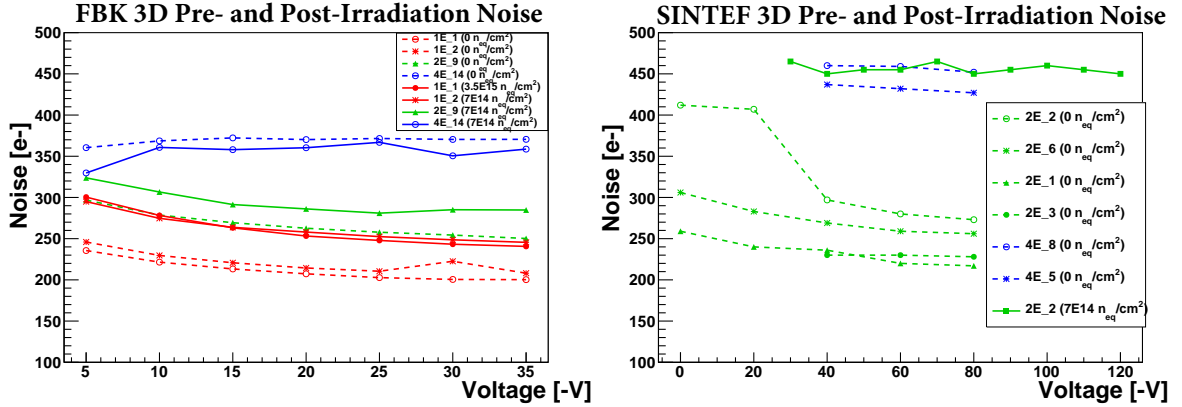
Figure 7. Noise before and after  $7 \times 10^{14} - 3.5 \times 10^{15} n_{\text{eq}}/\text{cm}^2$  irradiation: for ATLAS08 sensors (left) and SINTEF 3D sensors (right).

Figure 7 shows the measured noise before irradiation (dotted) and after irradiation (solid) for FBK ATLAS08 (left) and SINTEF 3D sensors (right). Higher number of electrodes leads to larger capacitance, and higher noise. Before irradiation, the noise of 2E (4E) sensors is  $\approx$  two (four) times larger than that of 1E and planar sensors. SINTEF 3D sensors have different thickness ( $200\ \mu\text{m}$  and  $285\ \mu\text{m}$  bulk with a support wafer of  $300\ \mu\text{m}$ ) which explains the difference in noise among various 2E sensors. Capacitance (and thus noise) should not rise much with radiation. The small increase in noise after irradiation ( $50e^- - 100e^-$ ) in FBK sensors is mainly due to increased shot noise caused by increased leakage current. The large increase in noise in SINTEF 2E sensor after irradiation is still under investigation.

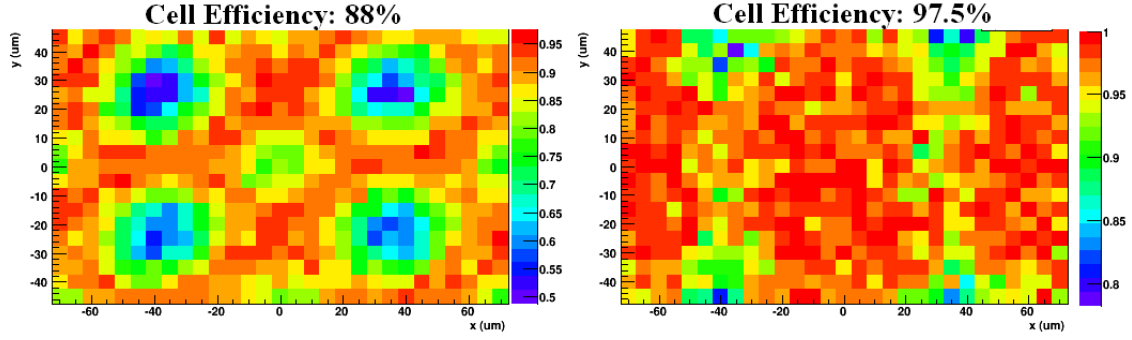
**Figure 8.** Hit efficiency of SINTEF 3D 4E sensor at 0 degree (left) and at 20 degrees (right) measured before irradiation in beam tests.

The hit efficiency in a pixel cell was measured for 2E and 4E sensors using events with single tracks. The sensors were operated with a threshold of 3.9 ke<sup>-</sup> before irradiation. Figures 8 (left) shows the efficiency for a 4E SINTEF pixel reconstructed from all the tracks information. The sensor was biased at -100V with the detector orthogonal to the beam (angle of 0°). The measured average hit efficiency was ≈ 88% for 4E sensor at 0°. The low average hit efficiency is explained by the charge loss in the bias and readout electrodes which are partially inactive volumes. As shown in Figure 2, a SINTEF 4E sensor has four n<sup>+</sup> readout columns in the middle of the pixel, and nine p<sup>+</sup> electrodes corresponding to bias columns surrounding them. The efficiency increases by rotating the Detector Under Test (DUT) at an angle of 20° on the short pitch with respect to the beam axis, reaching a value of 98.7% for 2E (from 94% at 0°) and 97.5% for 4E sensors (from 88% at 0°) respectively. This is shown in Figure 8 (right) for the 4E sensor. Increasing the angle beyond 20° did not improve efficiency further due to increased charge sharing, which reduced the charge collected inside the pixel below the threshold of the ROC. The loss of efficiency due to the electrodes is less problematic for 1E sensors.

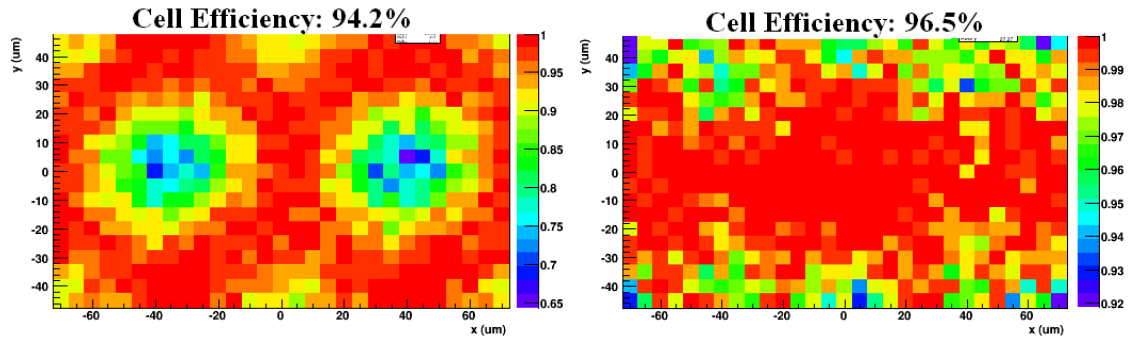
**Figure 9.** Hit efficiency of SINTEF 2E sensor after  $7 \times 10^{14} \text{ n}_{\text{eq}}/\text{cm}^2$  proton irradiation: at 0 degrees (left) and at 20 degrees (right)

in sensor performance causing increased noise (shot noise due to leakage current). Also, after irradiation, the depletion voltage increases, so higher  $V_{bias}$  must be applied in order to fully deplete the sensor and recover full charge and hit efficiency. Figure 9 shows the hit efficiency for a SINTEF 2E pixel sensor after exposure to a fluence of  $7 \times 10^{14} \text{ n}_{eq}/\text{cm}^2$ . The average efficiency of the SINTEF 2E sensor after irradiation is reduced to 94.2%. By rotating the sensor to  $20^\circ$  with respect to the beam on the short pitch, the average hit efficiency improves to 96.5% (Figure 9 (right)).

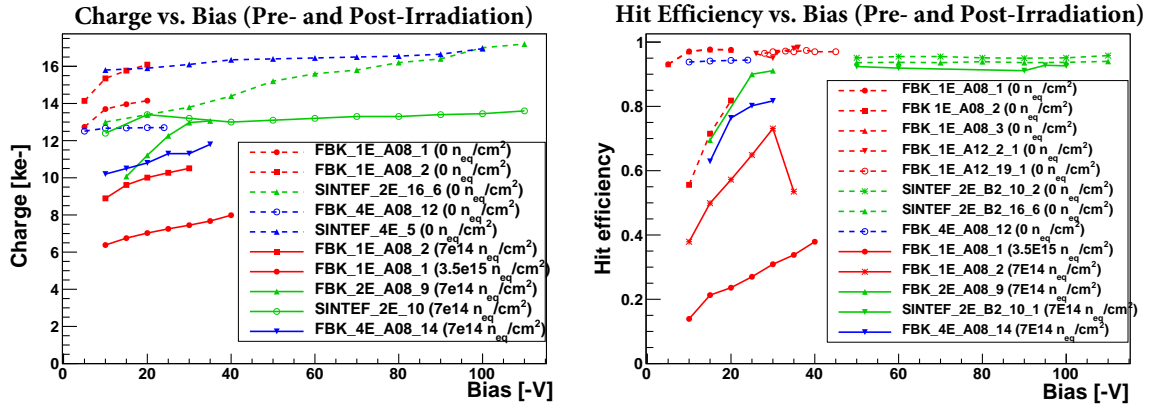
**Figure 10.** Charge vs. Bias using  $\text{Sr}^{90}$  source (left) and Hit Efficiency vs. Bias measured in beam tests (right) of FBK and SINTEF 3D sensors before and after irradiation.

Charge collection was measured in the laboratory with a  $\text{Sr}^{90}$  source, before and after irradiation for FBK and SINTEF 3D sensors. The analog ROC was operated with a threshold of  $3,900 e^-$ . Figure 10 (left) shows the most probable value (MPV) of the charge collected as a function of  $V_{\text{Bias}}$  before (dotted) and after (solid) irradiation. The amount of charge collected increases at larger values of  $V_{\text{Bias}}$ . Table 1 summarises the charge collected in various FBK ( $200\ \mu\text{m}$  thickness) and SINTEF ( $285\ \mu\text{m}$  thickness) 3D sensors, before and after irradiation. There are small differences between measured charge (as shown in Table 1) and expected values of charge collected (assuming 75 electron-hole pairs generated per micron thickness in silicon at room temperature) for both SINTEF and FBK 3D sensors. There are several possible factors which could explain the lower charge collected in these 3D sensors. One possible reason for the reduced charge collected in SINTEF

Figure 10 shows the charge collected (left) from Sr<sup>90</sup> source (discussed earlier in Section 3.2) and the pixel hit efficiency (right) as a function of  $V_{bias}$  for the same sensors, before irradiation (dotted curves) and after irradiation (solid curves). The FBK and SINTEF sensors are fully depleted by ~5V and ~10V respectively before irradiation, and the sensors reach their maximum hit efficiency at very low  $V_{bias}$ . Table 2 shows the average value of hit efficiency obtained after 20° rotation for various FBK and SINTEF 3D sensors. Hit efficiency, even after rotation, decreases going from 1E to 4E layouts since the inactive area due to readout electrodes increases.

Figure 10 shows the charge collected (left) and the hit efficiency (right) as a function of the  $V_{bias}$ . Both quantities typically increase as a function of  $V_{bias}$ , up to full depletion voltage after which both the charge and efficiency remains constant. However, for many irradiated FBK sensors due to early breakdown after irradiation, the applied bias voltage is not high enough to saturate the charge collected or hit efficiency. Nonetheless the charge collected for all 3D sensors is above 6,000  $e^-$  already at 10V for all 3D detectors types. Table 2 summarises the hit efficiency for various FBK and SINTEF 3D sensors, before and after irradiation. The efficiency loss is a strong function of fluence and rises as the fluence increases. The average hit efficiency loss of FBK 1E sensors rises from 25% to 59.9% after a fluence of  $7 \times 10^{14} \text{ n}_{eq}/\text{cm}^2$  and  $3.5 \times 10^{15} \text{ n}_{eq}/\text{cm}^2$  respectively. The average hits efficiency loss in FBK ATLAS08 batch and SINTEF 2E sensors ranges between 2-4 % while FBK 4E sensors show a loss in average hit efficiency of 13% after an irradiation to  $7 \times 10^{14} \text{ n}_{eq}/\text{cm}^2$ . 2E sensors exhibit the best performance after irradiation. As observed earlier in Section 3.2, the charge loss after irradiation is less in 4E sensors compared to 2E, but the larger inactive volume due to 4 inactive readout electrodes makes the hit efficiency of 4E sensors worse compared to 2E sensors.

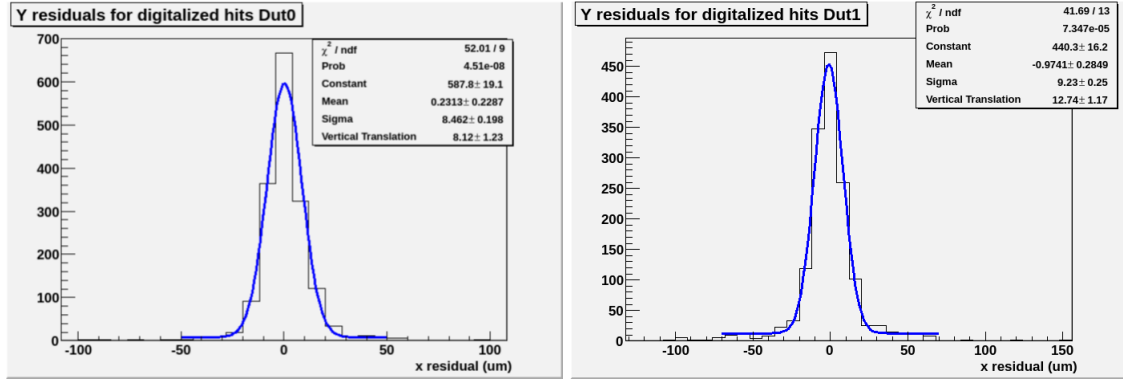
**Figure 11.** Y residual of SINTEF 2E sensor before irradiation (left) and after  $7 \times 10^{14} \text{ n}_{\text{eq}}/\text{cm}^2$  proton irradiation (right).

Track residuals are calculated as the distance between the predicted and measured positions of a cluster, in either the local X or Y direction. The residuals are fitted with a Gaussian distribution: the overall sensor resolution is determined from the sigma of the Gaussian fit. The uncertainty due to the telescope resolution is subtracted from the the total track resolution (including DUTs) to obtain the DUT resolution. For FBK sensors from ATLAS08 batch, best post-irradiation residual of  $12.56 \mu\text{m}$  was measured for a 2E sensor. Figure 11 shows the measured track residual for a SINTEF 2E sensor, before and after irradiation. The measured track residual was  $8.5 \mu\text{m}$  before irradiation (left) and  $9.2 \mu\text{m}$  after irradiation (right).

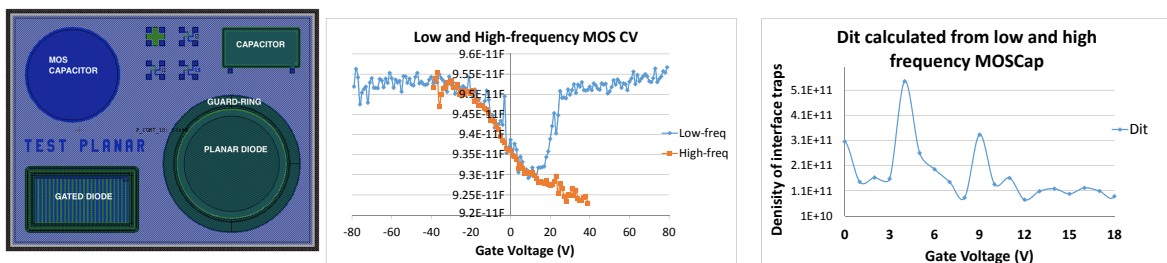
**Figure 12.** Various test structures from FBK ATLAS10 batch (left), low and high frequency CV of MOS capacitor (middle), and measured density of interface traps (right).

The electrical and tracking properties of pixel sensors depend on material properties of bulk silicon and its interface with silicon dioxide. For example, in pixel sensors, interface traps and fixed oxide charge affect the surface current, the breakdown voltage, the capacitance, and the isolation between electrodes. Moreover, ionizing radiation also affects the noise and gain of the front-end readout chip. In order to better understand the bulk and interface properties of silicon sensors, and their effects on sensor properties, various test structures for FBK ATLAS10 and later batches were measured and their material parameters were calculated. Figure 12 (left) shows some of these structures: MOS capacitors, planar diodes, gate controlled diodes and other structures. The measurements include I-V measurements, I-T measurements, and quasi-static and high frequency C-V measurements. Figure 12 (middle) shows the low-frequency (1-2 Hz) and high-frequency (1kHz) C-V measurements measured for MOS capacitors. Figure 12 (right) shows the density of interface traps for ATLAS10 sensors calculated by combining quasi-static and high-frequency C-V measurements. The density of interface traps measured was  $1.6 \times 10^{11} - 8.9 \times 10^{11} \text{ traps}/\text{cm}^2$ . This value is comparable to the ideal value of  $10^8 - 10^{10} \text{ traps}/\text{cm}^2$ . Similarly, by measuring I-V and C-V of planar diodes and combining the results, generation lifetime of electrons was measured as  $\tau_{g1} = 5.78 \text{ ms}$  and  $\tau_{g2} = 3.64 \text{ ms}$  for two different diodes. Generation and recombination lifetimes help to understand the leakage current and charge collection results.
