ATLAS silicon module assembly and qualification tests at IFIC Valencia

ABSTRACT: ATLAS experiment, designed to probe the interactions of particles emerging out of proton proton collisions at energies of up to 14 TeV, will assume operation at the Large Hadron Collider (LHC) at CERN in 2007. This paper discusses the assembly and the quality control tests of forward detector modules for the ATLAS silicon microstrip detector assembled at the Instituto de Física Corpuscular (IFIC) in Valencia. The construction and testing procedures are outlined and the laboratory equipment is briefly described. Emphasis is given on the module quality achieved in terms of mechanical and electrical stability.

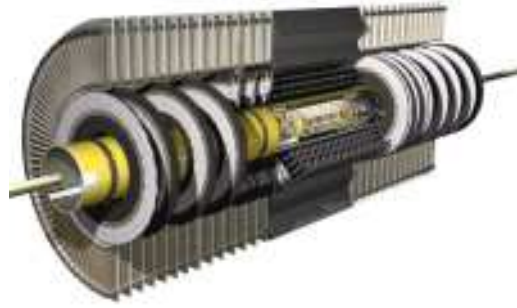
Figure 1: Layout of the ATLAS Inner Detector: it comprises the Transition Radiation Detector, the Semiconductor Tracker and the Pixel system from the outer to the inner radii, respectively.

The microstrip detector (Semiconductor Tracker, SCT) [4], as shown in Fig. 1, forms the middle layer of the ID between the Pixel detector [3] and the TRT [5]. The SCT system comprises a barrel made of four nested cylinders and two end-caps of nine disks each. The barrel layers carry 2112 detector units (*modules*) altogether, while a total of 1976 end-cap modules are mounted on the disks. The whole SCT occupies a cylinder of 5.6 m in length and 56 cm in radius with the innermost layer at a radius of 27 cm.

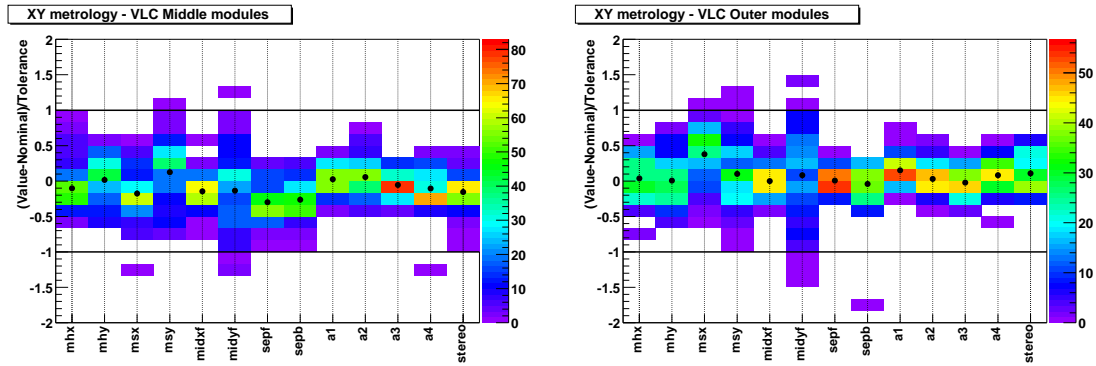
Figure 9: XY-parameters distributions for middle (left) and outer (right) modules, normalised as $(value - nominal) / tolerance$.

As mentioned before, the module dimensions were measured twice: just after gluing the components together and before wire-bonding, and once more after the thermal cycling. The overall final-measurement results for all 13 XY parameters are shown in Fig. 9. The majority of the modules are well within the specifications, apart from some cases where parameter *midyf* exceeds the allowed limits. These cases stand for the majority of the modules characterised as *Pass*.

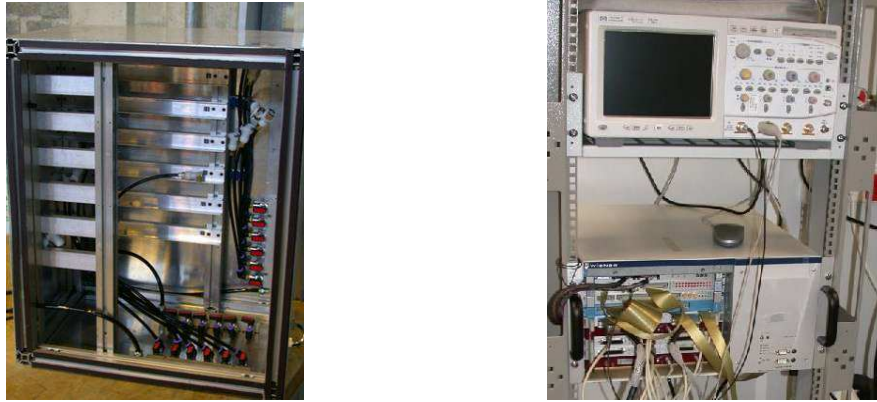
Figure 11: Electrical tests setup: the light-proof box (left) and the readout boards installed in the VME crate (right).

In all the measurements performed, the ASICs are powered with three standard SCT low-voltage power supplies, SCTLV, and read out electrically via a system, comprising one SLOG, one MUSTARD and one AERO board, installed in two VME crates as pictured in Fig. 11 (right). Two SCTHV high voltage units provided detector bias to the modules. A second complete setup including the respective readout system was also built, to serve as a backup in the event of failure of the first one. A detailed description of the SCT readout system is given in Refs. [19, 7].

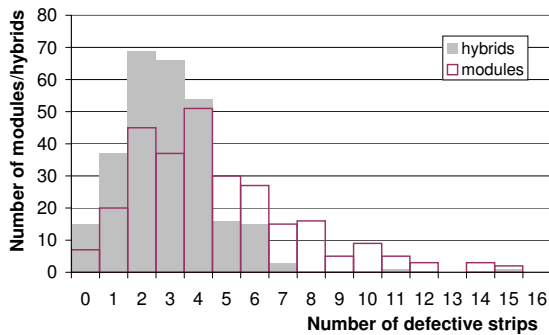
Figure 14: Number of defective strips distribution per hybrid and per module.

The distributions of the number of defective channels per unassembled hybrid and per module are shown in Fig. 14. These include types of critical defects, such as dead, stuck, noisy channels, channels that have not been wire-bonded to the strips and channels that cannot be trimmed (*untrimmable*). These channels are masked during normal operation and are practically *lost*. Also included in the distributions are less critical faults such as low or high gain (or offset) with respect to the chip average, which are still operational.

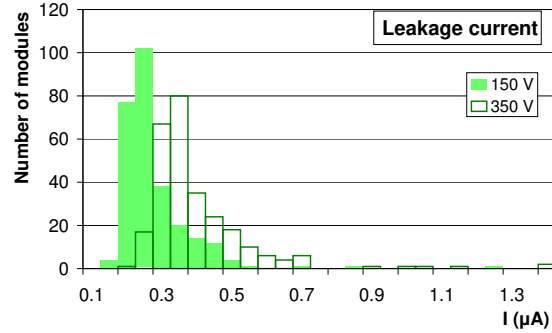
Figure 17: Leakage current distributions at 20 °C for a bias voltage of 150 V and 350 V.

The distributions of leakage current for a bias voltage of 150 V and 350 V are shown in Fig. 17. These results, taken at a hybrid temperature of $\sim 20^\circ\text{C}$, represent the final current measurements during module assembly and they do not include modules rejected because of high current. The values spread partly reflects the strong dependence of the leakage current on temperature, roughly doubling every 7°C . The last 11 modules were assembled with sensors demonstrating relatively high leakage current that were designated for use during the (pre-)qualification phase. After training at progressively increasing high voltage for long periods of time (1–2 days), all of these modules, apart from one (#160), were successfully recovered delivering an acceptable IV curve.

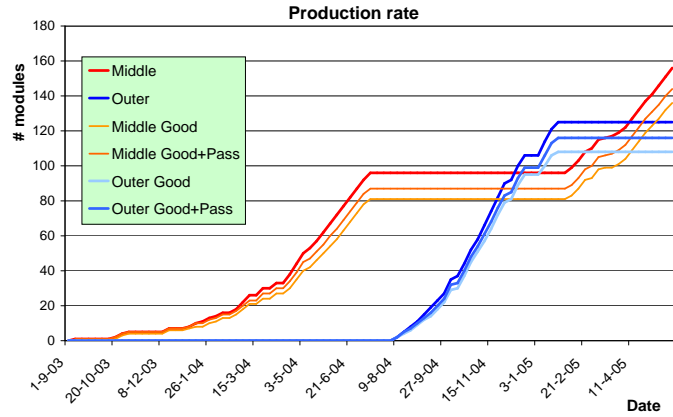
Figure 21: Accumulated number of produced modules as a function of time.
