ISR PERFORMANCE REPORTRun 133, 15.12.1971, 22 GeV, 20 bunchesPurposes

ISR RUNNING-INRun 132 - 14 December 1971Rings 1 and 2 - 22 GeV/c - 20 bunchesParasitic activity during setting upQ shifts introduced by horizontal bumps in I6Working line 22 FB in both rings

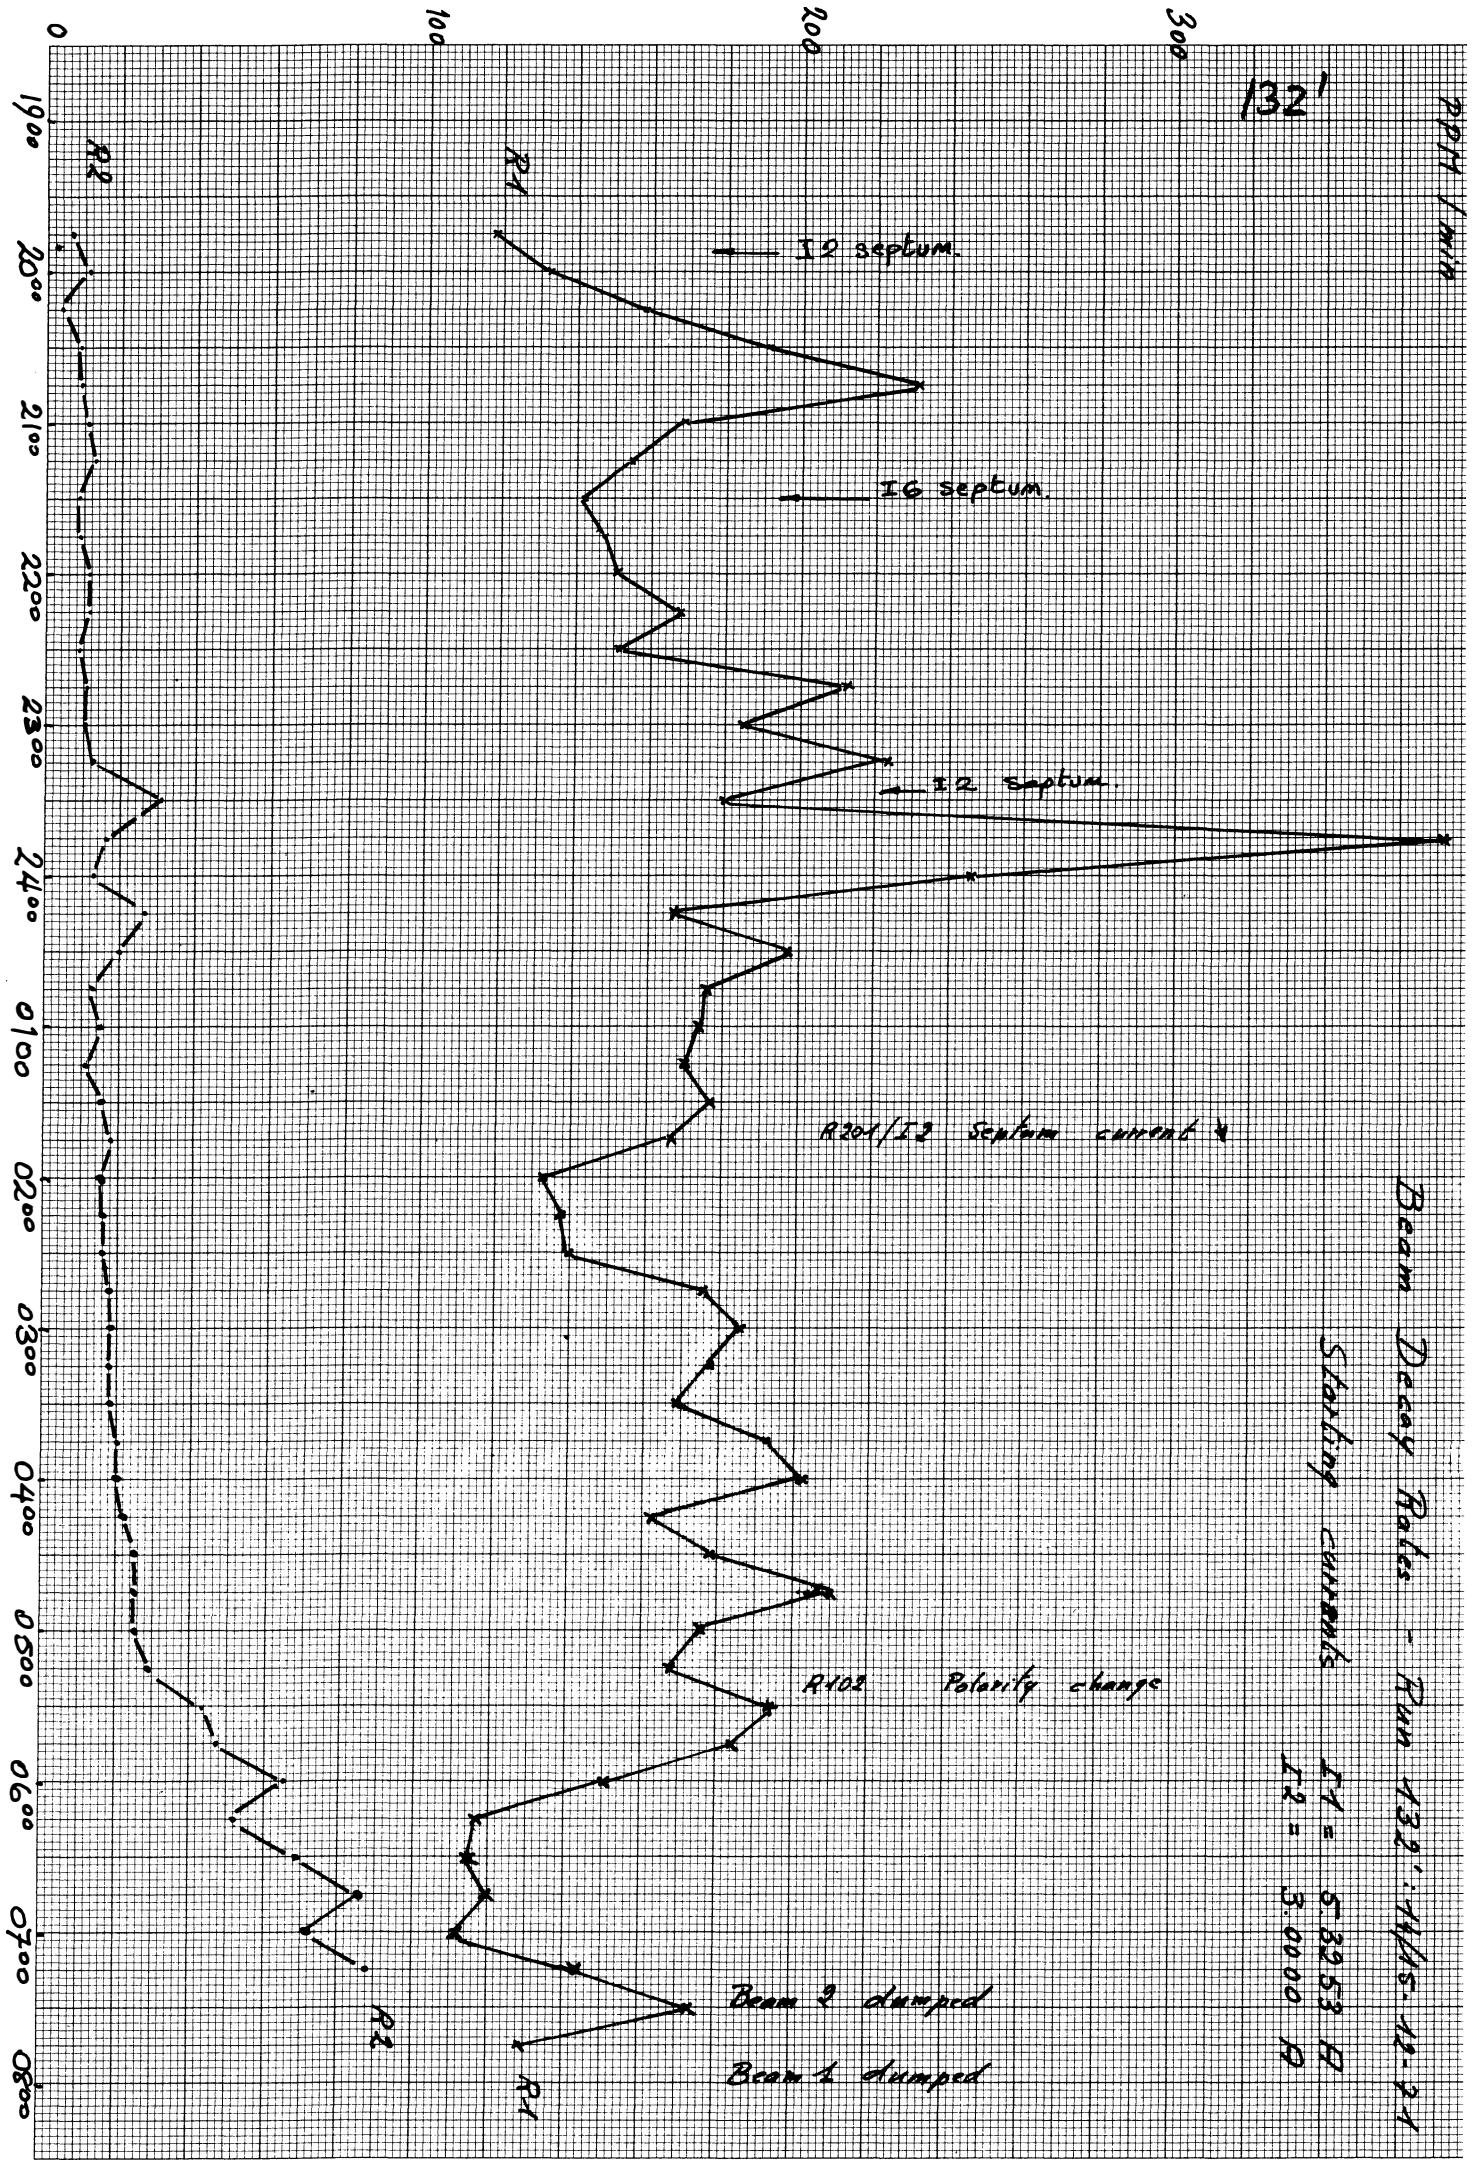
Beam Decay Rates - Run 132' : 11/15 - 12-21

Starting currents

I1 = 5.8253 A
I2 = 3.0000 A

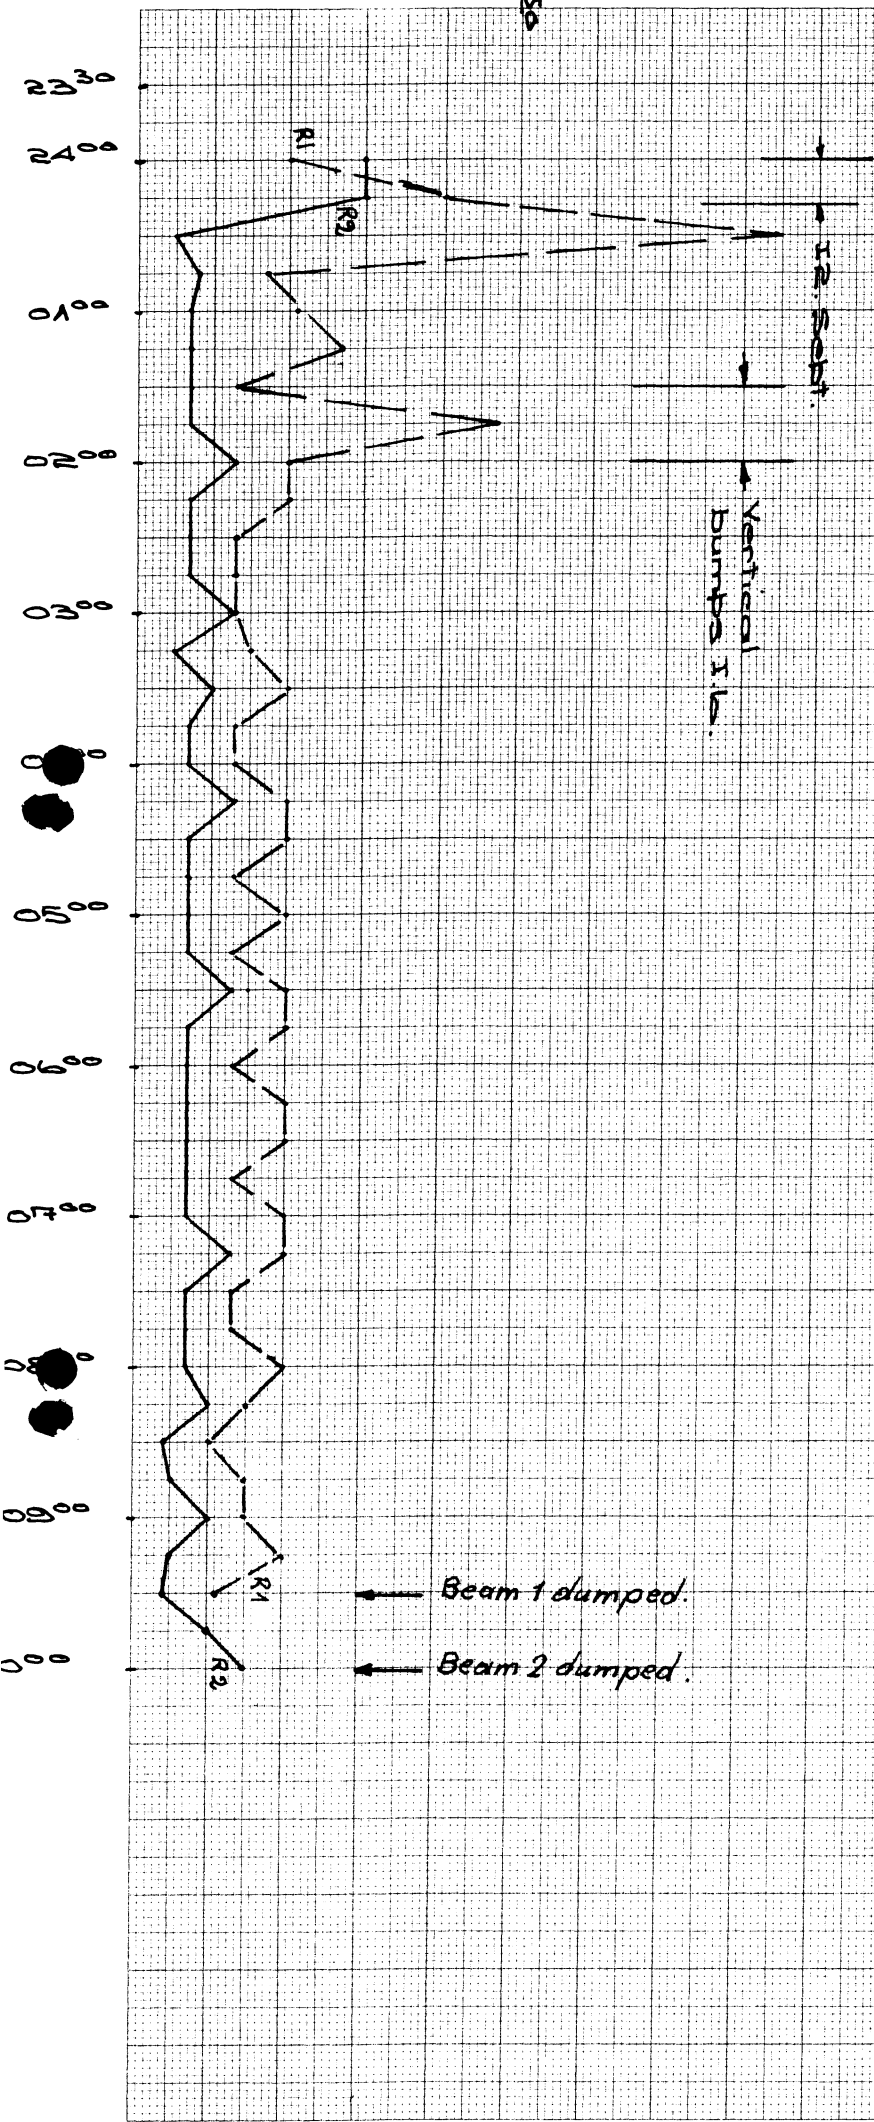
Beam Decay rates - Run 131' 13/14.12.71

Starting currents

R1 = 1,3346A.
R2 = 1,3645A.

— R1.
- - - R2.

Beam 1 dumped.

Beam 2 dumped.
