# JTA Skyway 2017 Routine Inspection of Bridge Structures

Prepared For:  
Jacksonville Transportation Authority

Prepared By:  
RS&H, Inc. with/  
FIT Engineering, LLC

Final Draft Report

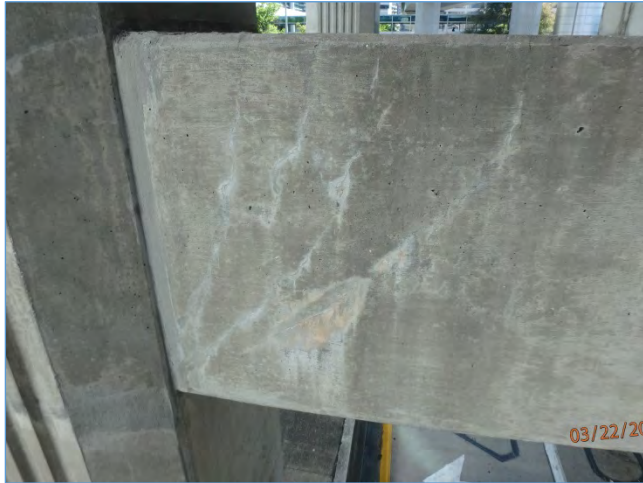
The worst substructure cracking in the system is located on the pier caps and load bearing struts at the San Marco Station; Piers 237 thru 240. Numerous shear, flexure and shrinkage cracks are present on the caps and the struts, noted up to 0.04" wide. The major design difference between these piers and those elsewhere throughout the system (including at other stations), is the unsupported length of caps. For nearly the same depth of section, these caps (and struts) are spanning much longer distances. Elsewhere in the system, the maximum cap length between column centerlines is about 35'. At the San Marco Station, the cap and strut lengths range between 47' and 57'. See the photos below.

Pier 238: Diagonal Shear Cracks on Strut at RT Column
